Unit 1 Primary Containment Vessel Internal Investigation ～ Analysis of image data and dose data ～

July 27, 2017

Tokyo Electric Power Company Holdings, Inc

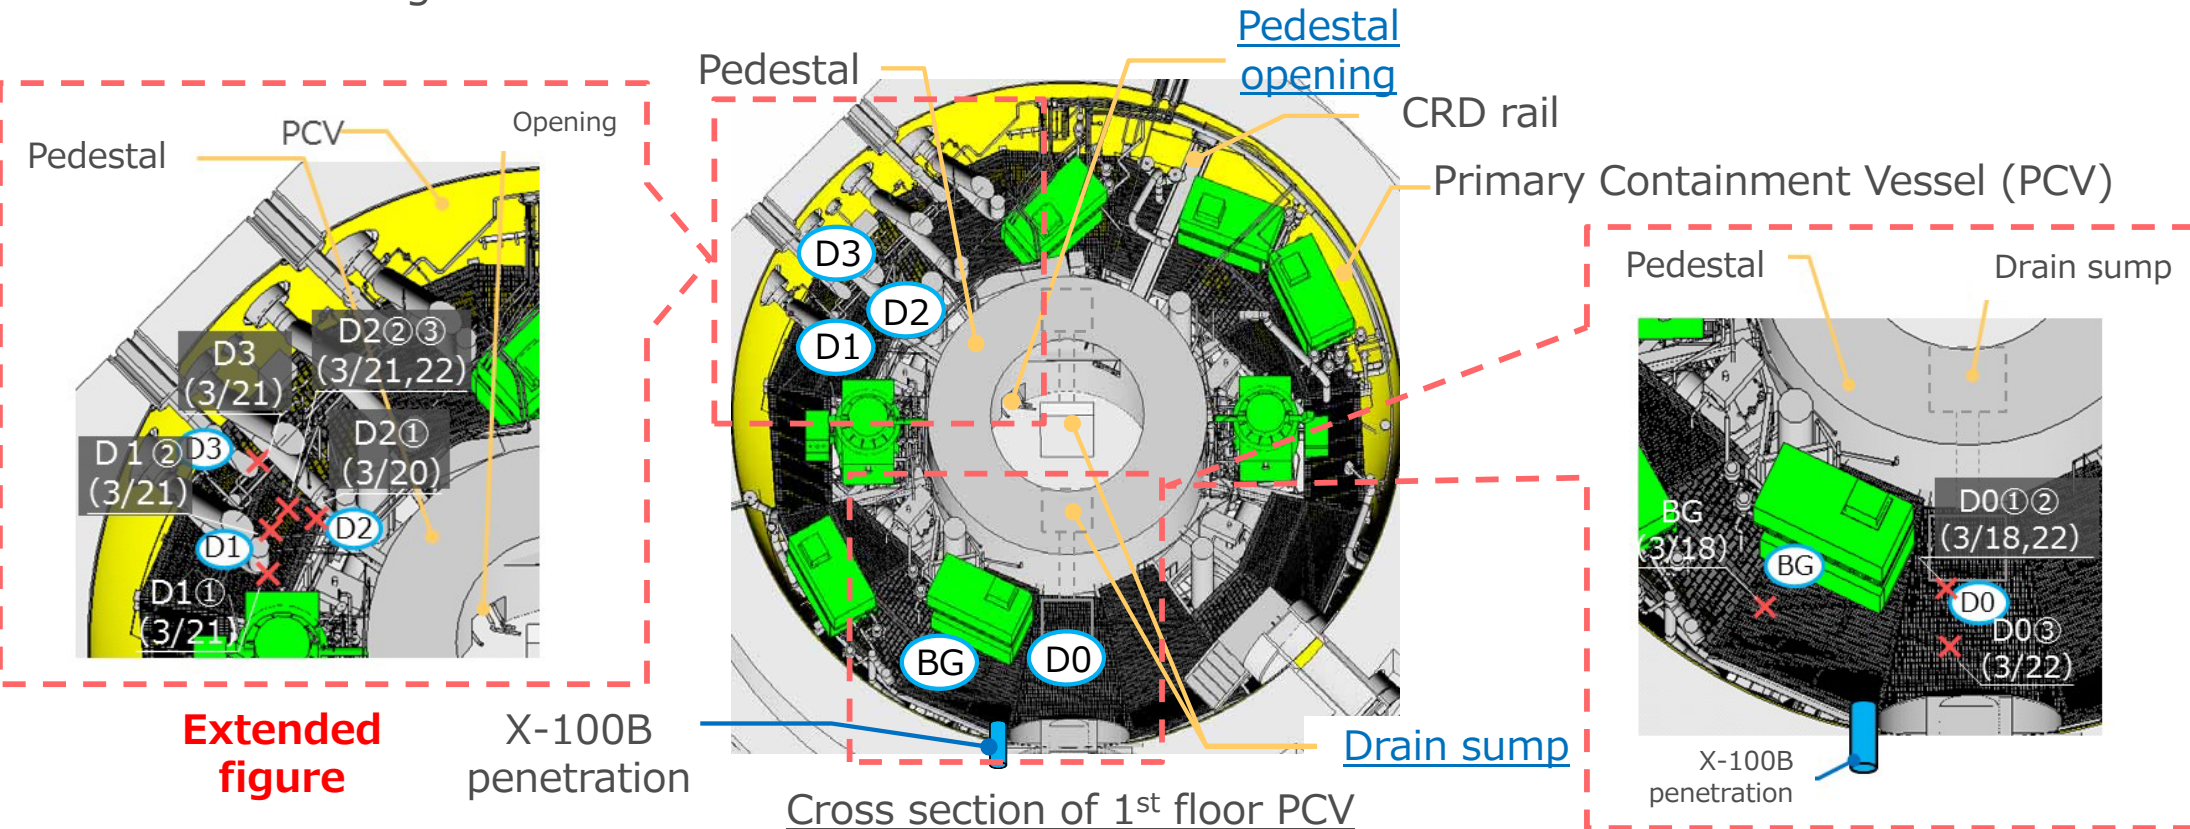
- We sharpened the images took in March, 2017 and re-analyzed, while examined the possibility of debris diffusion from the pedestal opening using dose data gathered in the investigation.
- Positions of image and dose data are as follows:

Measurement points	Purpose of measurement
D0①～③	Diffusion of fuel debris from the drain sump
BG	Background levels against D0～D3 measurement
D1①②, D2①～③	Diffusion of fuel debris from pedestal opening
D3	Possibility of fuel debris reaching to the PCV shell

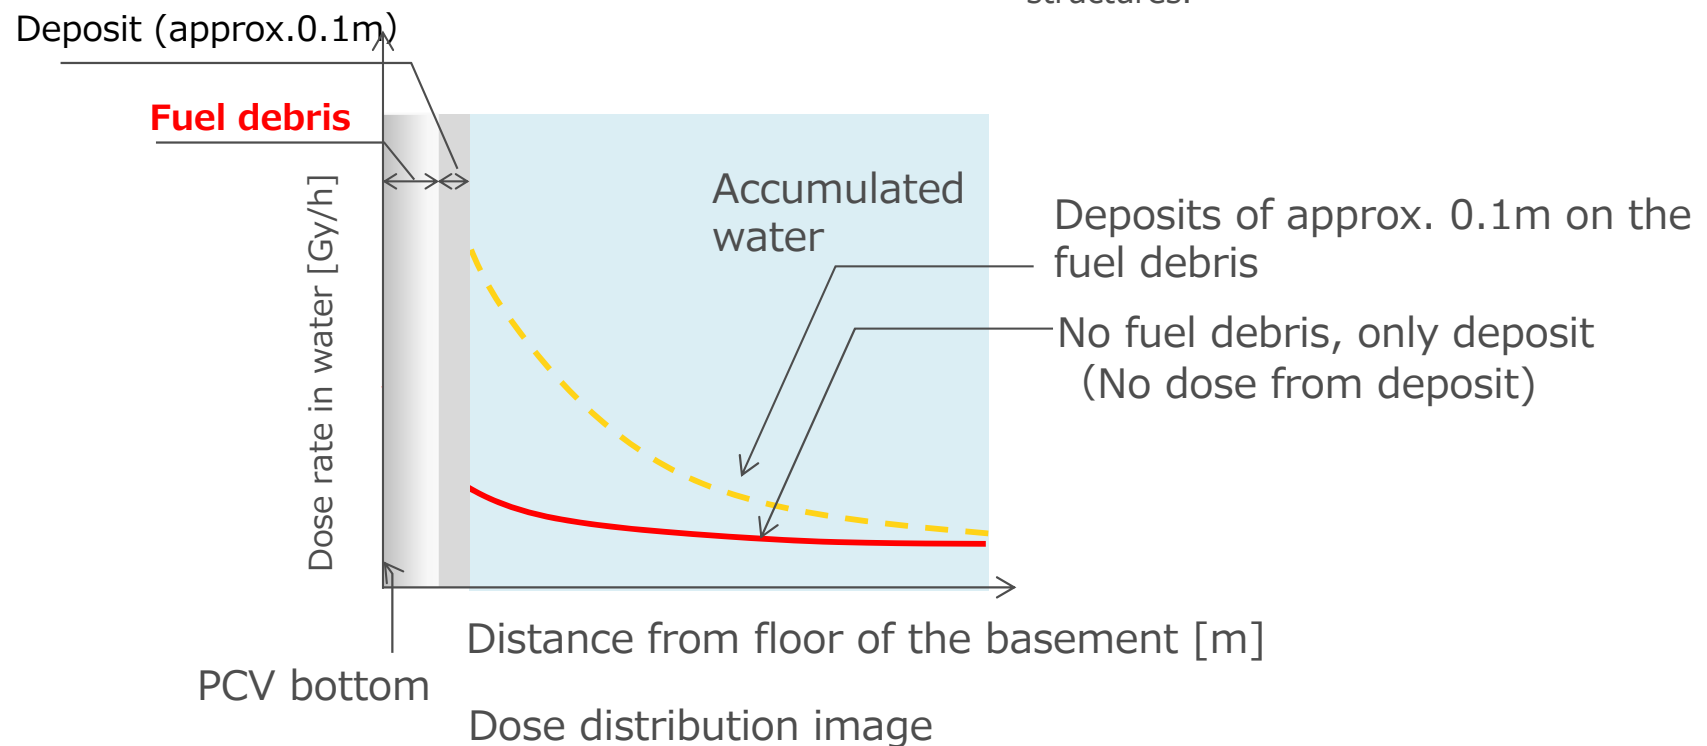
- In the case that fuel debris exist at the PCV bottom※ and there are deposits of less than 0.1 m (assuming concrete as deposit in analysis) on the debris, we found it possible to estimate the possibility of fuel debris under deposits.

※ It is assumed that fuel melted the structures in the reactor at the accident and fused with Co-60 in the structures.

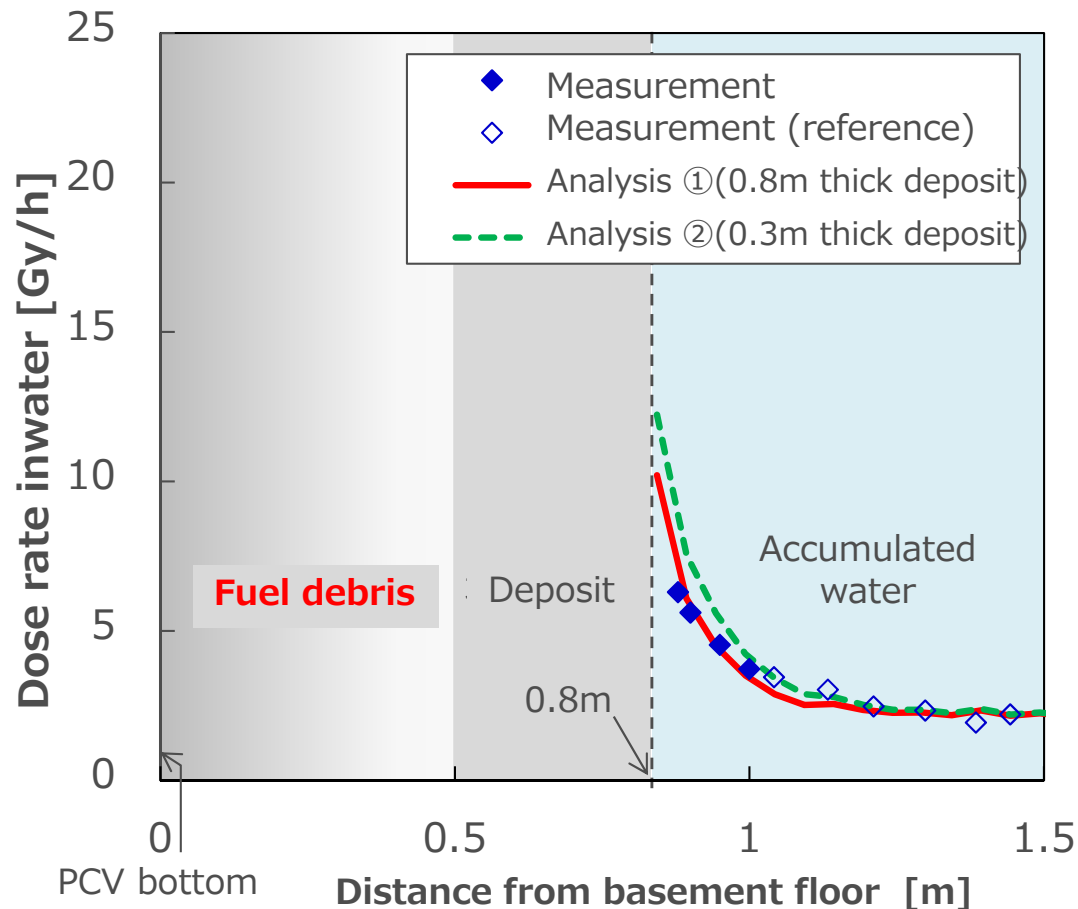
■ Point D1①

Analysis condition (Deposit height is 0.8m)

① Deposit thickness : 0.8m

② Deposit thickness : 0.3m

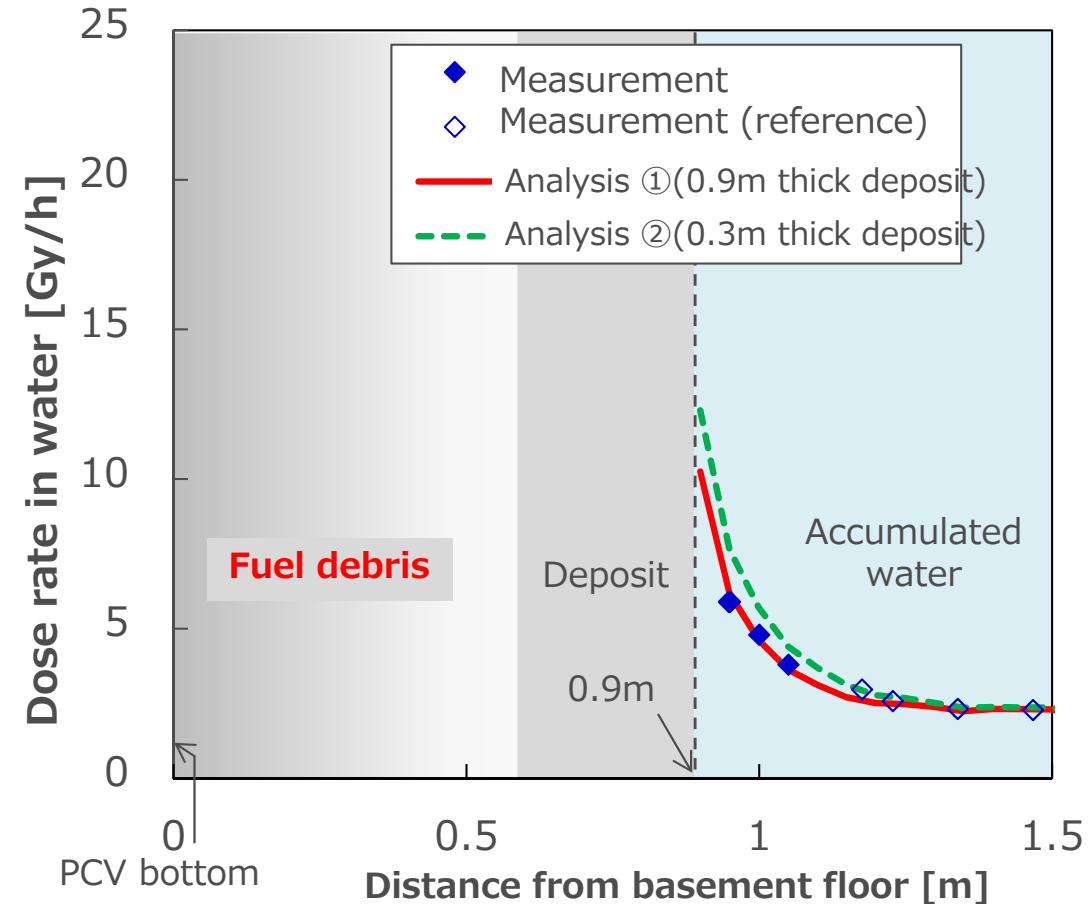
■ Point D1②

Analysis condition (Deposit height is 0.9m)

① Deposit thickness : 0.9m

② Deposit thickness : 0.3m

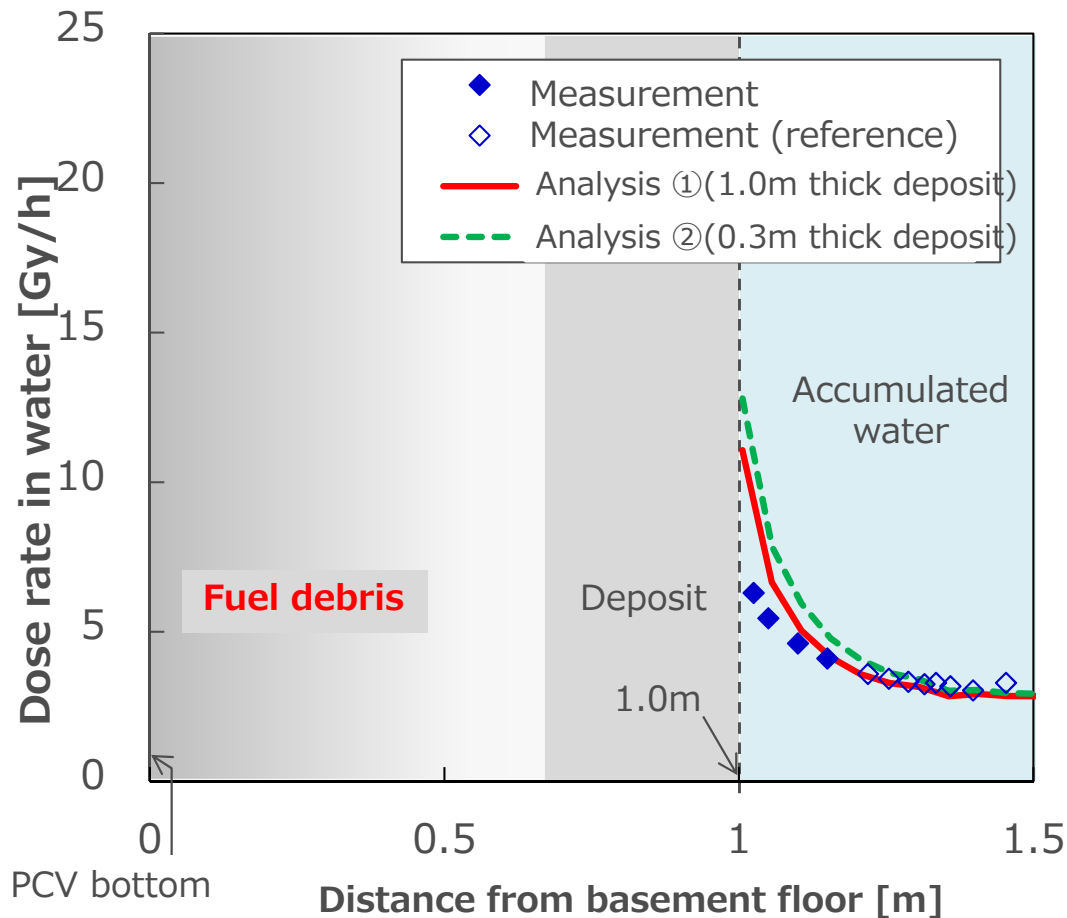
■ Point D2①

Analysis condition (deposit height is 1.0m)

① Deposit thickness : 1.0m

② Deposit thickness : 0.3m

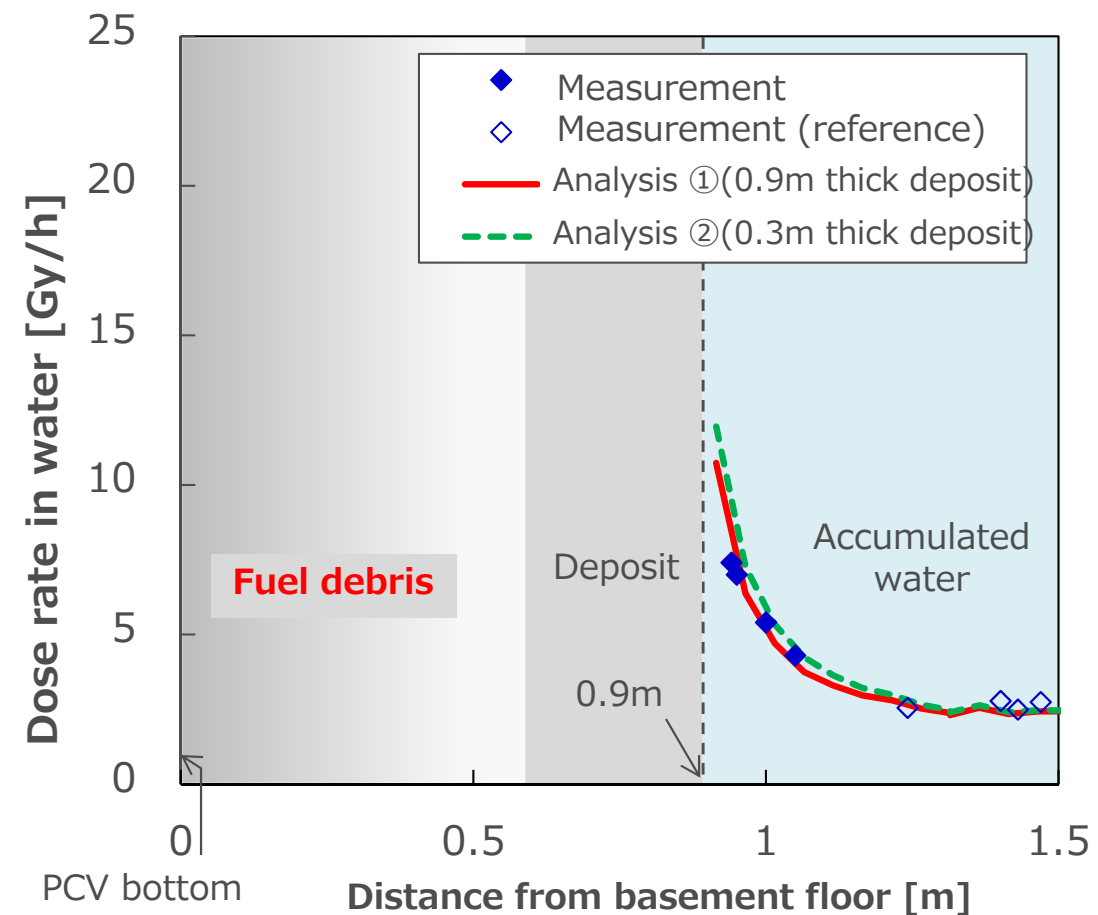
■ Point D2②

Analysis condition (deposit height is 0.9m)

① Deposit thickness : 0.9m

② Deposit thickness : 0.3m

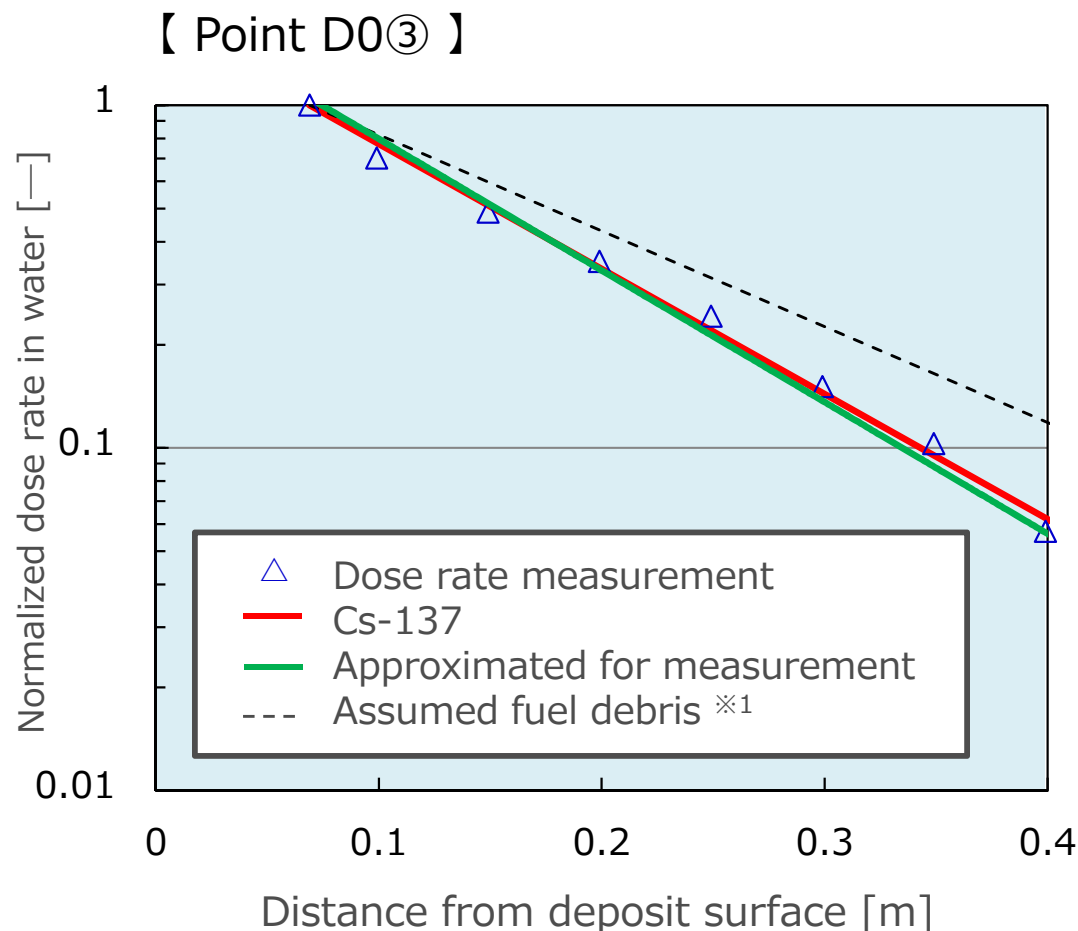
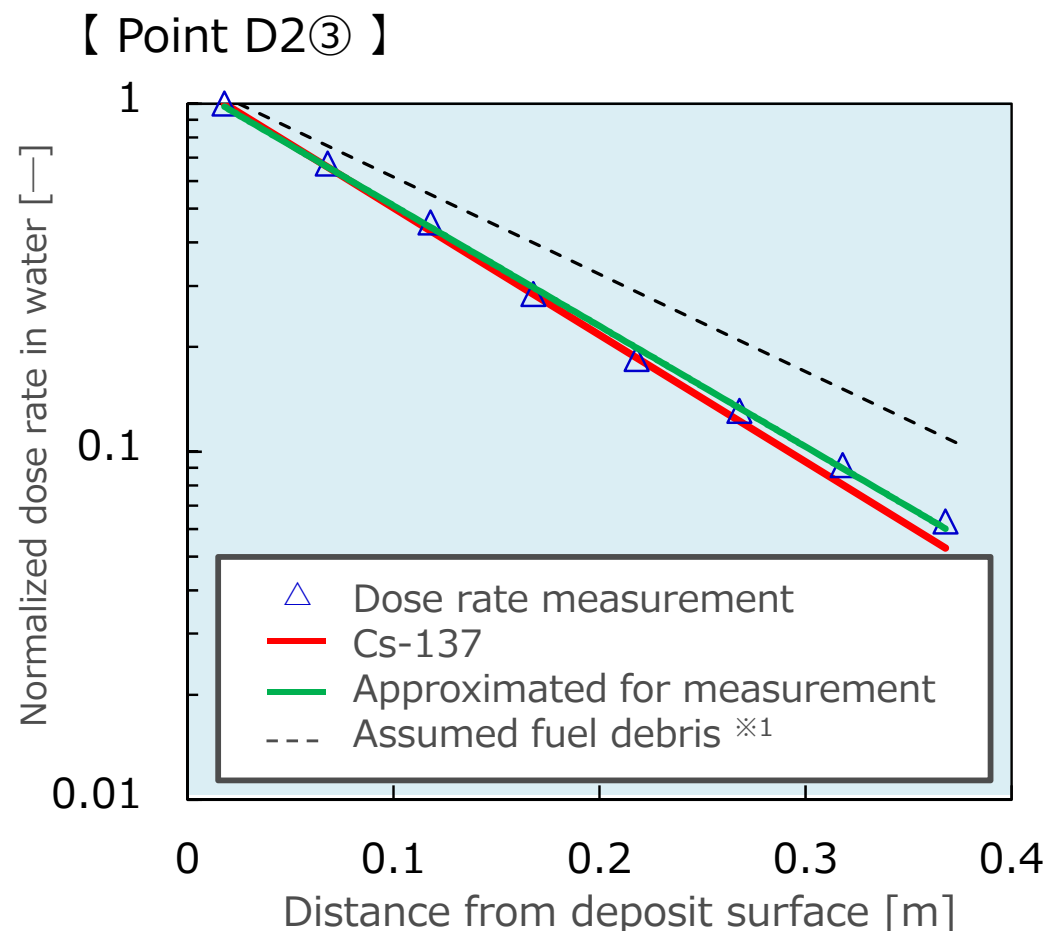
Main source on the deposit surface – D0③,D2③

※1 It is assumed that fuel melted the structures in the reactor at the accident and fused with Co-60 in the structures.
