Unit 2 Primary Containment Vessel Internal Investigation

November 30, 2017

Tokyo Electric Power Company Holdings, Inc.

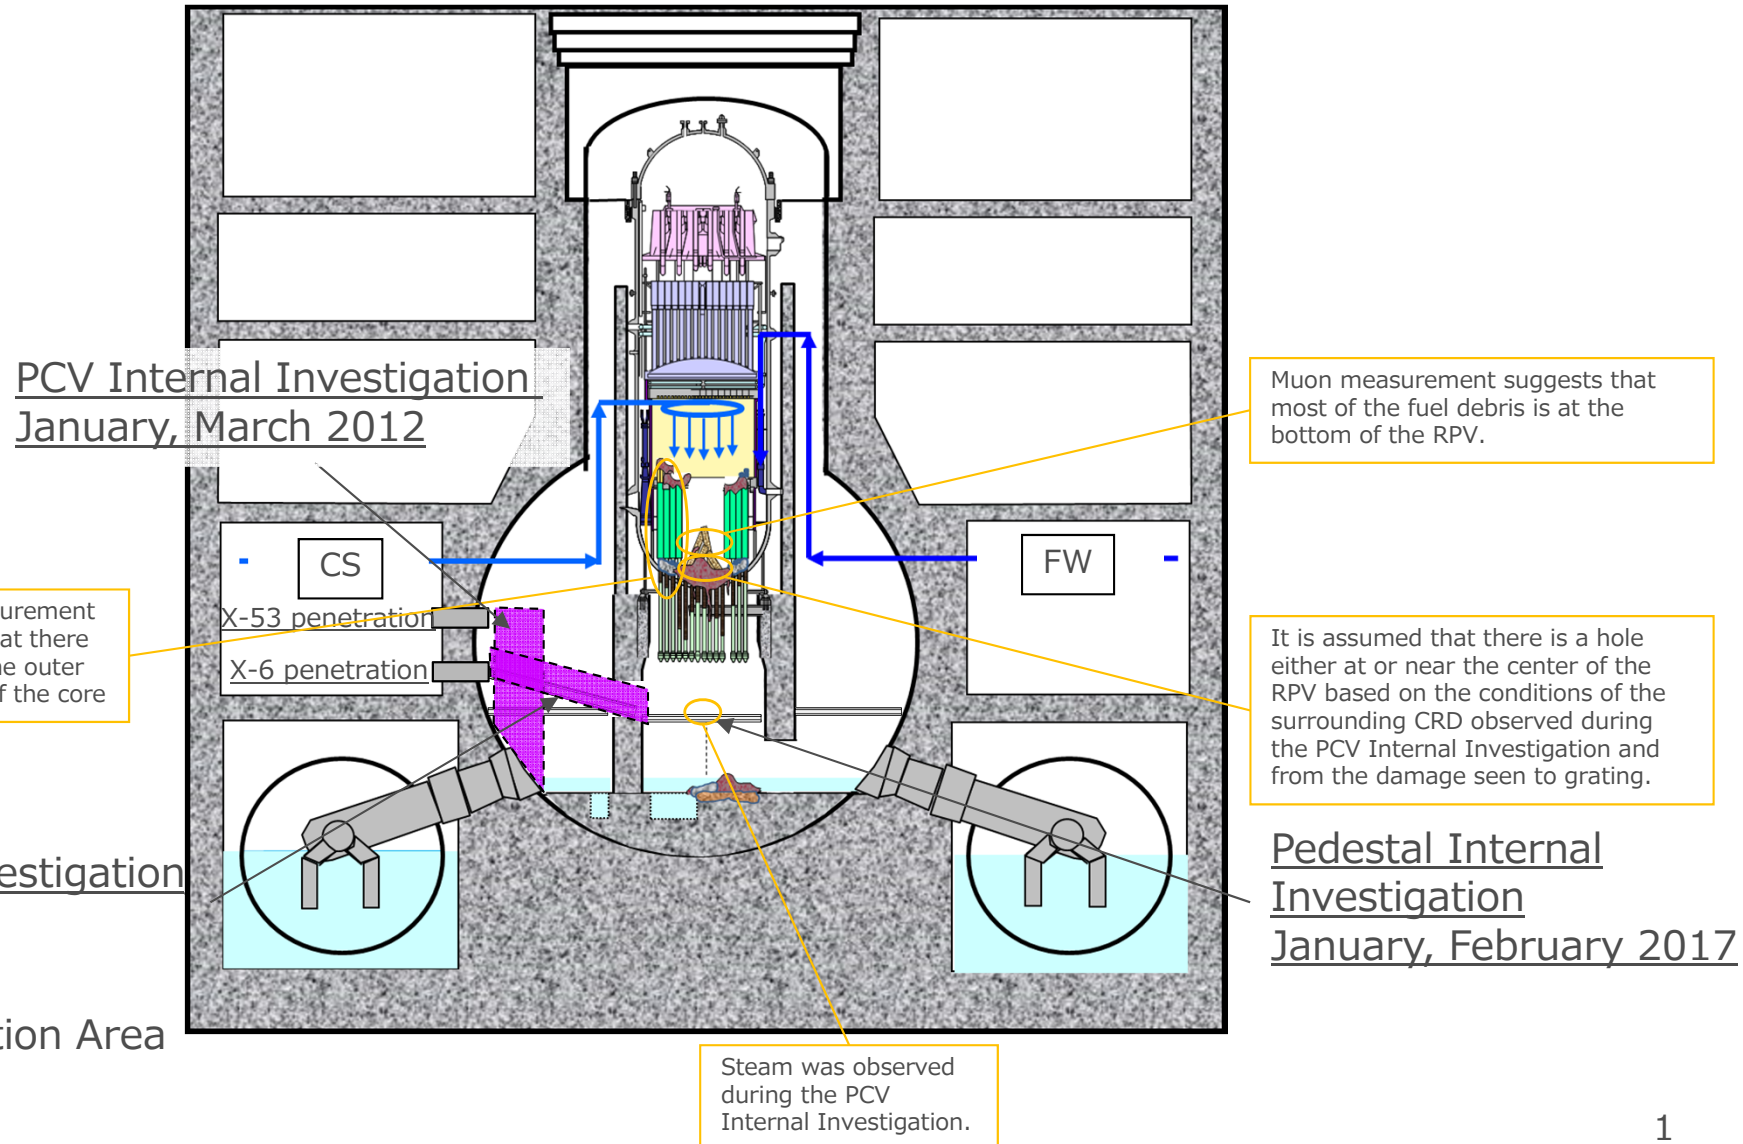
1. Conditions inside the Unit 2 PCV

- According to accident development analysis, it is assumed that part of the melted fuel fell to the plenum at the bottom of the Reactor Pressure Vessel (RPV) or onto the pedestal, with some still remaining in the core.

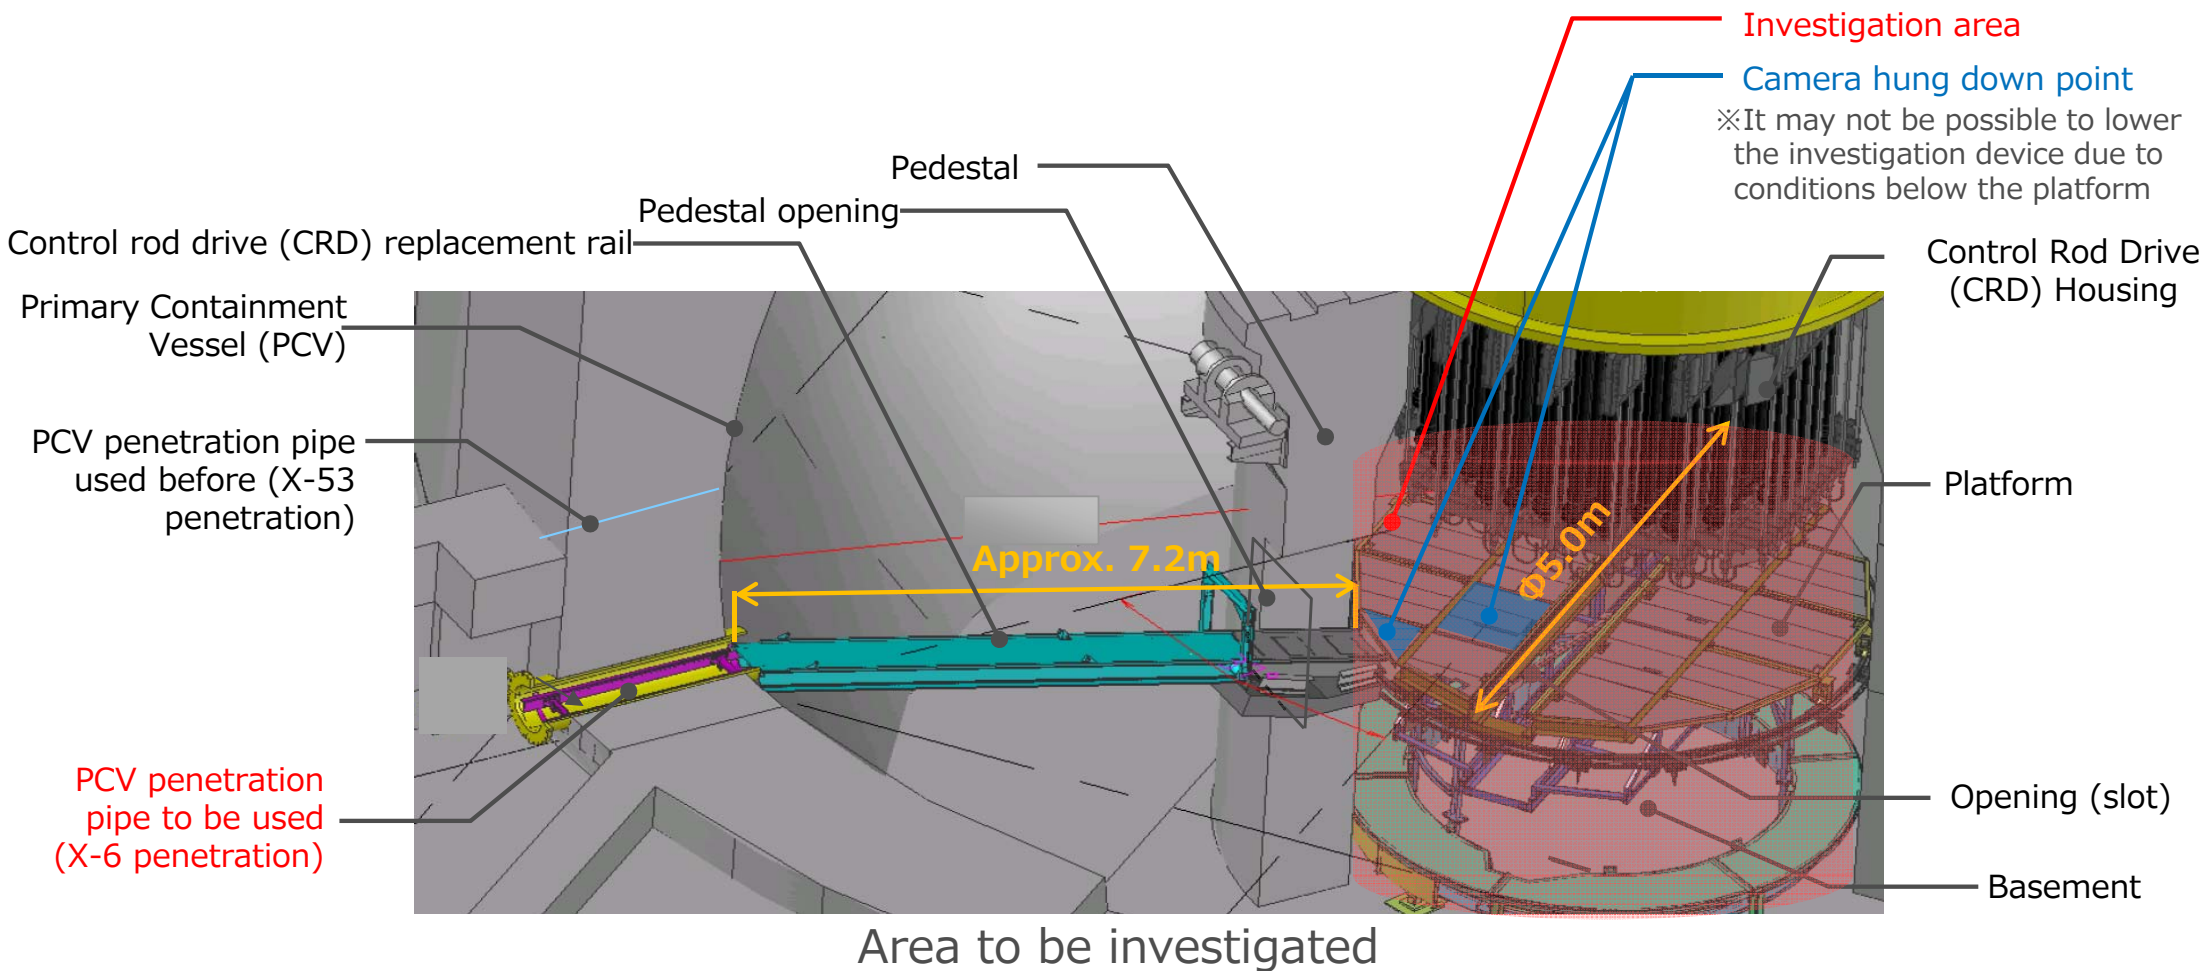
3. Outline of the next PCV Internal Investigation

【Plan】 :Conditions under the platform where fuel debris may exist will be examined.

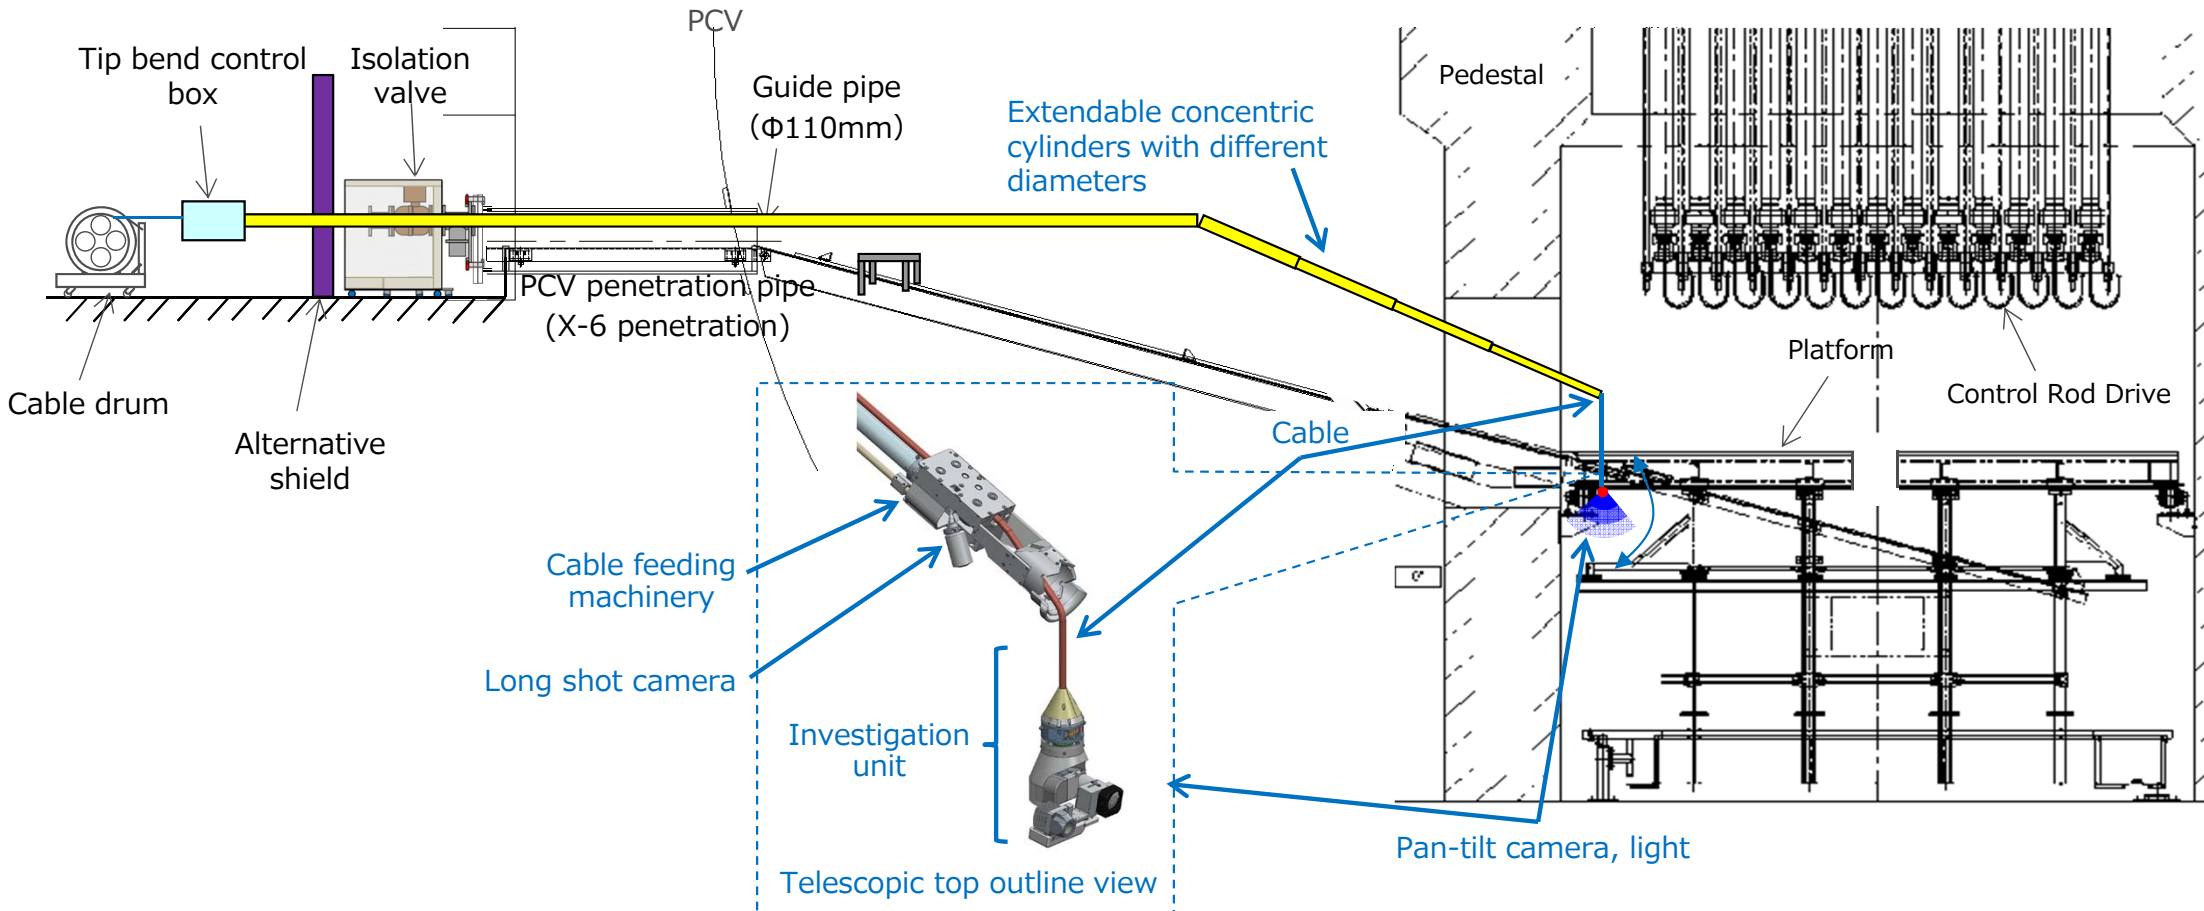
Outline of pre-investigation inside the pedestal (Telescopic investigation device)

- The telescopic device used in the PCV internal investigation conducted between Jan. to Feb. 2017 will be improved so that it can extend the length of the guide pipe and has a camera-mounted investigation device affixed to the end
- After the investigation device reaches the area above the missing part of the grating inside the pedestal, the camera will be lowered to examine under the platform.
- This improvement will enable the investigation device to reach the end of the guide pipe inside the pedestal, much further than during the investigation conducted in January~February, and allow conditions above the platform, such as the CRD housing, to be reexamined.

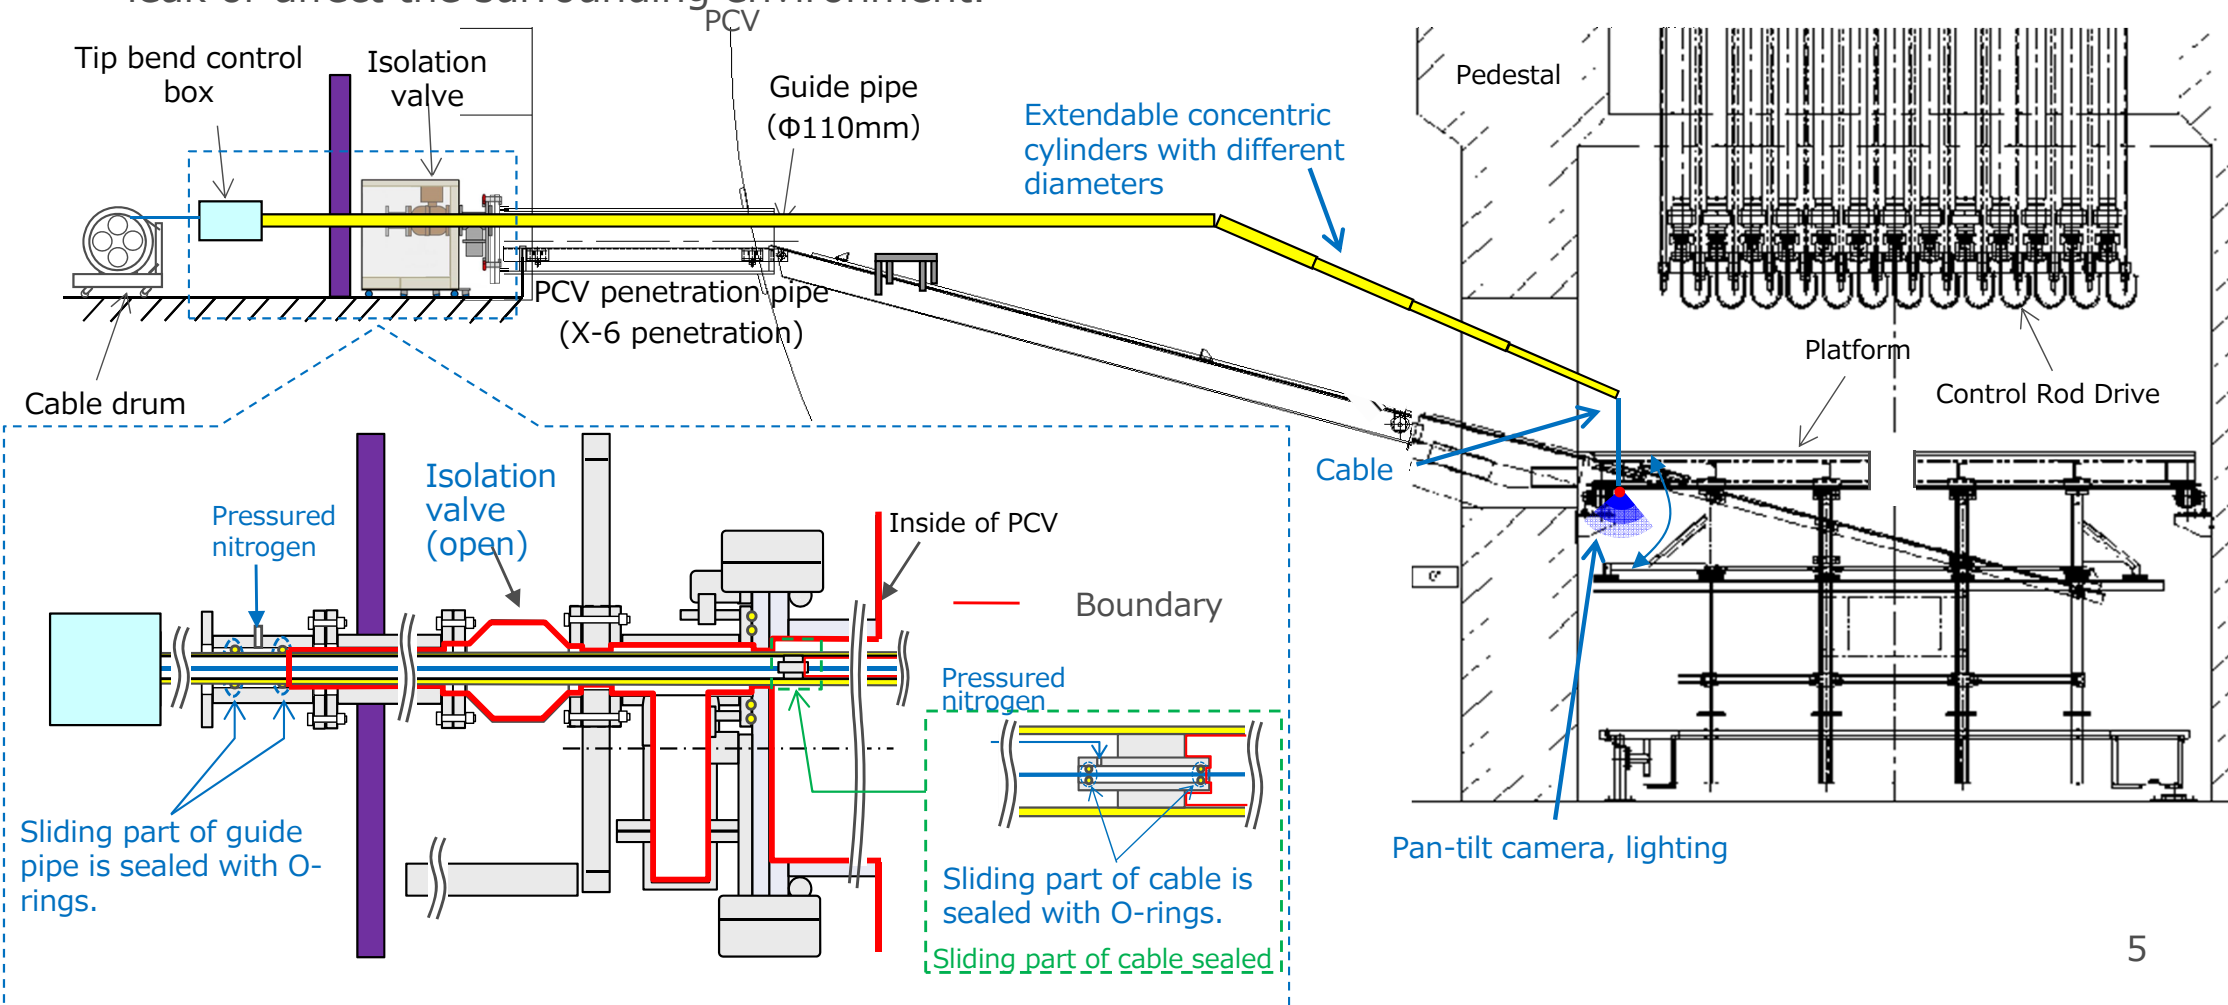
4. Investigation method (2/2)

- Just like the PCV internal investigation conducted in January~February, a boundary will be formed as shown below by sealing the sliding part of the guide pipe with double O-rings and pressurizing the pipe with nitrogen to prevent gas inside PCV from leaking outside and affecting the surrounding environment during the investigation.
- A similar boundary will be formed for the sliding part of the cable as well.
- Dust concentration will be monitored during the operation to check that gas inside the PCV does not leak or affect the surrounding environment.
