Unit 2 Primary Containment Vessel Internal Investigation

December 21, 2017

Tokyo Electric Power Company Holdings, Inc.

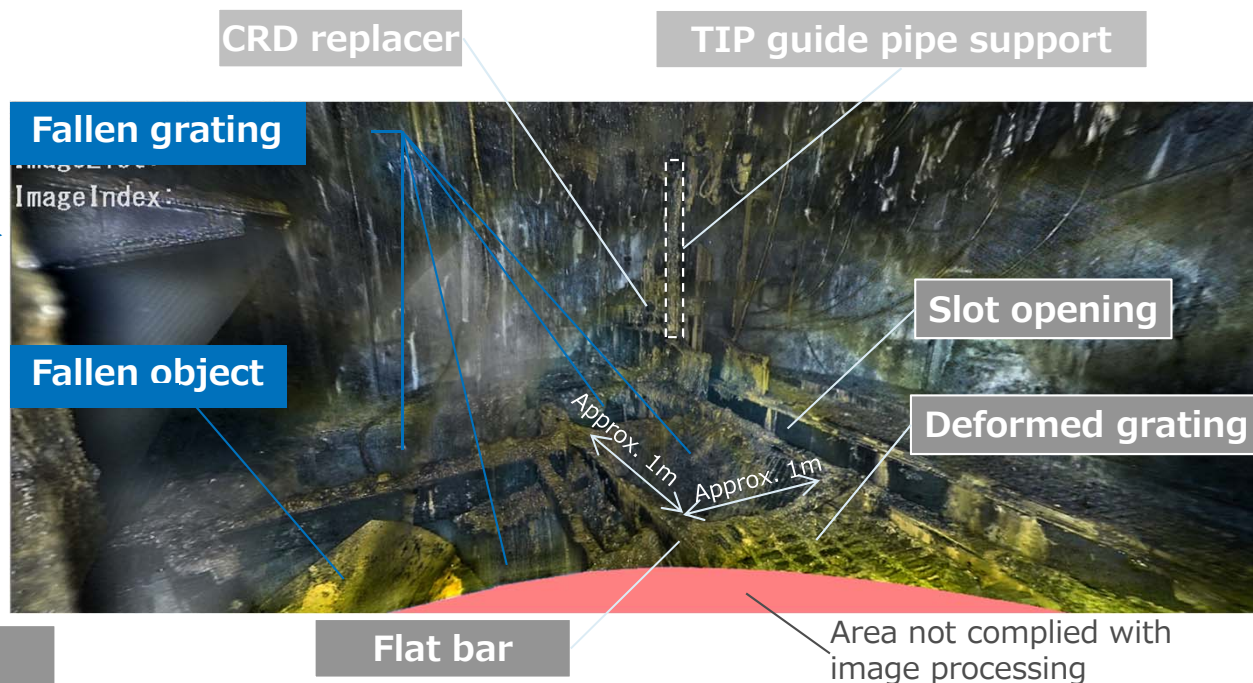
(Reference) Photo taken during periodic inspection inside Unit 2 pedestal

* The TIP guide pipe and its supports were removed to inspect Unit 5.
