Fukushima Daiichi Nuclear Power Station Unit 2 Primary Containment Vessel Internal Investigation

April 26, 2018

Tokyo Electric Power Company Holdings, Inc.

1. Primary containment vessel internal investigation overview

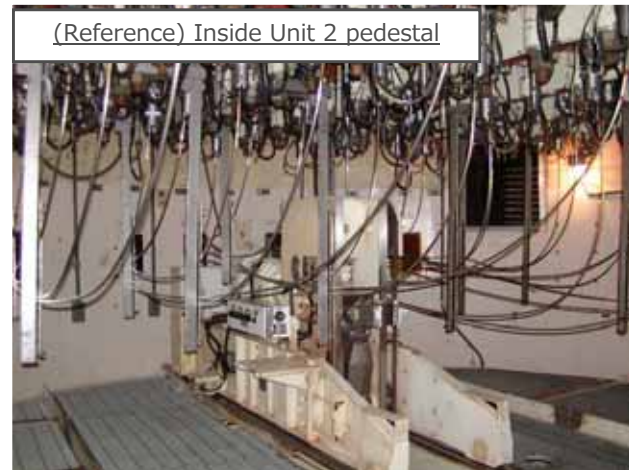
- No significant damage was seen to the CRD replacer or platform frame, etc., and the conditions of these objects remain unchanged from the last investigation (January 2017).
- Structures in the foreground of the camera image (TIP guide tube, PIP cable and grating, etc.) were found to be damaged and fallen, which may indicate the path of the fallen fuel debris in consideration of the relatively large amount of adhered substances on top of the platform frame.
- Blind spots in the background of the camera image prevent observation of structure deformation or damage, as well as the conditions of the fallen grating and adhered substances.
- As with the previous investigation (January 2017) no damage was seen to the inner walls of the pedestal within the scope of the observed area.

※Fallen grating ① cannot be seen in this image
 LPRM (Local Power Range Monitor)
 : Measures the level of neutron flux in the reactor
 TIP (Traversing In-core Probe)
 : Used to calibrate the LPRM
 PIP (control rod Position Indicator Probe)
 : Used to detect the position of the control rods

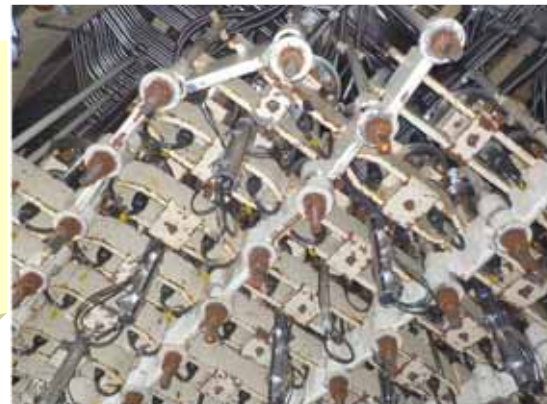
- The CRD housing supports directly above the piece of fallen grating ① shows no significant deformation or damage and remains unchanged since the last investigation (January 2017)
- Within the scope that was investigated none of the CRD housing supports appear to have fallen.

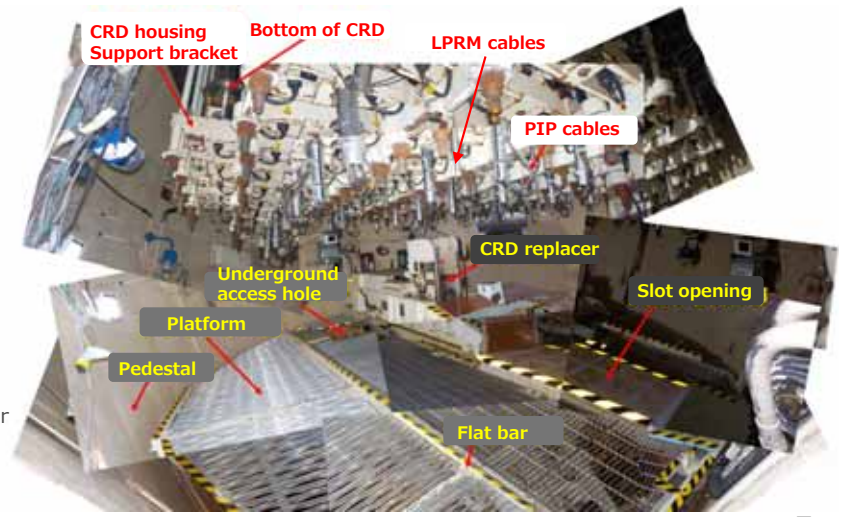
- Parts of the TIP guide tube, PIP cables and LPRM cables could not be observed due to adhered substances.
- The grating directly below the areas where parts of the TIP guide tube, PIP cables and LPRM cables could not be observed was found to have fallen.

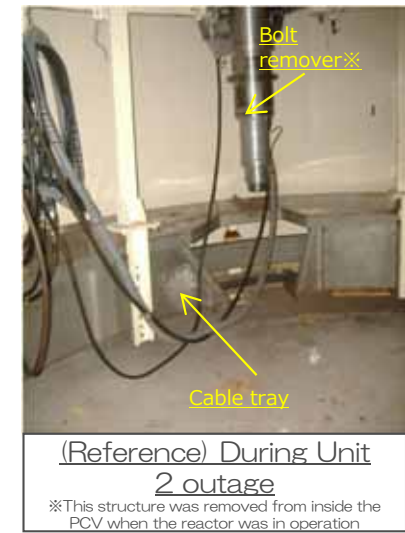
- No significant deformation or damage was seen to structures such as the CRD replacer rotating frame, mid-level work platform frame, struts, or cable trays, etc.
- Pebble and clay-like deposits cover the entire bottom of the pedestal.
- Although the deposits appear to be solidified molten material, it is possible that the temperature of the deposits when this substance started to accumulate on top of the cable tray was not hot enough to cause deformation of the cable trays in consideration of the fact that no deformation of the cable trays (4mm thick stainless steel) could be observed.

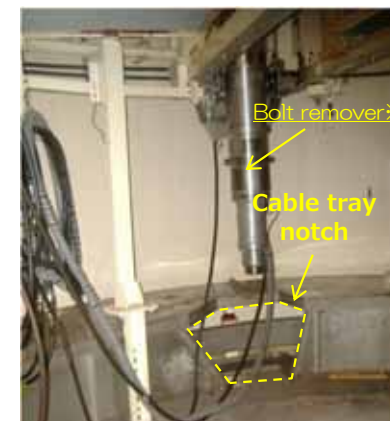
- Considering that cooling water is pouring in and that the temperature around the bottom of the pedestal is approximately 21°C it is assumed that the deposits are being kept cool and stable by the cooling water that's being injected.
- Puddles were found on the side of the worker access opening and in cable trays through the cable tray notches.

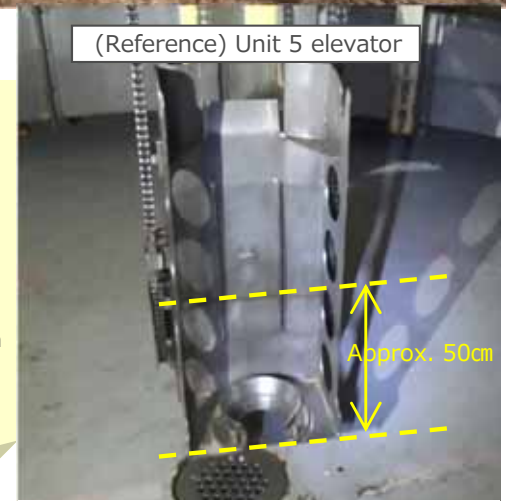
Height of deposits in which the CRD replacer elevator is buried

- When looking at the center of the pedestal from the location of the lowered camera the step in elevation that should be present around the cable tray on the left side (approximately 70cm in height) was not clearly defined thereby suggesting that the height of deposits in this area may exceed 70cm at some points. The height of deposits around the CRD replacer elevator appears to be between 40cm to 50cm considering the extent to which the elevator is buried. Furthermore, when looking from the position where the camera was lowered, it was confirmed that the height of the deposits in the area behind the elevator are lower than the cable tray.

- When viewing the left side of the center of the pedestal from the location where the camera was lowered parts of a fuel assembly (top tie plate) could be seen and fallen objects shaped like rods, pipes, and springs, could be seen in the vicinity. Furthermore, since the height of deposits in this area is higher than that in the surrounding areas, it is possible that the area directly above this location marks one of the paths by which fuel debris fell.

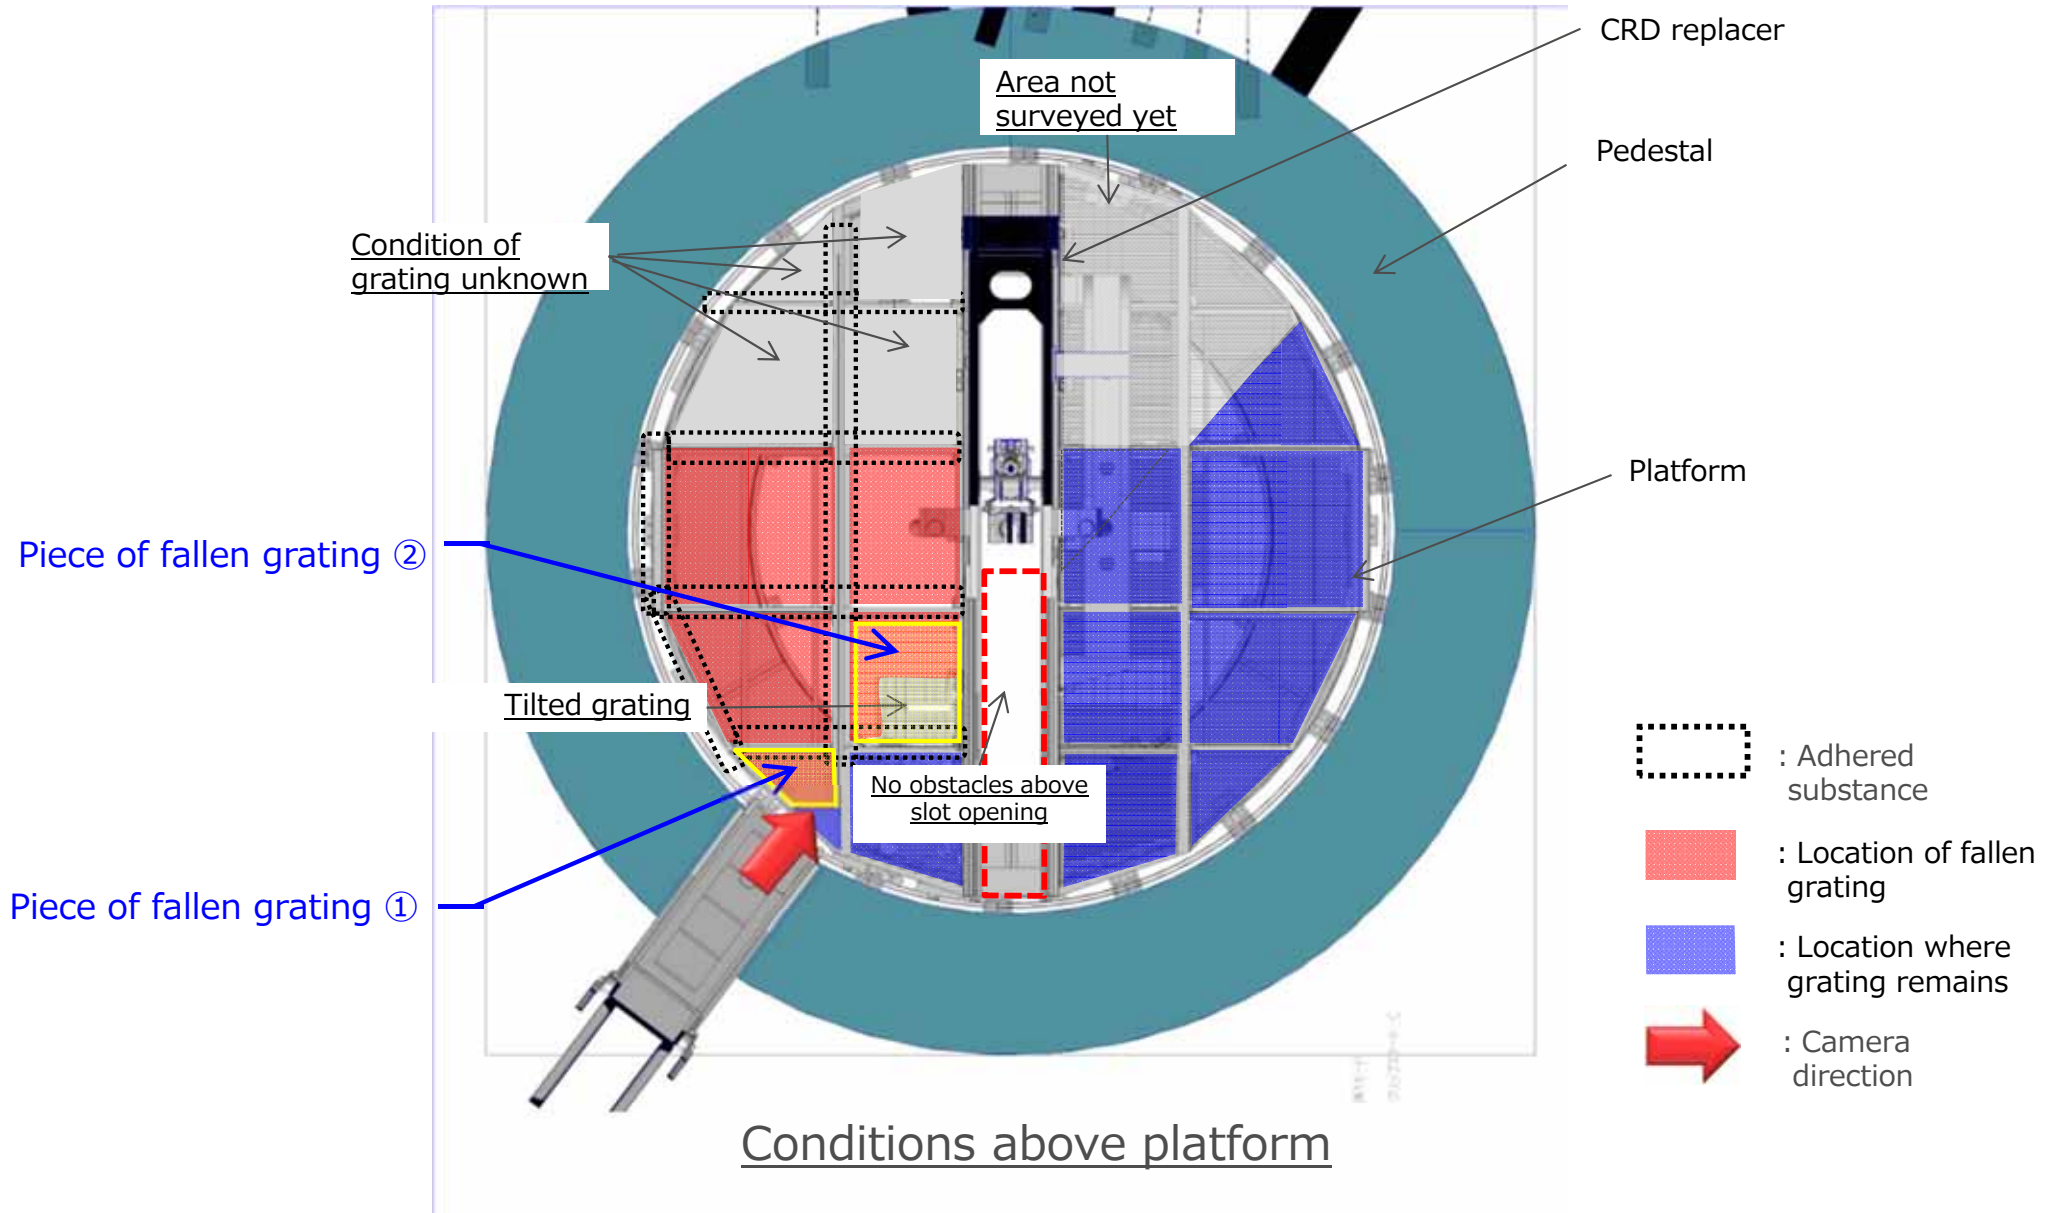
Above Platform

- Above the platform the structures in the foreground of the image taken with the lowered camera (TIP guide tube, PIP cable, and grating, etc.) have been significantly damaged and/or have fallen, and a relatively large amount of adhered substances were found on top of the frame.

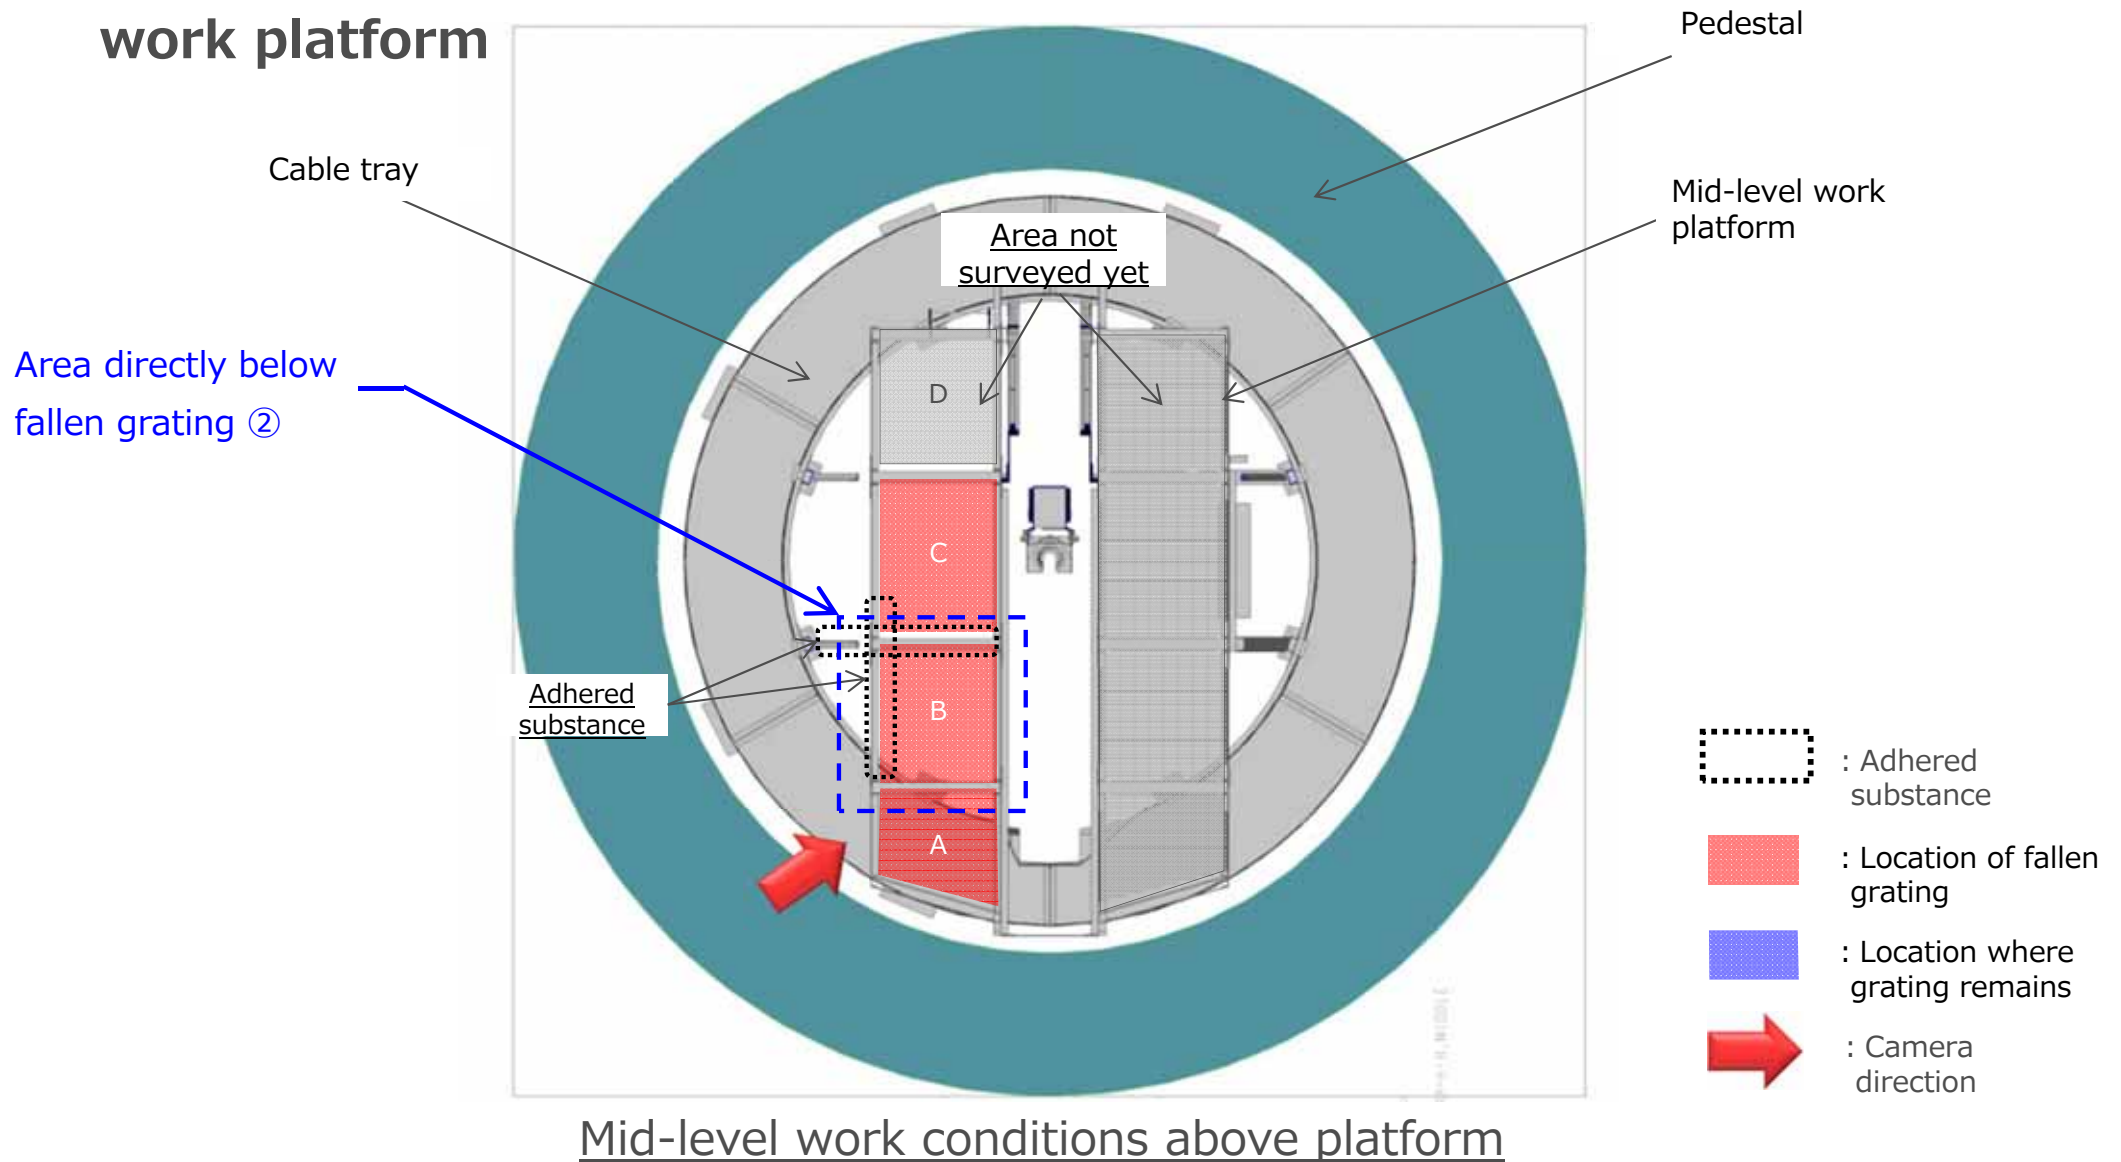
■ Around the mid-level work platform

- On the mid-level work platform grating in the foreground of the images taken with the lowered camera were found to have fallen, much like the conditions above the platform.

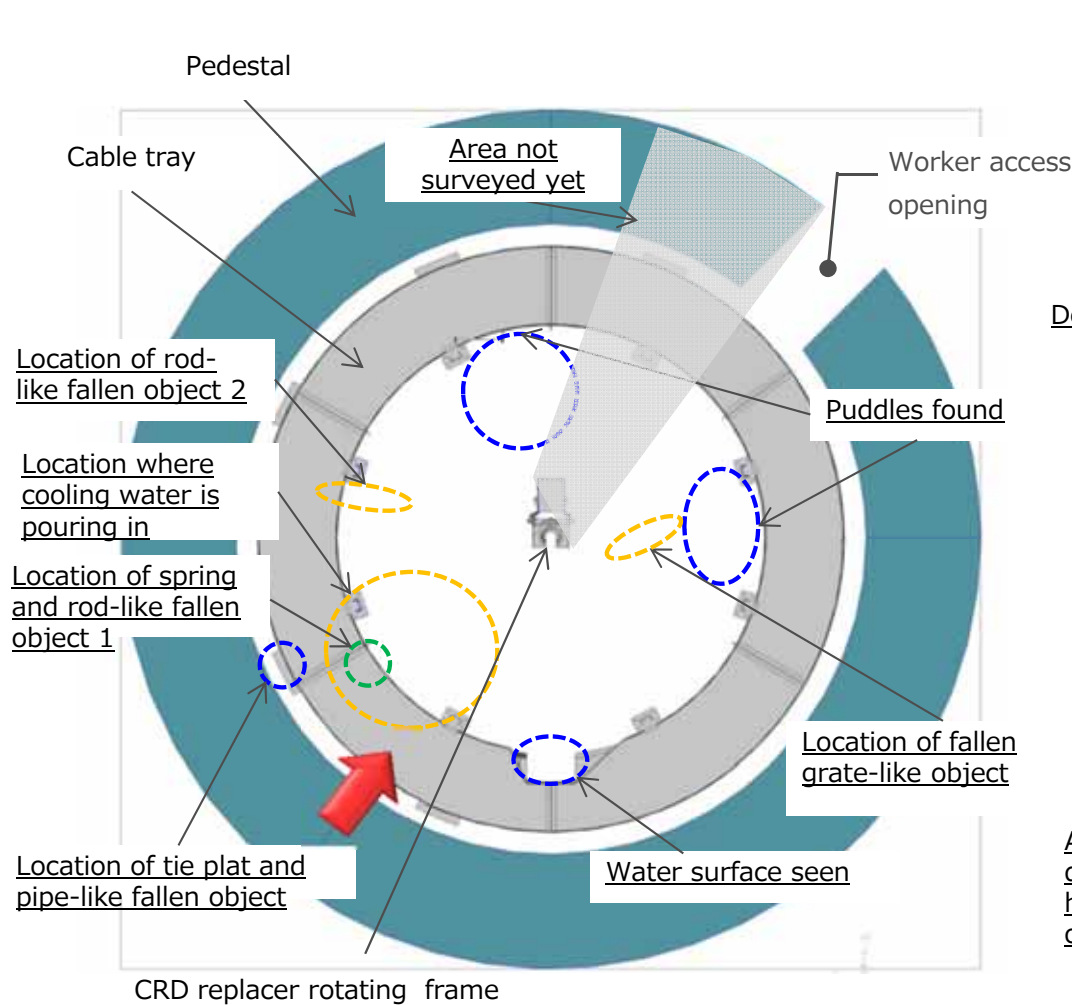
Puddles and fallen objects found at the bottom of the pedestal

- At the bottom of pedestal no significant deformation was seen to the CRD replacer rotating frame, mid-level work platform frame, struts, or cable tray, etc. Furthermore, considering that cooling water is pouring in and that the temperature around the bottom of the pedestal is approximately 21°C it is assumed that the deposits are being kept cool and stable by the cooling water that's being injected.

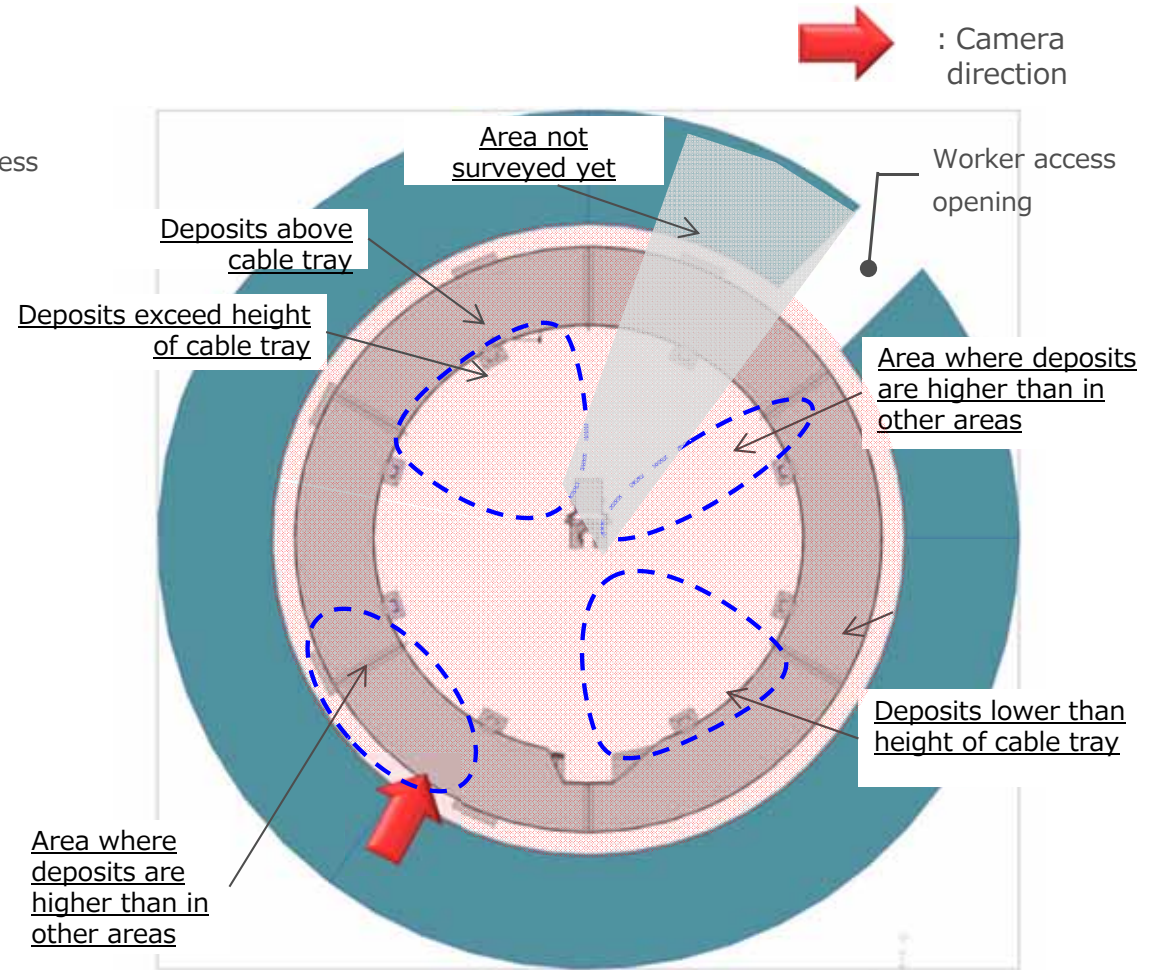
Deposits found at the bottom of the pedestal

- Since the height of the deposits at the bottom of the pedestal is higher on the left side of the center of the pedestal when viewed from the position of the lowered camera, it is possible that the area directly above this location may be one of the paths by which fuel debris fell.

- At the same time, since deposits on the side of the worker access opening are higher than in the surrounding area it is possible that there are multiple paths by which fuel debris fell.
