The crack of axle linkage casing at the overhead crane in the building of spent fuel common pool, Fukushima Daiichi Nuclear Power Station (survey result)

< Reference >
Dec.23 2011
Tokyo electric Power Company

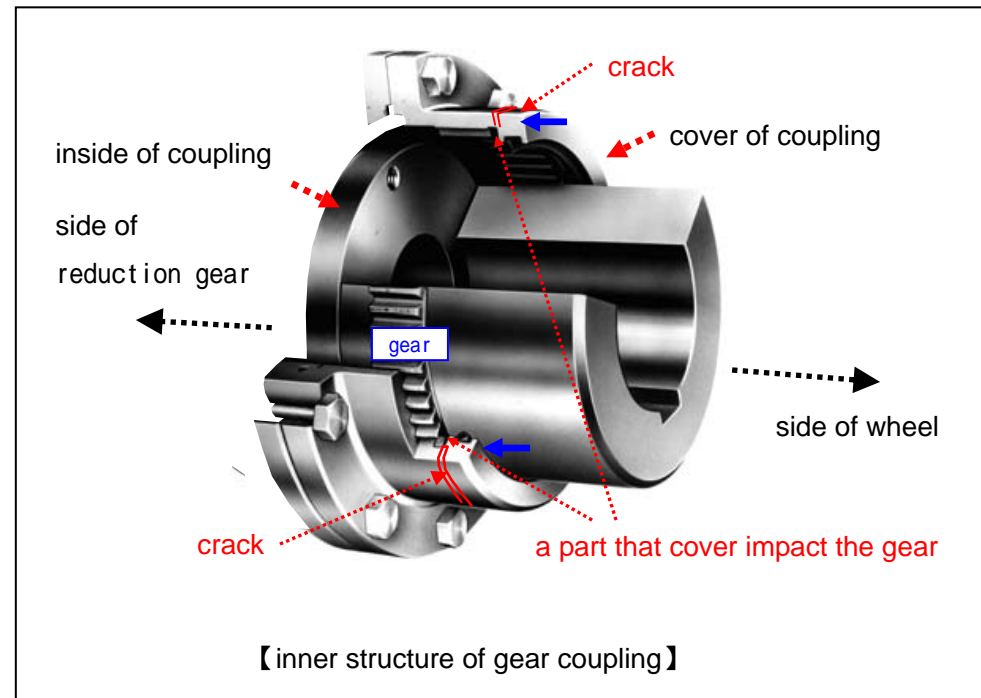
【drive unit of travel motion】

At the time of the earthquake, it is conjectured that the wheel slipped to the cross direction on the rail, because the wheel which connected with the gear coupling contacts on the rail.

When the wheel stopped moving at the top of the rail, the cover of the coupling hit the gear and it was cracked by the impulsive load.

We are ordering new gear coupling and will exchange it on arrival.
