Status of inspection work of the main turbine of Unit 4

< Inspected equipment >

Low pressure turbine (A) 【moving blade(whole), stationary blade(upper half)】
 High pressure turbine 【moving blade(whole), stationary blade(upper half)】
 Bearing(from High pressure turbine to Low pressure turbine (A))

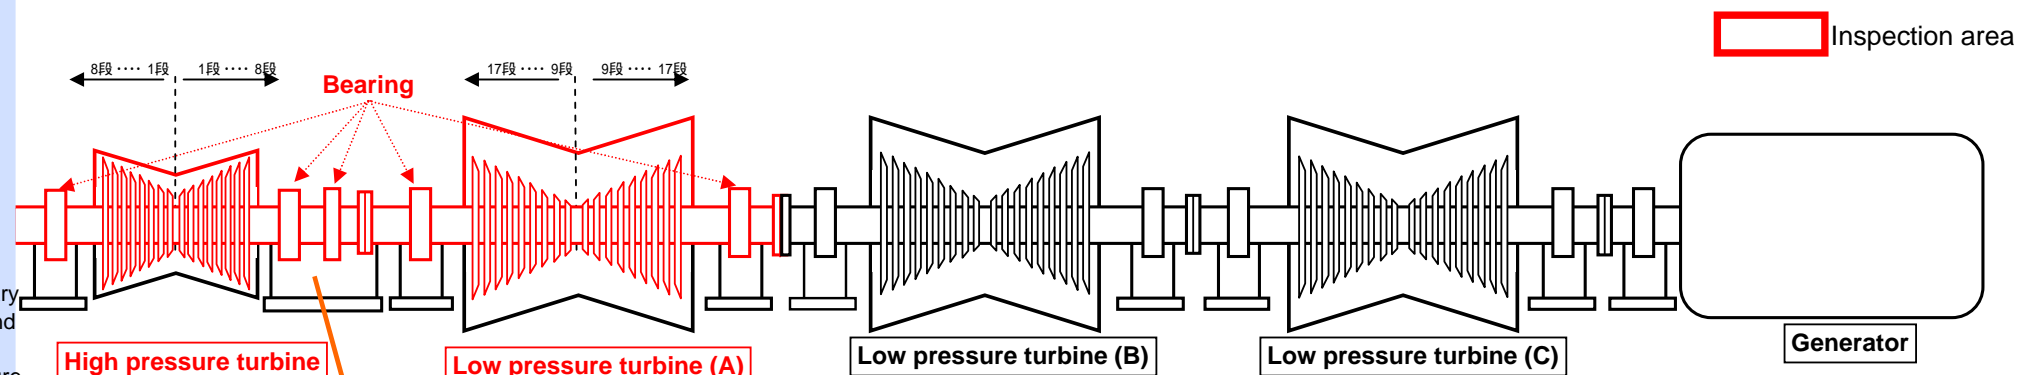
Although we found not only some cracks caused by normal operation but also some contact traces, which is located at moving and stationary blade of the low pressure turbine (A) and the high pressure turbine and oil thrower bearing, caused by the Tohoku-Chihou-Taiheiyou-Oki Earthquake, we confirmed they are minimal damage and we made sure there was no security issues.
