Increase in the Reactor Injection Water Amount at Unit 3 of Fukushima Daiichi Nuclear Power Station

November 27, 2012
Tokyo Electric Power Company

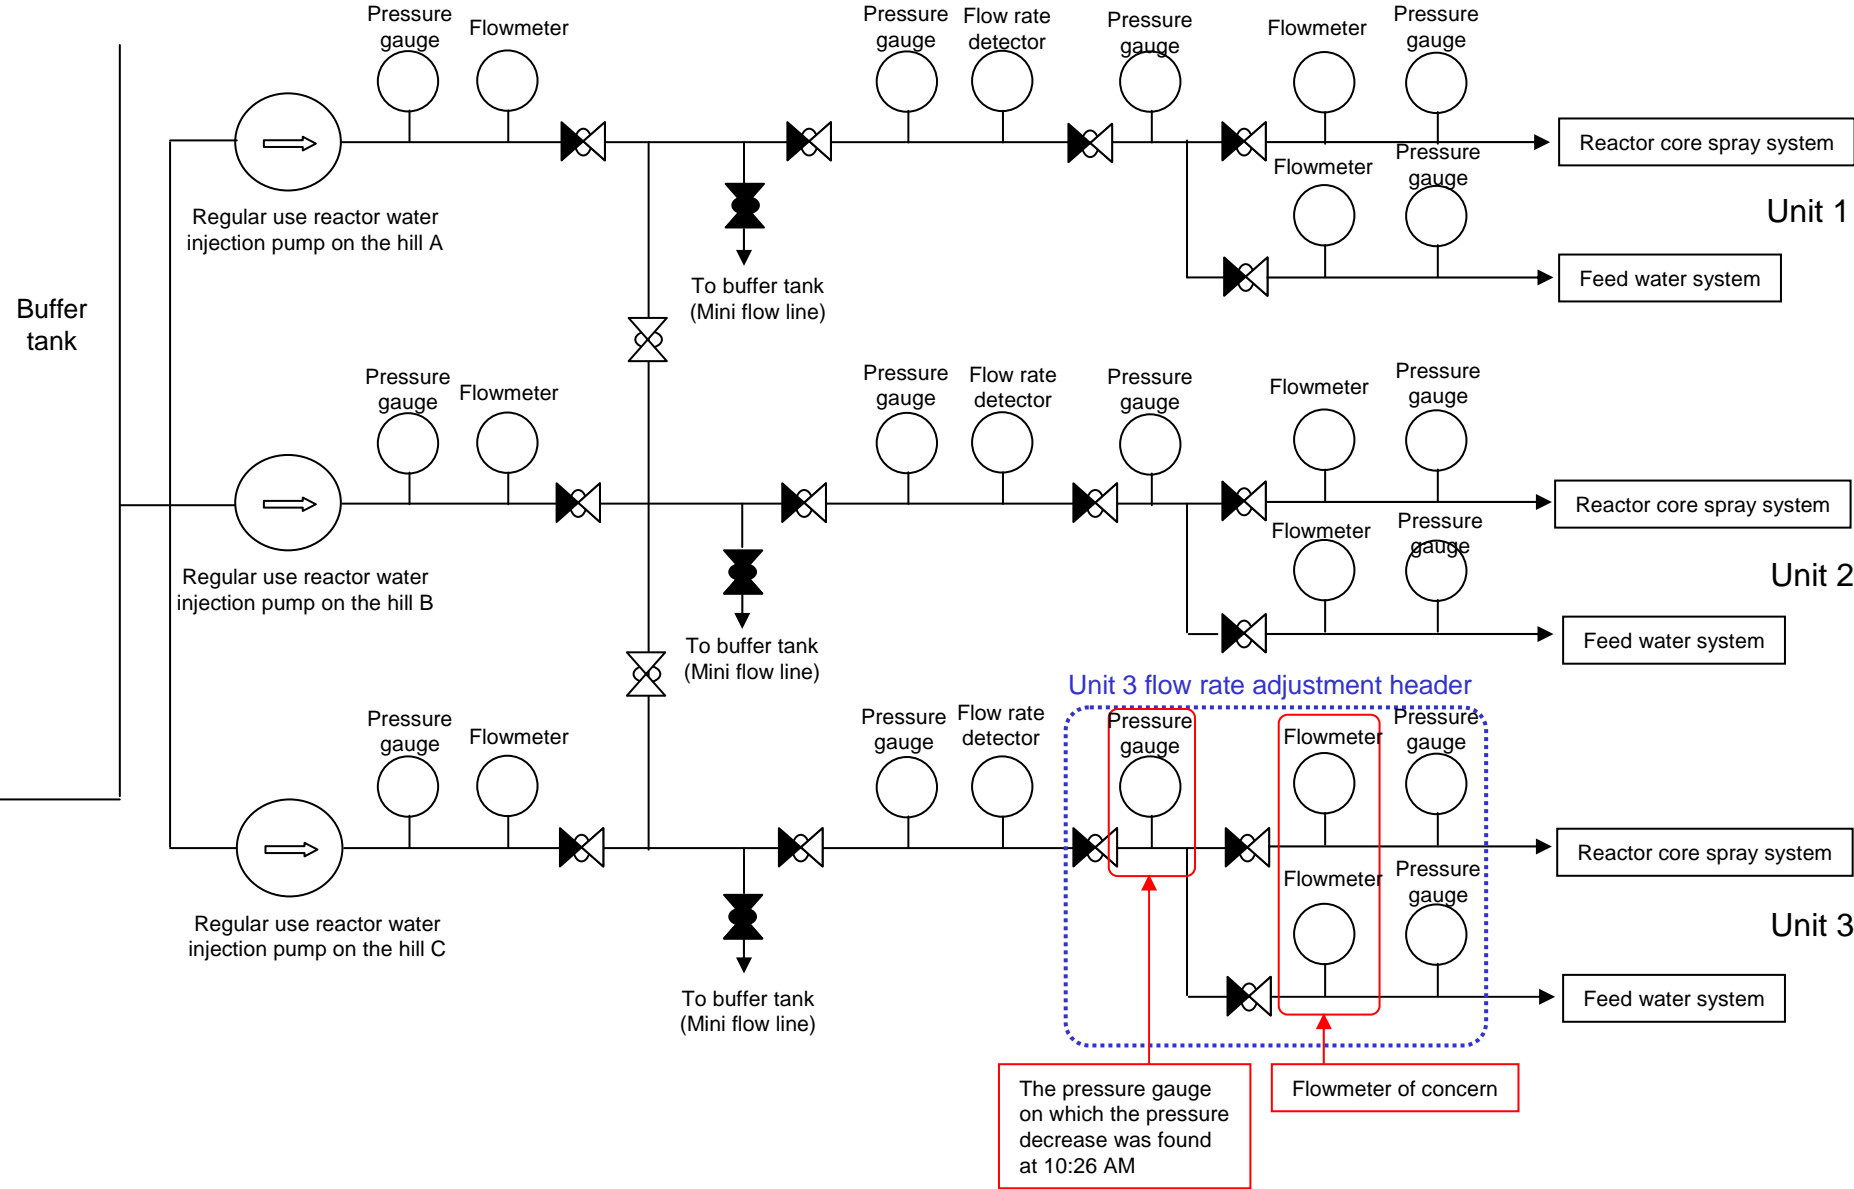
2. Reactor Water Injection System

- Upon checking the related plant data to identify the cause of the increase in the reactor injection water flow rate, it was found that the reactor injection water pressure was found to have decreased from 0.73MPa to 0.48MPa at 10:26 AM on November 26.

- At about the same time, it was confirmed that a worker was removing heat insulating material near the flow rate adjustment valve to prepare for replacing the reactor injection water flowmeter.

The pressure gauge on which pressure was found to have decreased at 10:26 AM
