Results of the Third Soundness Inspection of Unit 4 Reactor Building at Fukushima Daiichi Nuclear Power Station

November 29, 2012

Tokyo Electric Power Company

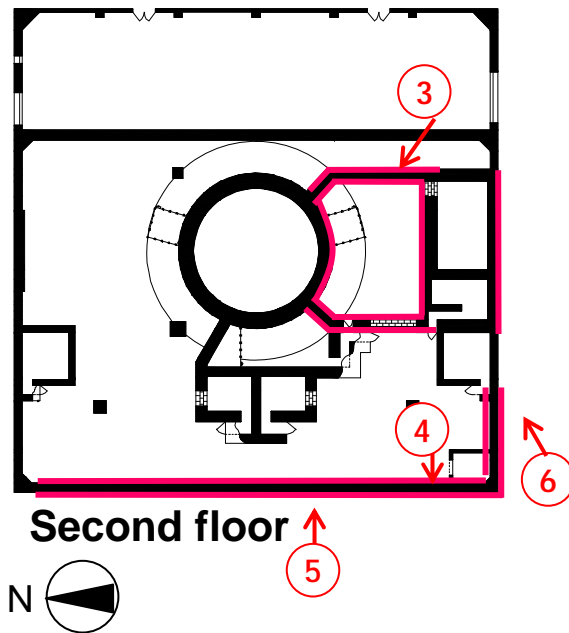
③ Wall on the SFP side

As a result of visual inspection, no crack of a width of 1mm or more or with possible rebar corrosion was found (similarly to the past results).
