Table 7 Evaluation of Faults which does not Consider in the Anti-earthquake Design (faults around the site)

Kashiwazaki Kariwa Nuclear Power Station

Figure 3 Distribution Map of Fault within the site

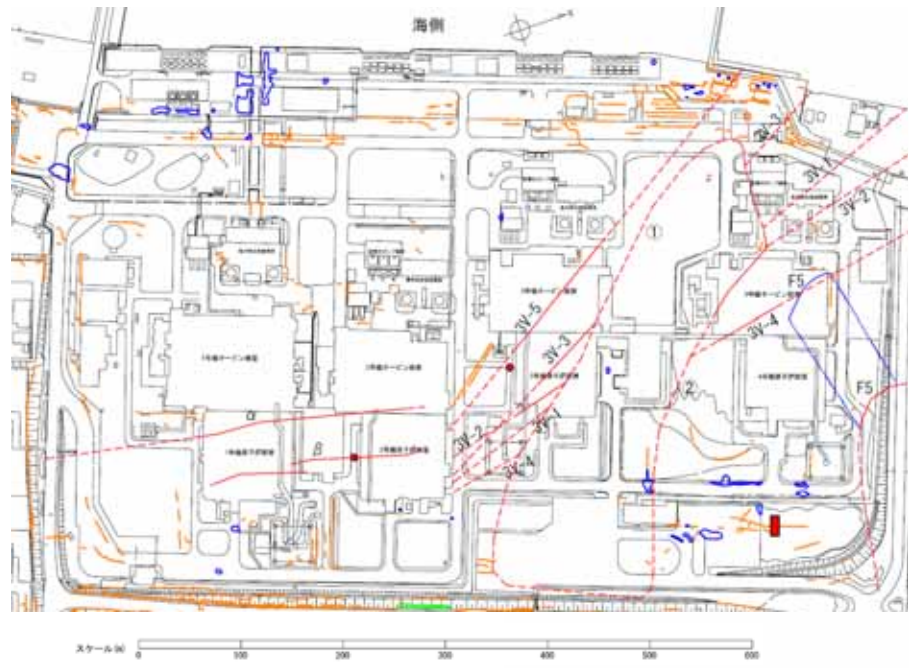
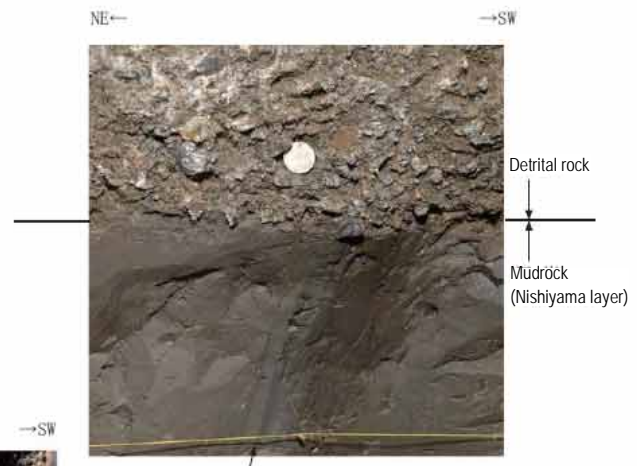
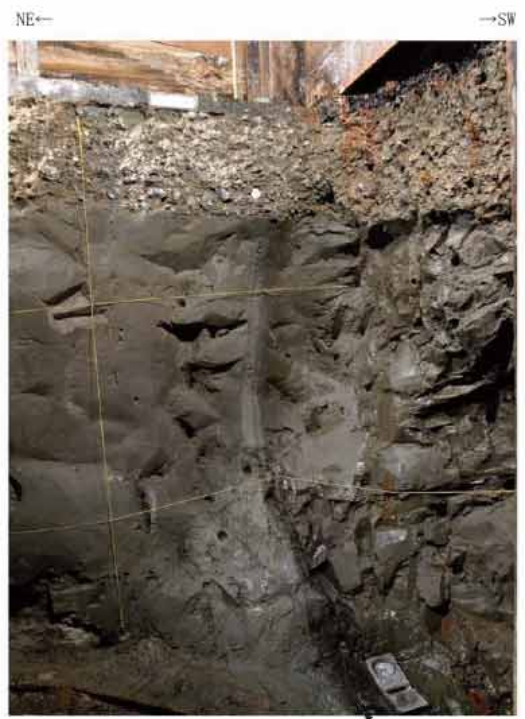
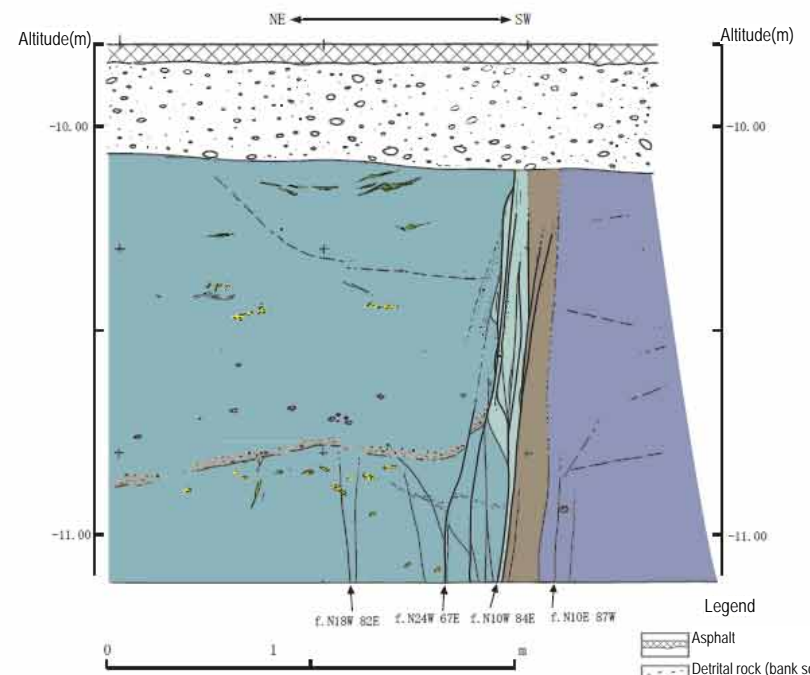
Attachment Drawing 14-2 Developed Slope Survey Result of β Fault

Survey Item	Survey Method	Survey Result	Remarks
Bibliographic Survey	—	Fault Description : N/A	
Geomorphological Survey	Aerial Photograph Interpretation	Lineament : N/A	
Ground Surface Geological Survey	Ground Surface Exploration	Fault Outcrop : N/A	
Developed Slope Survey	Slope Geological Observation	Stopped at low angle fault of Yasuda Layer, no upper continuation	Attachment Drawing 14-1 Attachment Drawing 14-2
Vertical Shaft Survey	Shaft Wall Geological Observation	On β fault, no slip in the crushed stone or asphalt of the temporary yard for construction at the time of Chuetsu Oki earthquake	Attachment Drawing 14-3
General Evaluation	<p>α fault is stopped at low angle fault of Yasuda Layer and no upper continuation is recognized, so we evaluated that at least there is no activity after the deposition of Yasuda Layer.</p> <p>β fault is stopped at low angle fault of Yasuda Layer and no upper continuation is recognized, so we evaluated that at least there is no activity after the deposition of Yasuda Layer.</p>

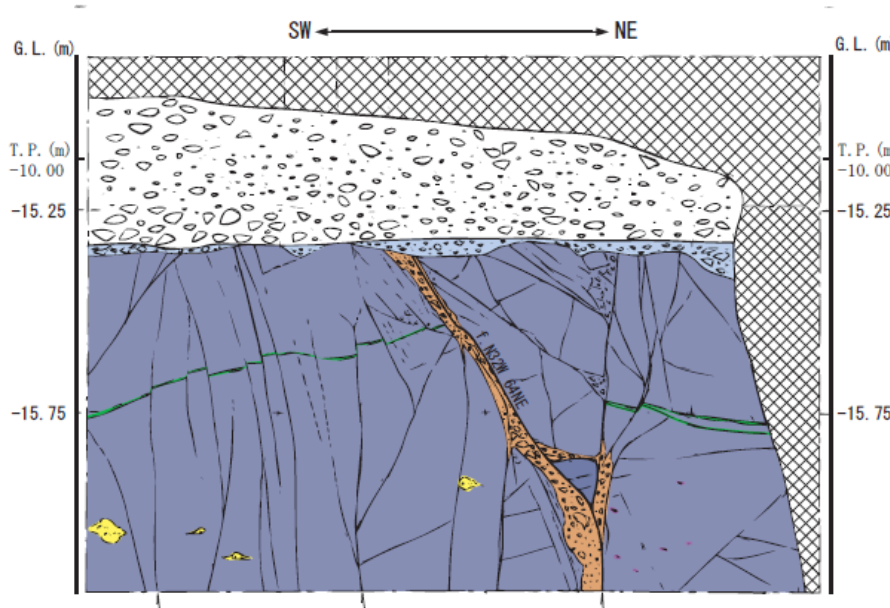
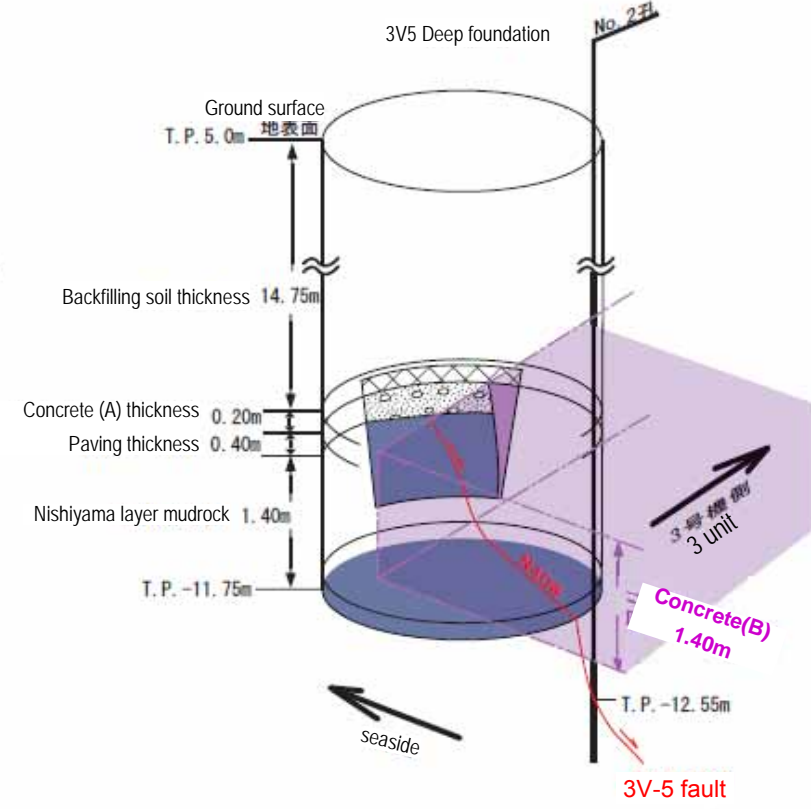
Attachment Drawing 15-3: Result of Vertical Shaft Survey of 3V-5 Fault

Survey Item	Survey Method	Survey Result	Remarks
Bibliographic Survey	—	Fault Description : N/A	
Geomorphological Survey	Aerial Photographic Interpretation	Lineament : N/A	
Ground Surface Geological Survey	Ground Surface Exploration	Fault Outcrop : N/A	
Test Pit Survey	Test Pit Geological Observation	As the result of the survey on 3V-1 and V ₂ layers where they have relatively wider fracture surface and greater drop, there is no displacement at the boundary face between Yasuda layer and Nishiyama Layer, and no continuation in Yasuda Layer.	Attachment Drawing 15-1 Attachment Drawing 15-2
Vertical Shaft Survey	Vertical Shaft Wall Geological Observation	There is no displacement at macadam and asphalt in temporary yard for construction even at the time of Chuetsu Oki Earthquake.	Attachment 15-3
Comprehensive Evaluation	<p>3V-1Fault has no displacement at the boundary face between Yasuda and Nishiyama Layer, and no continuation in Yasuda Layer.</p> <p>V₂ Fault has no displacement at the boundary face between Yasuda and Nishiyama Layer, and no continuation in Yasuda Layer.</p> <p>From the above, we evaluated that at least there is no activity of V Faults after the deposition of Yasuda Layer.</p>

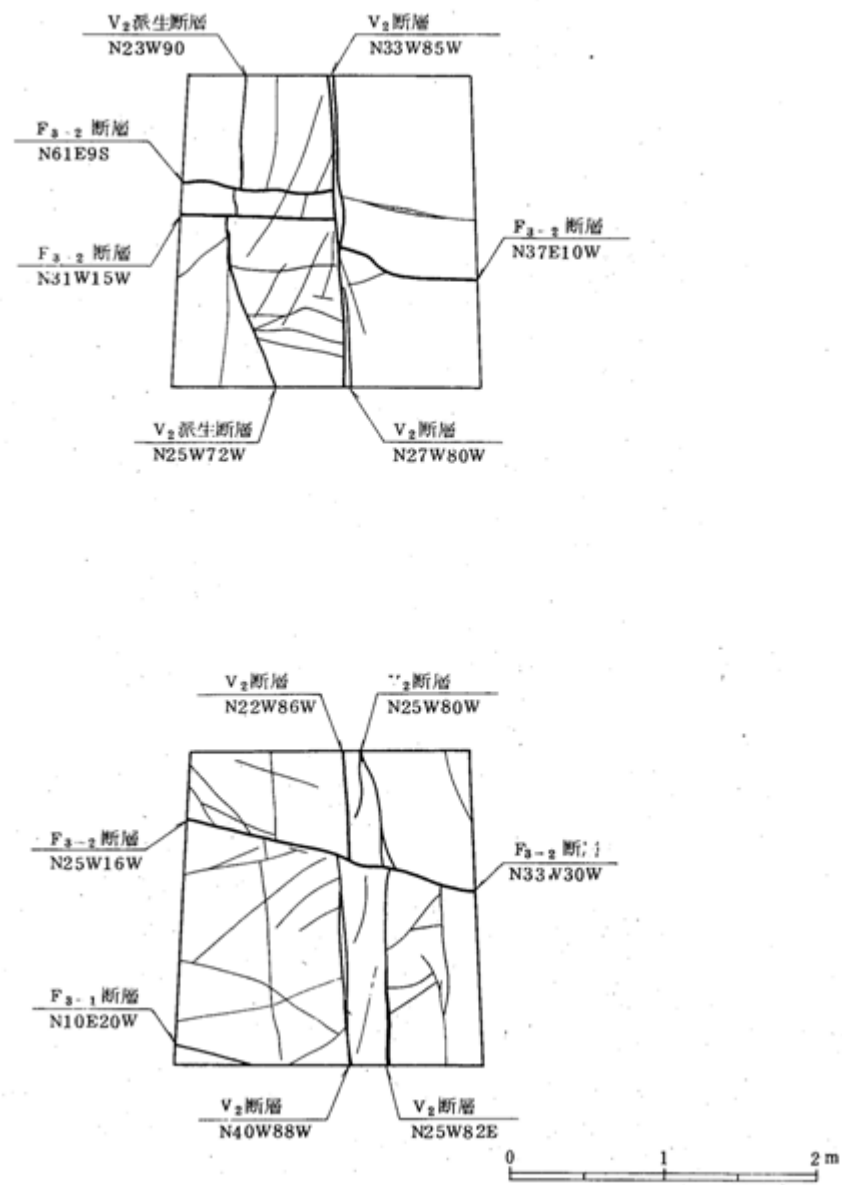
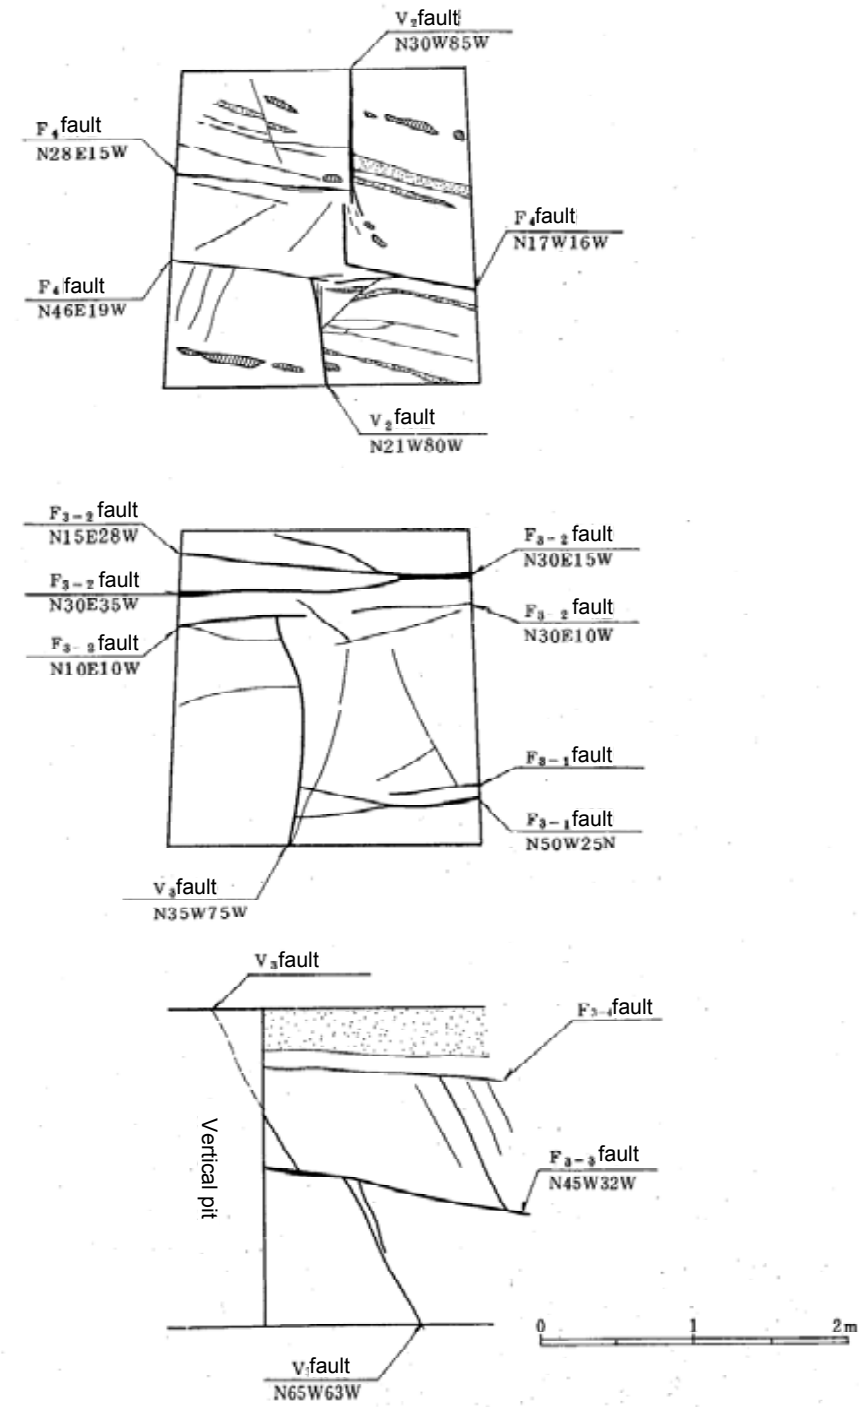
Attachment 16-2: Joining Section of F Fault and V Fault

Survey Item	Survey Method	Survey Result	Remarks
Bibliographic Survey	—	Fault Description : N/A	
Geomorphological Survey	Aerial Photographic Interpretation	Lineament : N/A	
Ground Surface Geological Survey	Ground Surface Exploration	Fault Outcrop : N/A	
Test Pit Survey	Test Pit Geological Observation	As a result of survey on F ₂ Layer where there is relatively large scale and continuity, it is observed that there is a displacement at the upper end of Nishiyama Layer, however, the displacement is disappeared soon in Yasuda Layer, and the F ₂ Fault and V ₂ Fault are connected with intercepting each other.	Attachment Drawing 16-1 Attachment Drawing 16-2
Vertical Shaft Survey	Vertical Shaft Wall Geological Observation	F ₃ Fault has no displacement in Yasuda Layer even when Chuetsu Oki Earthquake.	Attachment Drawing 16-3
Comprehensive Evaluation	<p>F₃ Fault has a displacement at the upper end of Nishiyama Layer, however, it is disappeared soon in Yasuda Layer.</p> <p>F₃ Fault and V₂ Fault are connected with interfering each other. F₂ Fault was formulated at the almost same time as when V₂ Fault was formulated.</p> <p>From the above, we evaluated that at least there is no activity of F Series Faults after the deposition of Yasuda Layer.</p>
