Response to the accumulated water containing radioactive materials that was found in the trench at Fukushima Daiichi Nuclear Power Station (Interim report)

January 6, 2011
Tokyo Electric Power Company

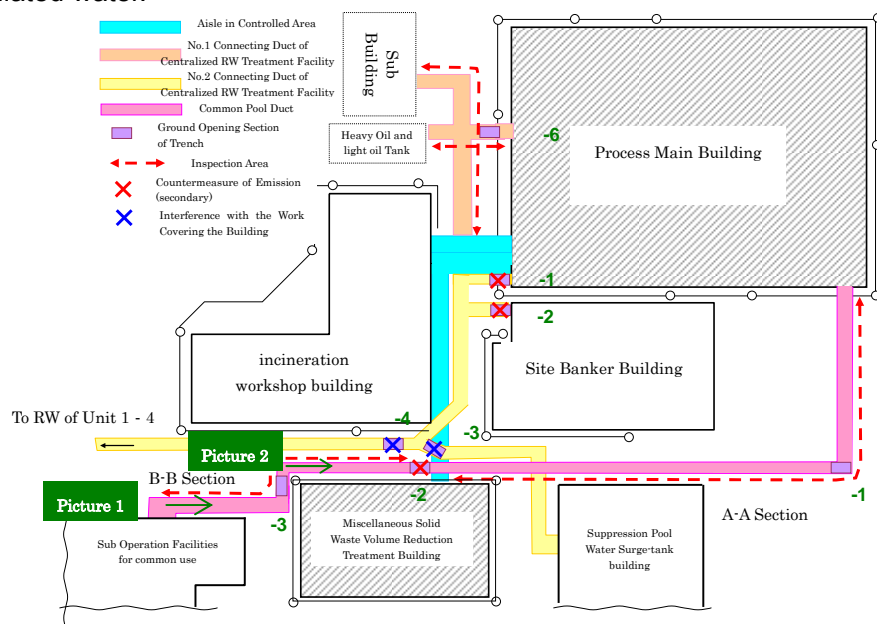
No accumulated water was found at the Common Pool Duct (B-B section). (Appendix-2)

No accumulated water.

【Photo 1】 Situation in the trench (No accumulated water)

The monitoring and inspection for the common pool duct (B-B section), the section which no accumulated water was found, will not be conducted this time because the possibility of highly concentrated contaminated water from the Process Main Building entering the B-B section is low. This is due to the cement injected inside the trench from the opening trench (-2) and the water level of the accumulated water in section A-A will be managed.

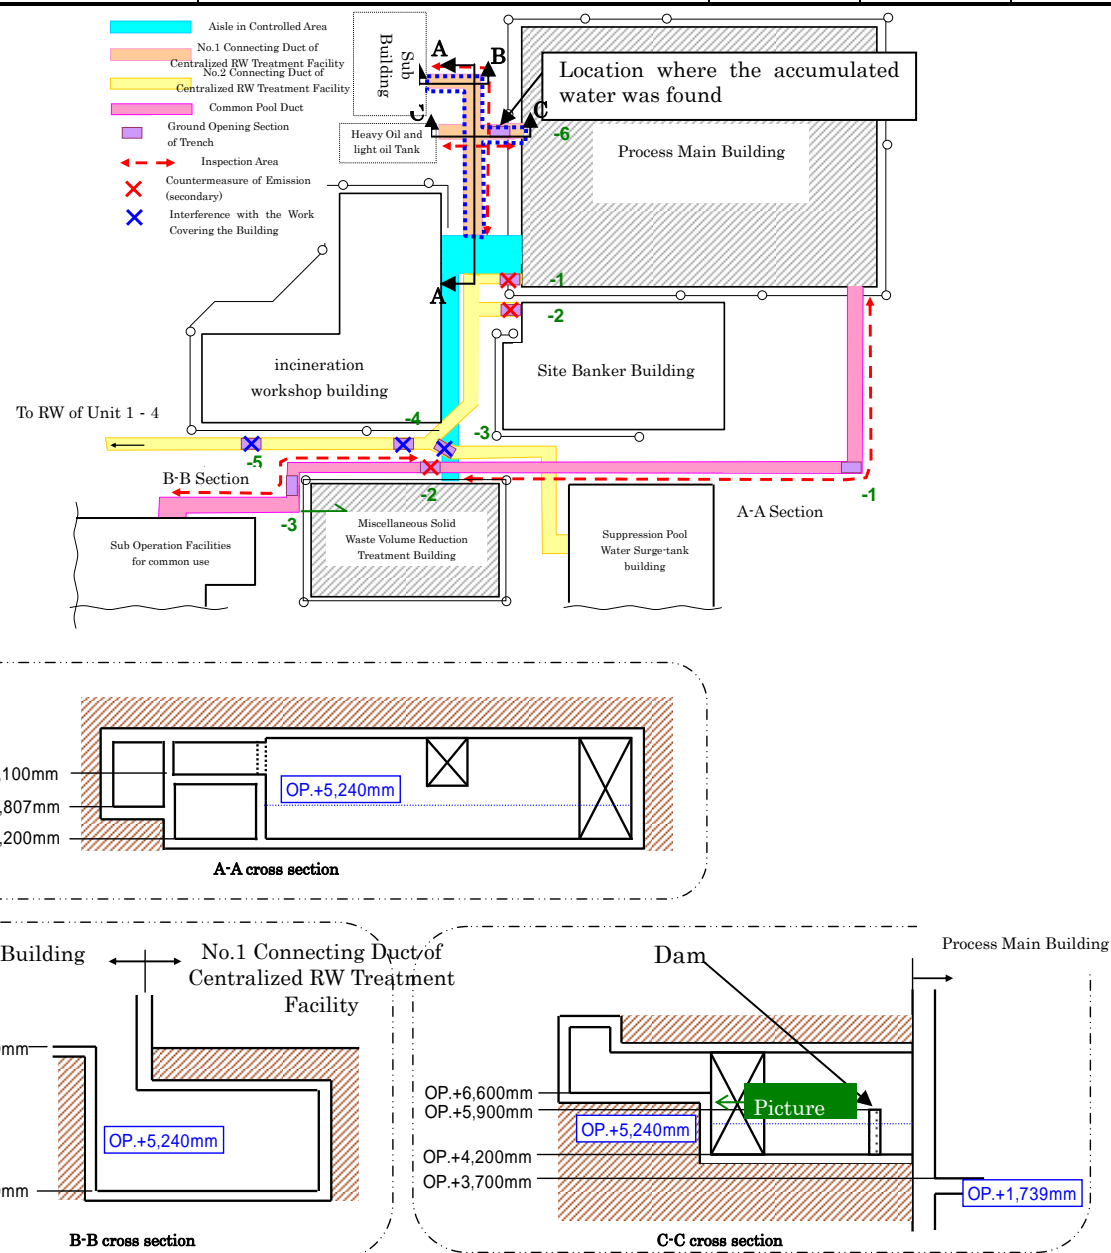
Appendix-3(2/2)

On the other hand, the accumulated water of approx. 142m³ was found at the Centralized RW Connecting Duct (Appendix-3). As shown in the table 4, the radioactive concentration of the accumulated water was low. Therefore, it is assumed that the accumulated water resulted from rain water etc., entering in from the opening hatch located at the upper trench rather from the leakage of the highly concentrated contaminated water that was transferred to the Process Main Building.

- There is accumulated water. The amount of water was approx. 142m³.
- Result of Nuclide Analysis :

Name of Trench/Duct	Location of Inspection	Radio Active Density (Bq/cm ³)		
		I-131	Cs-134	Cs-137
No.1 Connecting Duct of Centralized RW Treatment Facility	Around Opening Section for equipment hatch	ND	1.5×10 ⁻¹	1.7×10 ⁻¹
	Around the process main building	ND	7.8×10 ⁻²	1.3×10 ⁻¹

As for the Centralized RW Connecting Duct , construction to prevent leakage is being conducted by

injecting cement from the opening trench (-1) near the Process Main Building in addition to the leakage prevention construction conducted in April, 2011. Also, the floor level of the trench is higher than the recorded water level (OP+5m) of highly concentrated contaminated water in the Process Main Building and that floor level got higher towards the RW Building of Units 1 to 4 as well as the Suppression Pool Surge Tank Building (Figure1). Moreover, the floor level is higher than the recorded water level (OP+4m) of highly concentrated contaminated water in RW Building of Unit 1 to 4. Based on the aforementioned facts, we assume the possibility of highly concentrated contaminated water in the Process Main Building and RW Building of Units 1 to 4 leaking inside the trench is low.

The water level of the accumulated water and radioactivity concentration of the Common Pool Duct (A-A section) and Centralized RW Connecting Duct will be checked periodically (tentatively once a week). As for the centralized RW connecting duct , we are planning to implement preventive measures for rain water at the opening hatch of the upper duct.

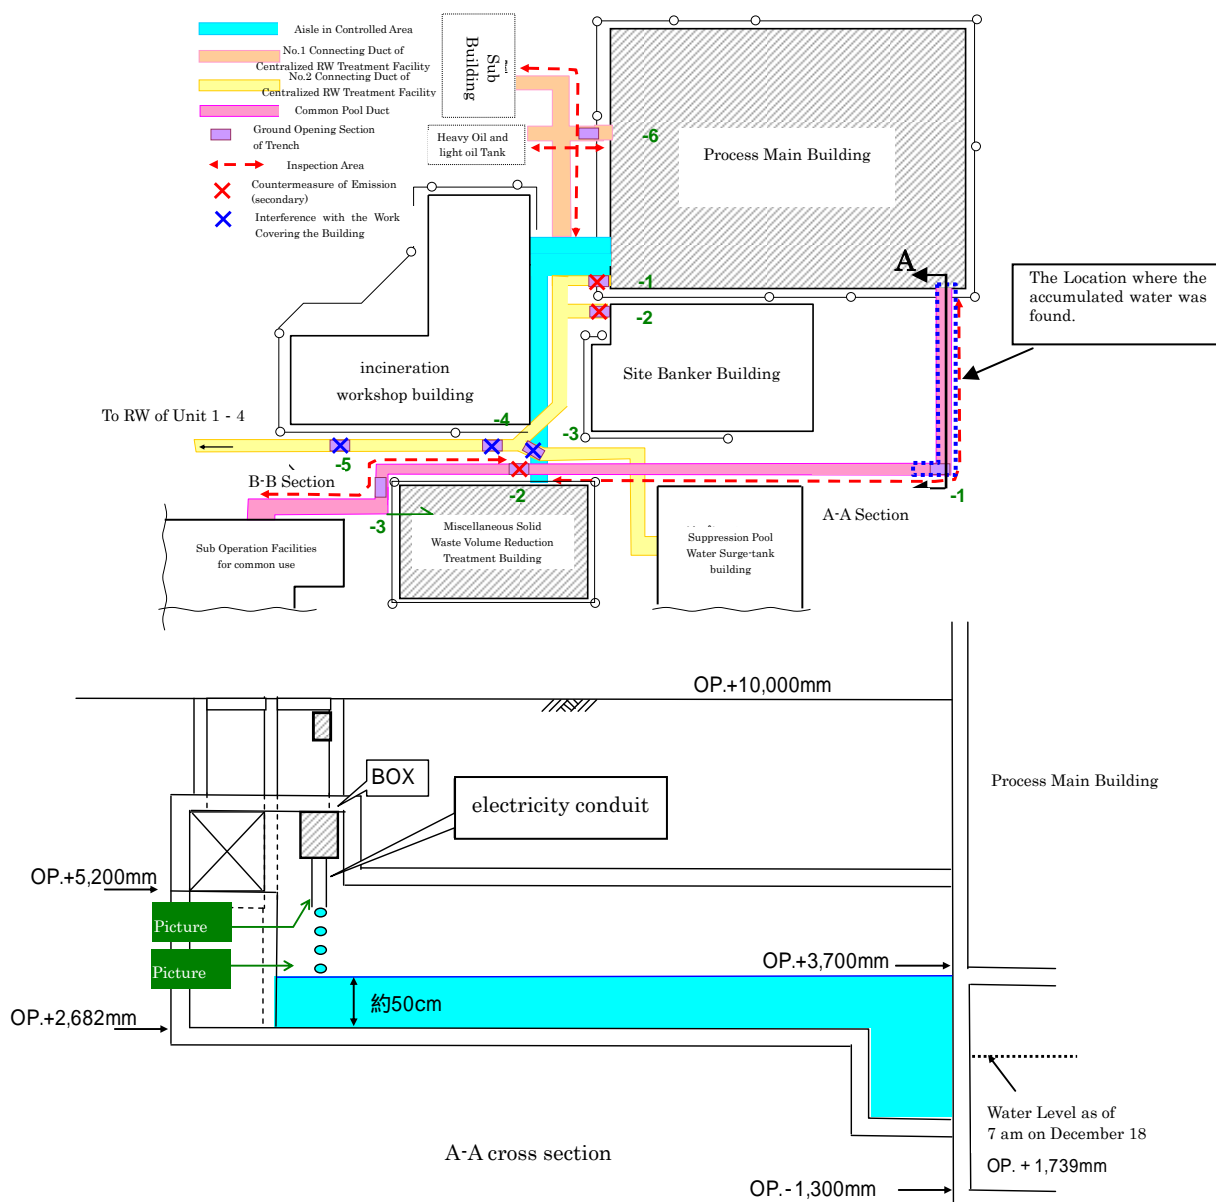
Appendix-4(2/2)

As previously announced on December 18, 2011, at the Common Pool Duct (A-A section), approx. 220m³ of accumulated water in the south side part and the water dripping from the cable conduit line was found (Appendix-4).

- There is accumulated water. The amount of water is approx. 220m³
- Result of Nuclide Analysis :

Name of Trench/Duct	Location of Inspection	Radio Active Density (Bq/cm ³)		
		I-131	Cs-134	Cs-137
A-A section of Common Pool Ducts (press has been informed)	In the trench	ND	4.2×10 ³	5.4×10 ³
	Dripping from the electricity conduits	ND	1.3×10 ⁻¹	1.2×10 ⁻¹

We cut off the cable conduit line as the Figure2 below shows, and stopped the water leakage by using sealing materials at the intake and outlet of the conduit line. On January 6, we confirmed the result of no water incursion from the conduit line located at the trench.
