The Current Statuses of Unit 1-4 Emergency Diesel Generators (D/G): 12 units

Recovery work for Unit 1 D/G (A, H) flooded due to Tsunami

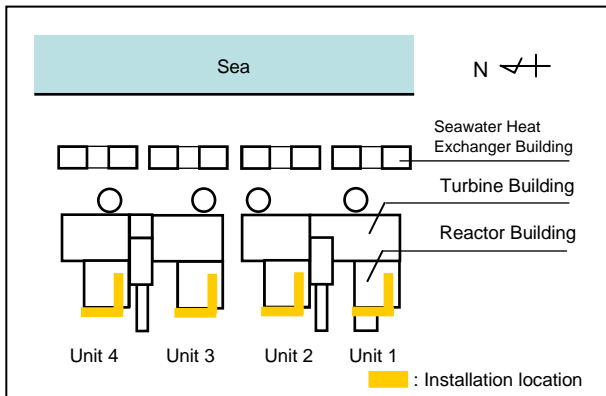
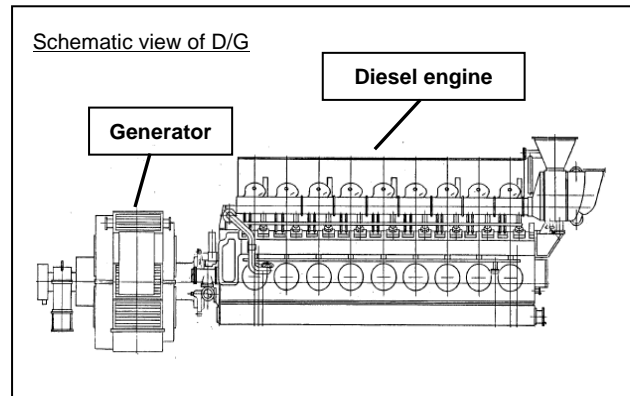
Unit 1-4 emergency diesel generators (hereinafter referred to as D/G) are installed on the second basement of the Reactor Building annex of each unit (3 for each). Due to the Tsunami generated by Tohoku-Chihou-Taiheiyou-Oki Earthquake, all 3 D/G installed in Unit 1 (A, B, H) were flooded. Those in Unit 2-4 (A, B, H) were not flooded, however, all of these except for Unit 3 D/G (B, H) and Unit 4 D/G (H) became unavailable after the Tsunami with other equipments (such as the power panel in the Seawater Heat Exchanger Building and the auxiliary pump) being flooded. Recovery work has progressed steadily, and 9 D/G except for Unit 1 D/G (A, H) and Unit 2 D/G (H) are currently in standby state (available).
