List of Documents concerning the Response Status at
Fukushima Daiichi Nuclear Power Station and
Fukushima Daini Nuclear Power Station (June 2012 version)

Fukushima Daiichi Nuclear Power Station

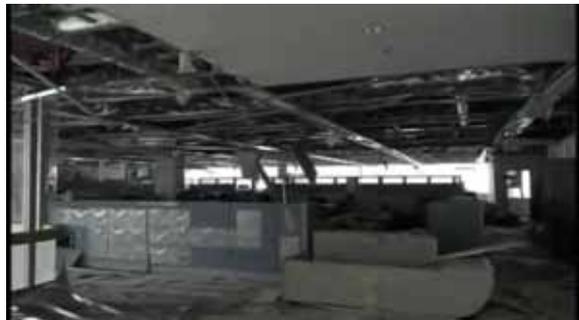
- At 14:46 on March 11, the earthquake occurred. The shaking became more and more violent. In the main building, each department managers ordered their staff to take cover under their desks. Employees protected themselves by putting on helmets used when working in the field.
- Disaster prevention department managers and members headed to the emergency broadcast room during the shaking in order to give an evacuation order but the broadcast facility was rendered inoperable by the earthquake. Members therefore ran around giving the order using megaphones.
- The shaking continued for a long time. Ceiling panels fell, bookshelves toppled scattering items all over the floor, desks moved

State of the Main Office

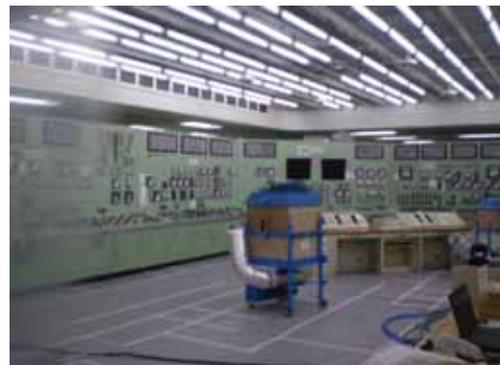
Unit 1 and 2 Main Control Room
(photo taken afterwards)

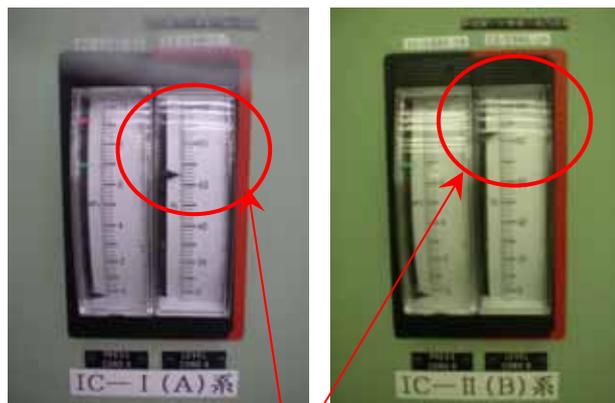
IC(A) Steam Pressure Gauge, Water Level Indicator (Photographed in the days after the accident) IC(B) Steam Pressure Gauge, Water Level Indicator (Photographed in the days after the accident)

The water level of IC(A), which was controlling reactor pressure, was lower than that of IC(B) (normally IC water level is approximately 80%). After arrival of the tsunami indicators were not visible due to loss of power.

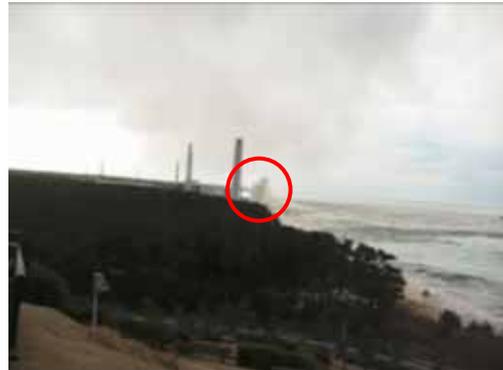
Tsunami Spray of approximately 50m

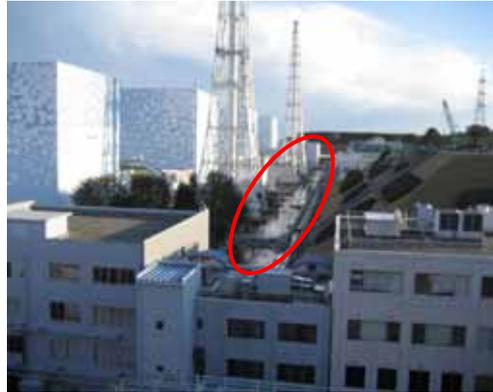
Units 1 to 4 flooded by tsunami

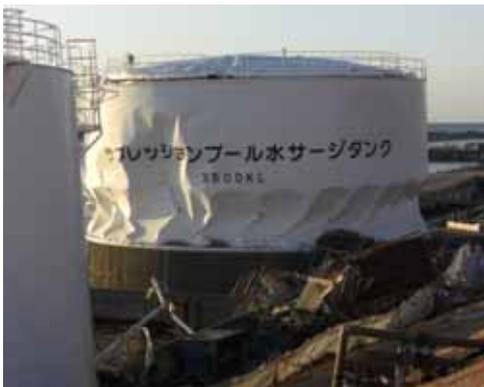
Tank deformed by the tsunami (Same tank shown in picture above)

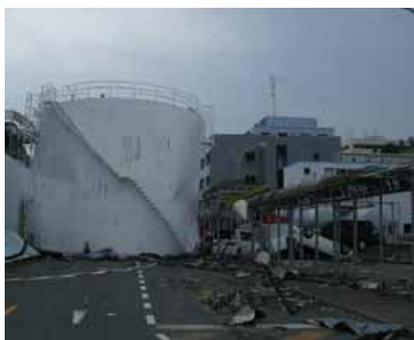
Heavy fuel oil tank swept up by the tsunami and blocking the road (Diameter: 11.7m Height: 9.2m)

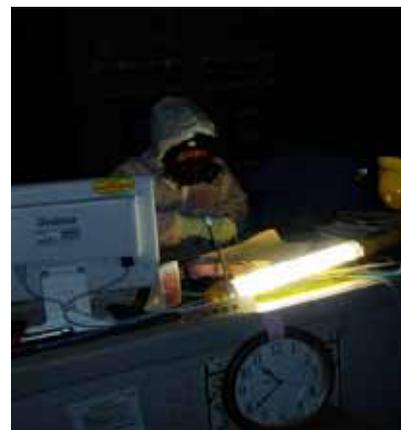
The assistant shift supervisor working at his desk with temporary lighting

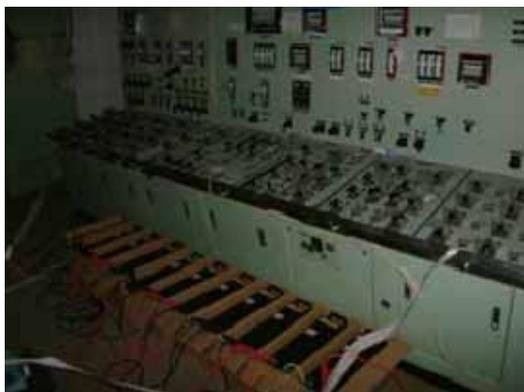
Temporary batteries were connected to instruments to power them

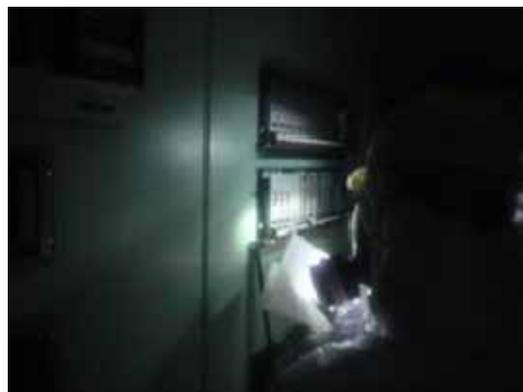
Indicators were checked using flashlights

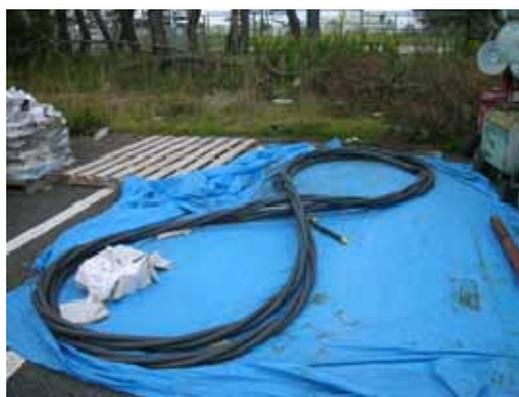
The cable in the photograph is approximately 15m long and weighs approximately 90kg. A cable more than 10 times this length was used to restore power to Unit 1 and 2 (photographed in the days after the disaster)

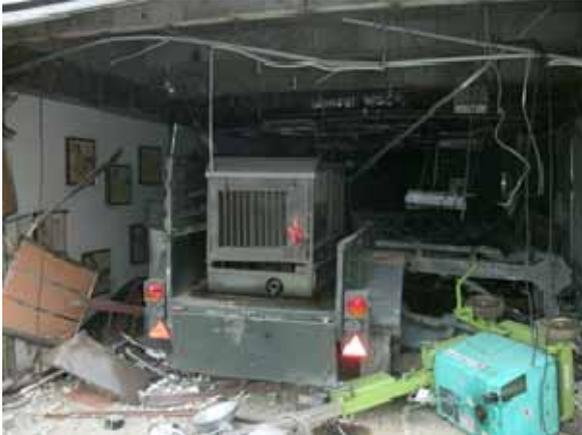
Low voltage. Needed to be towed since the generator was loaded on a trailer (photographed in the days after the disaster)

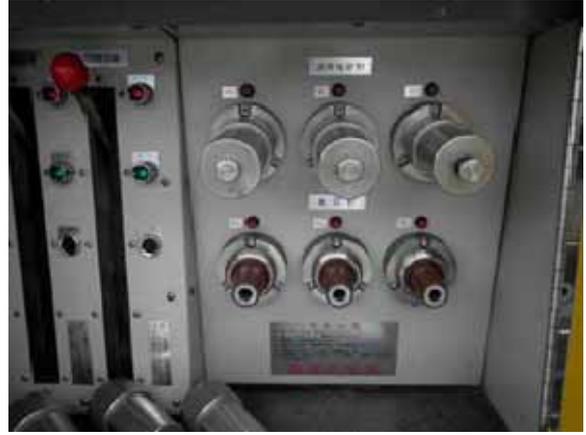
Tohoku Electric high voltage. As with high-voltage, temporary cables needed to be laid and terminals processed in order to send power to the P/C (photographed in the days after the disaster)

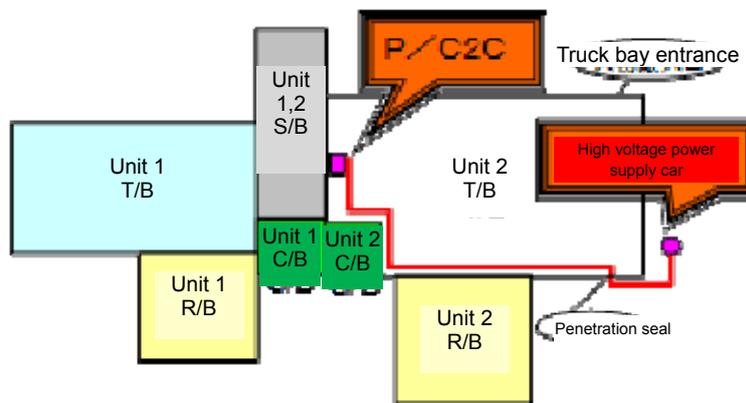
Units 1 and 2 cable laying route diagram

(High-voltage side cables carried in and laid to P/C2C. Thereafter one end of the cables were put through the penetration seals and connected to the power supply car located next to the building.)

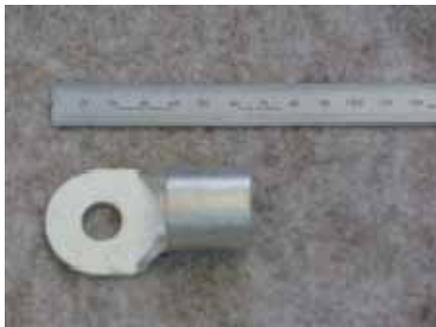
Terminal connected to cables during terminal processing

Six places (3 wires x 2 both ends) needed to be processed.

This photograph is of the same type of cable connection used during power restoration. (Photographed in the days after the disaster)

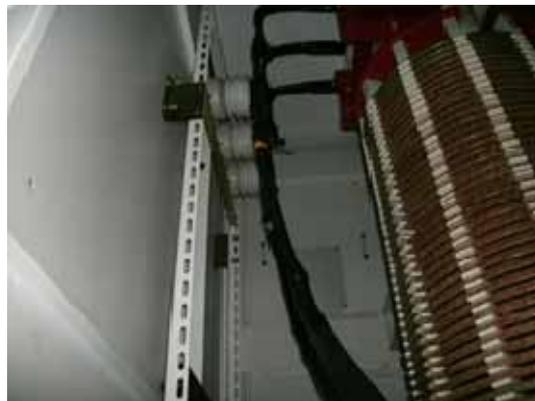
Cable connections to power panel. The 3 wire cable terminals are affixed with bolts and then wrapped with insulation tape.

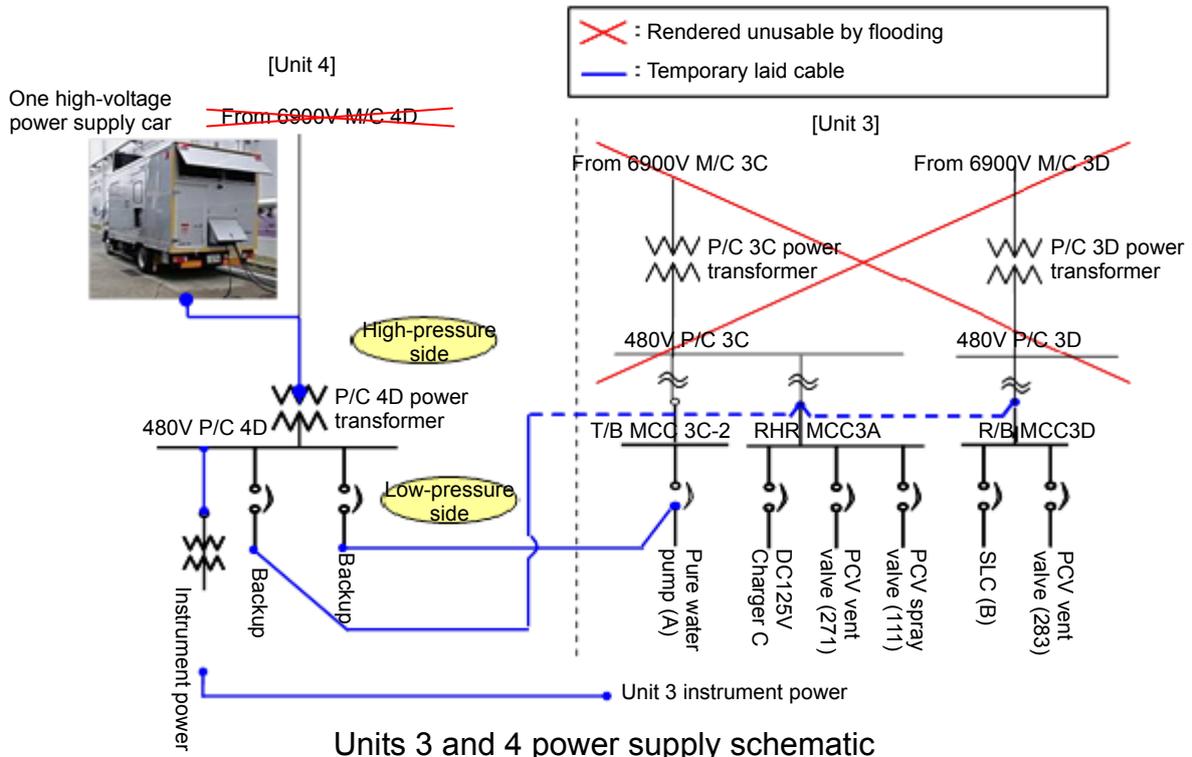
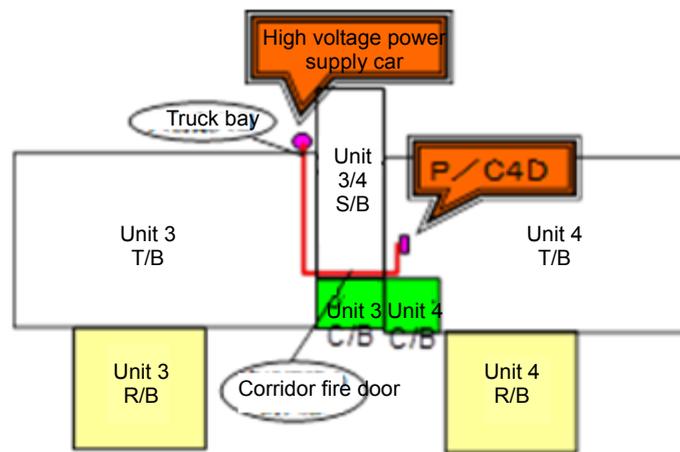
(The shutter to the truck bay and the fire door in the connecting corridor were cut open with torches and high voltage side cables were laid from the high voltage power supply car positioned in front to the P/C4D.)

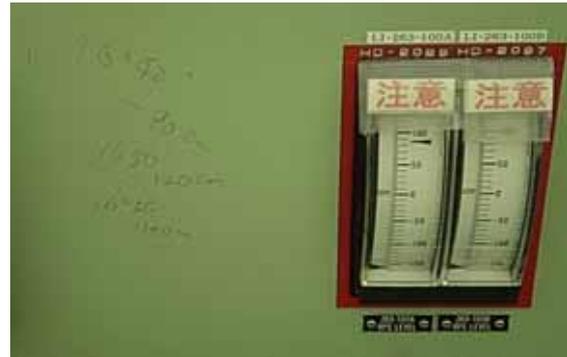
Reactor water level readings temporarily confirmed
(read values written next to gauge, monitoring continued)

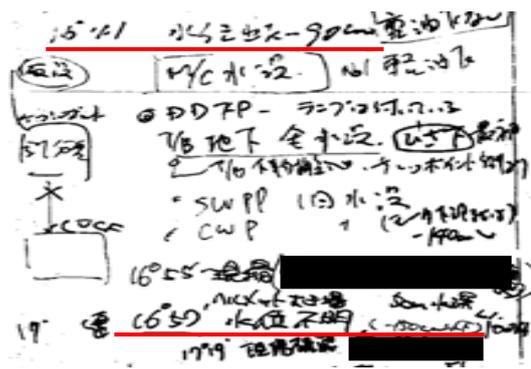
Part of whiteboard
(values read off gauges written here and shared)

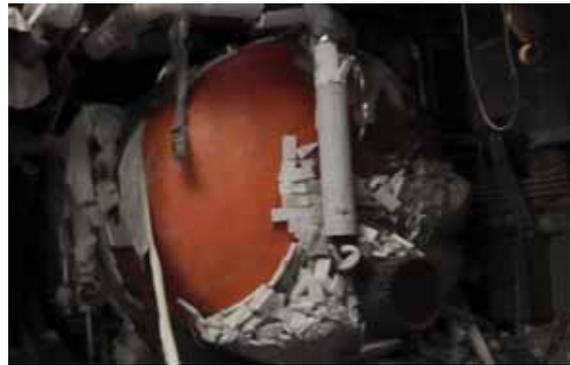
IC external view (photo taken on October 18, 2011)

The red portion is the IC body. It is believed the gray thermal insulation material had been stripped away due to the explosion.

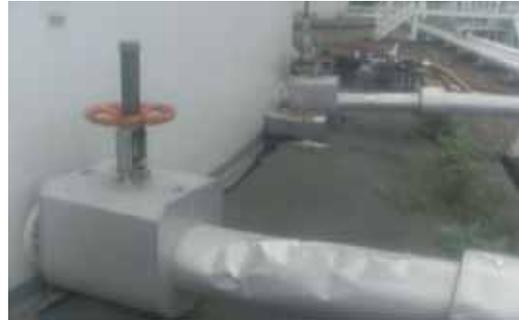
Tank outlet valve near filtered water tank

〔 All outlet valves other than the FP line needed for reactor injection were closed. 〕

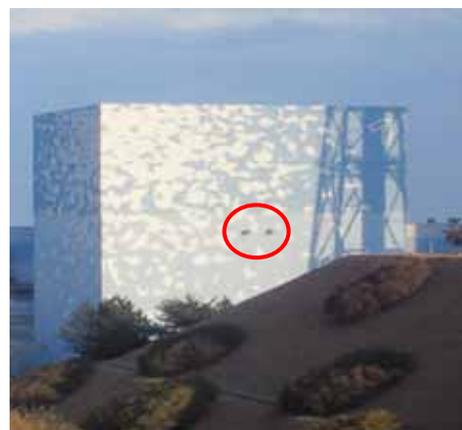
IC vent pipe (nicknamed “pig’s nose”)

- The amount of generated steam seen from the R/B was small, and it stopped shortly after. However, operators could not go into the field in total darkness and check the R/B IC vent pipes in person because at the time, the MCR could not find out the earthquake and tsunami damage status, and the large tsunami alert was in effect.

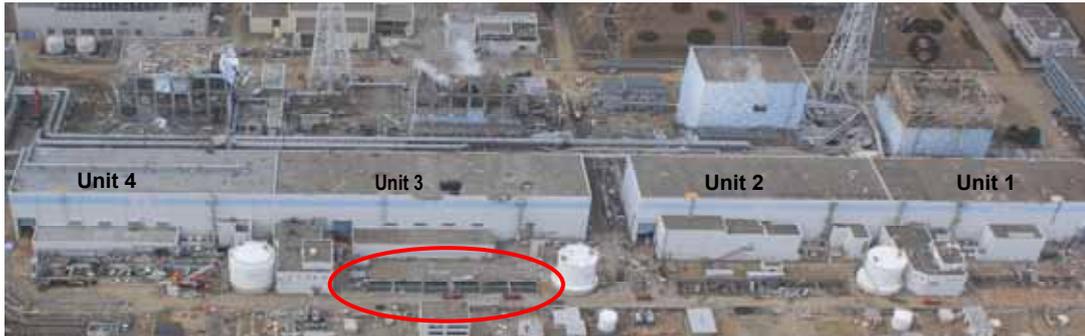
(Unit 3 backwash valve pit was used as water tank, since it was relatively unaffected by tsunami debris and seawater was accumulated there.)

- Based on the condition of on-site roads and the distance to Unit 1, it was decided that seawater would not be directly taken from the ocean. Instead, the Unit 3 backwash valve pit was selected as a water tank, since seawater from the tsunami had accumulated there.

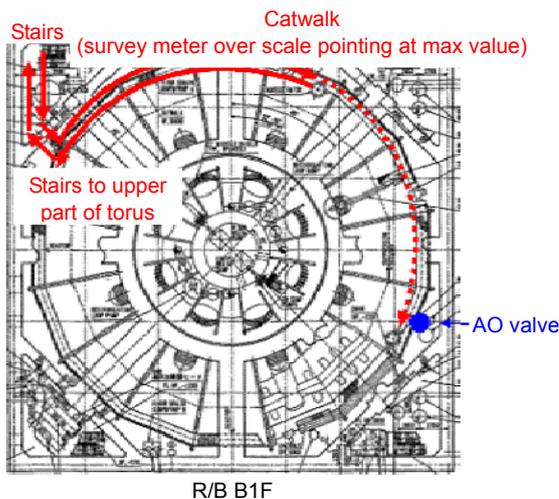
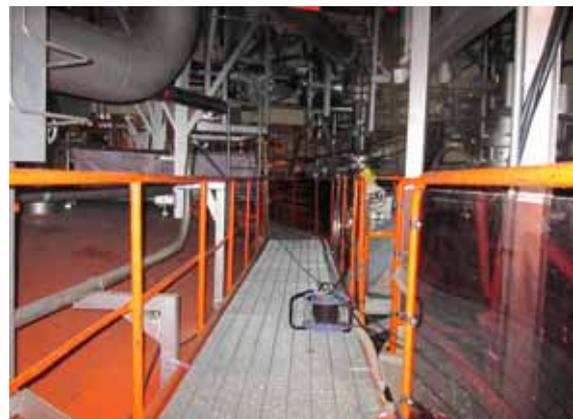
Catwalk (Unit 5, with light)

- Team 2 headed for the R/B B1F torus room to manually open the S/C vent valve (AO valve) bypass valve. They left the MCR at 09:24 on March 12. After entering the torus room, their dosimeter readings went off the charts about halfway through the hallway (catwalk). Due to the risk of exposure to doses exceeding the dose limit of 100mSv, they headed back to the MCR at 09:32.

With no lighting and only flashlights to guide them, operators headed into total darkness toward the AO valve. However, they were forced to turn back due to radiation level increase.

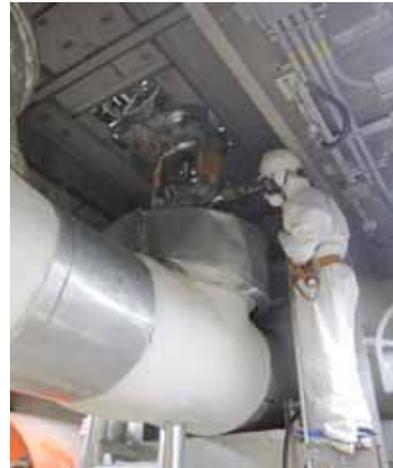
- Particularly for the RHR intake valve installed on piping approx. 60cm in diameter, the

RHR injection valve installed on piping approx. 60cm in diameter (Unit 5, with light)

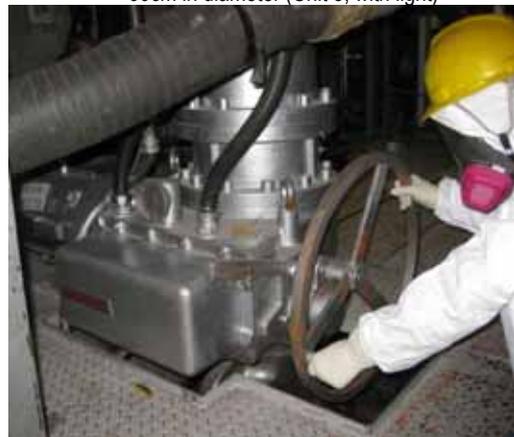
Example of RHR injection valve operation (Unit 5, with light)

(Manual operation handles were very rigid and hard to operate, with work taking place in confined areas.)

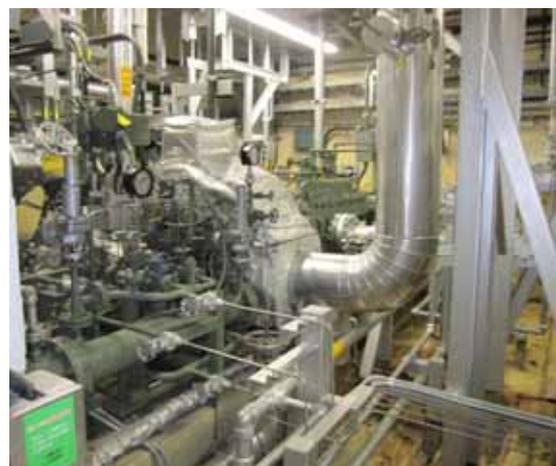
RCIC (Unit 5, with light)

The silver part in the middle (heat insulation) is the turbine and the green part towards the back is the pump. There were many pipes and support beams in the room. Work and movement was performed with only flashlights for light and with water covering the floor.

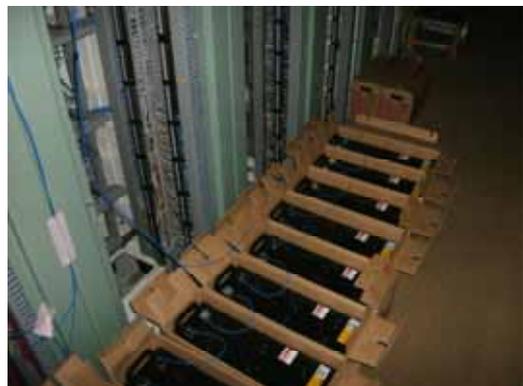
Ten 12V battery parallel[in series]
(photo taken at a later date, with light)

Wiring and terminal connectors were affixed with electrical tape. Risk of electric shock and short circuiting were present. Sparks were generated, and some terminals melted.

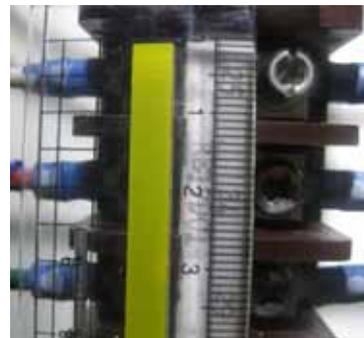
Terminal block (photo taken at later date)
Wires were connected to a terminal block
approx. 1cm wide

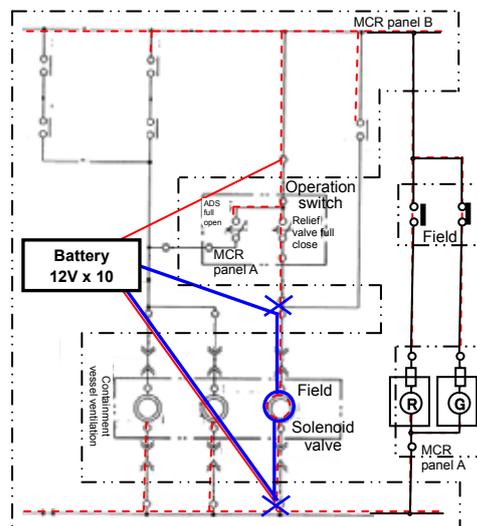
Example: SRV control circuit (SRV opening solenoid valve excitation method)

Red: Power supplied to entire circuit (incl. solenoid valve excitation) by setting operation switch to "on" position. Swift battery consumption.

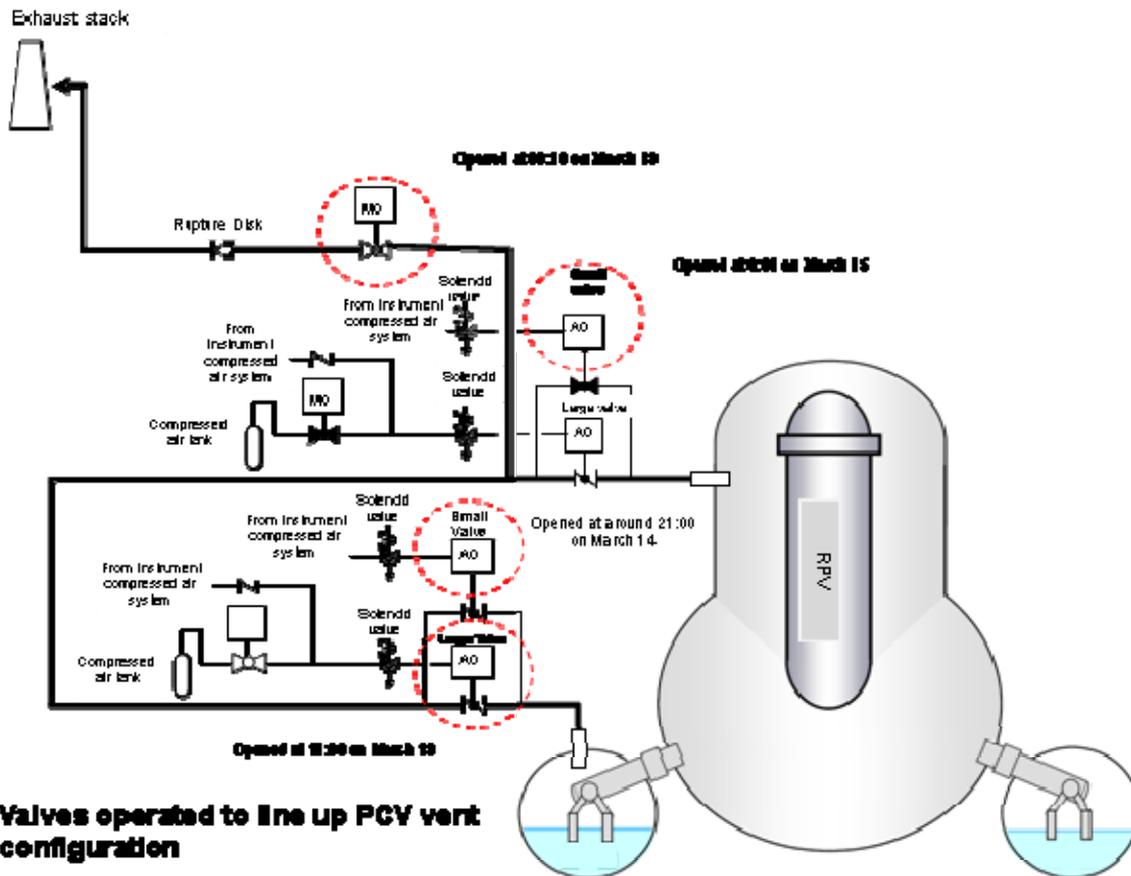
Valves operated to line up PCV vent configuration

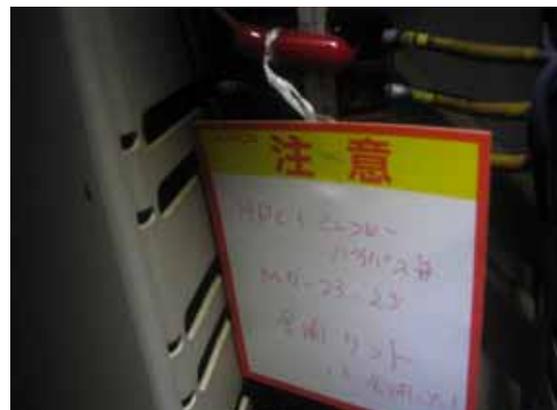
HPCI control panel

Minimum flow valve open/close circuit was fully closed to prevent S/C water level increase

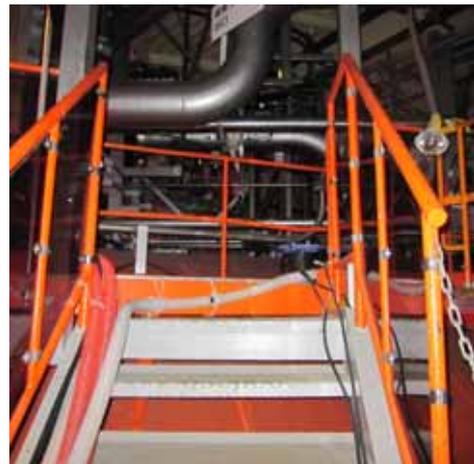
Torus room entrance (Unit 5 side, with light)

Operators headed toward the S/C spray valve to manually open it. The room was hot, muggy, and pitch black, lit only by flashlights.

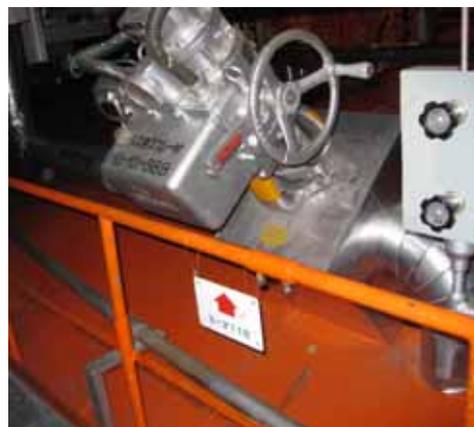
S/C spray valve (Unit 5 side, with light)

- The torus room had become even hotter by the time the S/C spray valve was closed. Soles of the rubber boots being worn by operators melted when they set foot on the upper parts of the S/C. The S/C spray valve operation handle was also hot, and could not be held for long periods of time.
- The D/W and S/C pressure increase was halted due to the D/W spray, and the pressure plateaued. The station ERC decided to stop the D/W spray and expedite PCV venting line assembly toward early implementation of PCV venting.
- Operators manually opened the RHR intake valve, manually closed the D/W spray valve, and switched to the reactor alternate injection line between 08:40 and 09:10 on March 13.

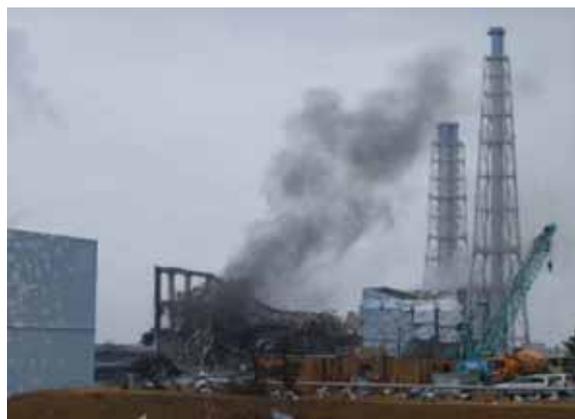
After directing several trucks, the sound of an explosion was heard, and the entire area was blanketed in thick white smoke. Debris began falling noisily thereafter, and the fire brigade took cover under some nearby piping. Although cover was not sufficient, this incident thankfully ended without injuries.

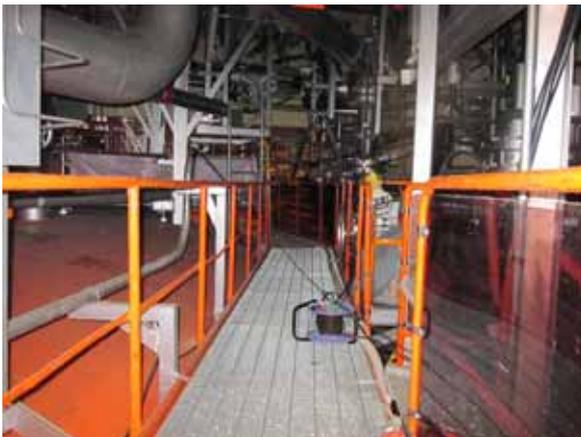
Torus room conditions (Unit 5, with light)

The orange parts are the S/C. The S/C vent valve is in the upper parts of the torus room (pictured to the right, circled in red), and cannot be checked without climbing onto upper parts of the S/C. In total darkness and with only flashlights for light, operators stepped onto the upper part of the S/C. Their boots melted the moment they set foot onto it.

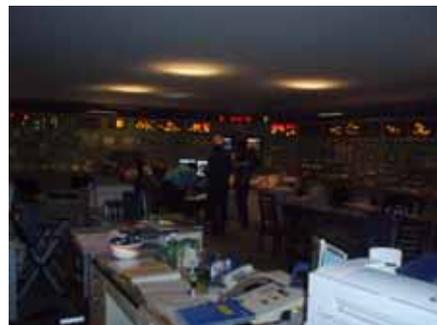
Units 5 and 6: Unit 5 side
(With only emergency lights turned on)

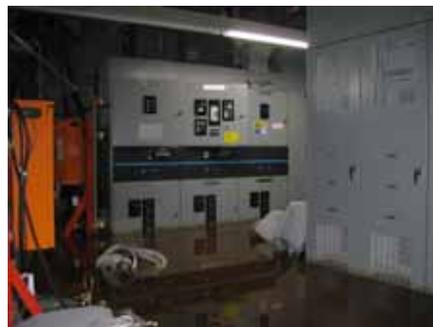
- Since later Unit 5 high voltage power panel (M/C) flooding meant Unit 5 low voltage power panel (MCC) could not be provided with power, installation of temporary power cables began. These would directly connect the Unit 6 T/B low voltage power panel (MCC) to equipments needed for Unit 5 restoration operation. The Unit 5 standby gas treatment system (SGTS) was activated at 21:01 on March 13 (the Unit 6 SGTS had continued operating after the earthquake). This allowed negative pressure to be maintained at the R/Bs for Units 5 and 6 from then on, and also allowed suppression of radioactive material release in case such release occurred.

Unit 6 electric item room flooding status

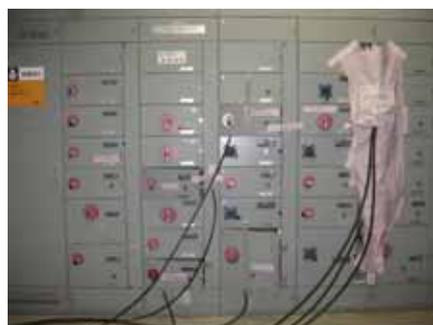
Temporary power source cable connection status
(photo taken at later date)

- By installing temporary power cables directly between the Unit 6 S/B instrument power panel and Unit 5 Control Building instrument power panel, power could be provided to MCR Unit 5 monitoring instruments which could operate on AC power sources.

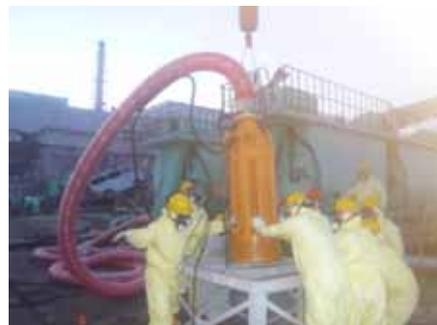
- The restoration team performed soundness check of the Units 5 and 6 RHR seawater pumps and discovered they were unusable. In coordination with the headquarters, they deliberated temporarily connecting the general use underwater pump to seawater system pipes for restoration as an alternate RHR cooling seawater pump.

Underwater pump installation work

- Underwater pump installation area rubble removal and leveling for construction roads began on March 16. Installation of temporary power cables from the high voltage power supply cars, outdoor pump operation panel installation, and temporary underwater pump installation were completed on March 18 for Unit 5 and on March 19 for Unit 6. The temporary RHR seawater pump was activated at 01:55 on March 19 for Unit 5 and at 21:26 of the same day for Unit 6.

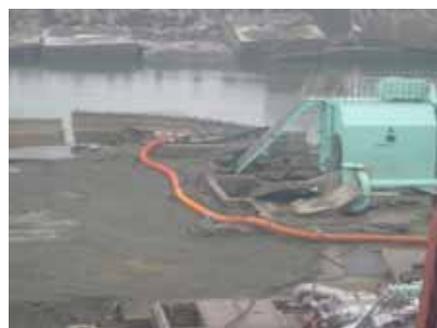
Underwater pump installation status
(installation took place on later date)

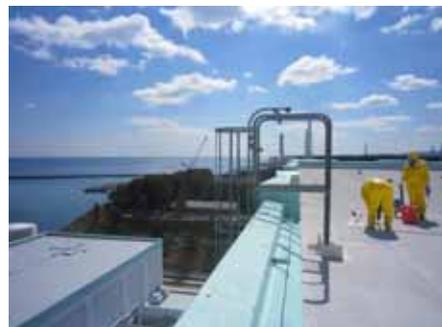
Work on the rooftop

- Reactor and SFP water levels were maintained after earthquake occurrence, and hydrogen gas was not generated at this time. However, due to the risk of injection function and RHR function loss due to aftershocks, the station ERC deliberated hydrogen gas accumulation prevention measures just in case. It was decided that boring machines would be used to open holes in three areas (diameters ranging from approx. 3.5cm to approx. 7cm) in the concrete roofs of the R/Bs for Units 5 and 6 on March 18.
- Work began in the early morning hours of March 18. 4 employees and 4 contractor workers wore full face masks with charcoal filters and coveralls before climbing on the rooftop of the R/B, and worked a total of approx. 11 hours on Units 5 and 6 (Unit 5 work completed at 13:30 and Unit 6 work completed at 17:00).

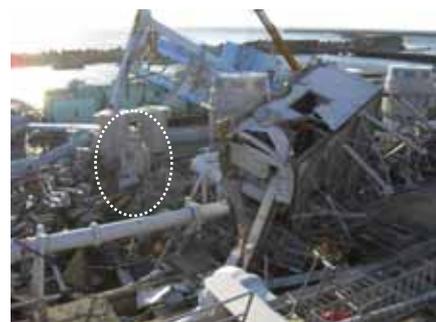
(○) circled area is DG (6A) seawater pump

- The seawater pump for Unit 6 DG (6A) cooling was covered by seawater during tsunami. Operators and the restoration team confirmed

Seawater pump area status

pump soundness via visual checks of outdoor seawater pump area flooding and external damage status, alongside insulation resistance measurement. The pump was activated at 19:07 on March 18.

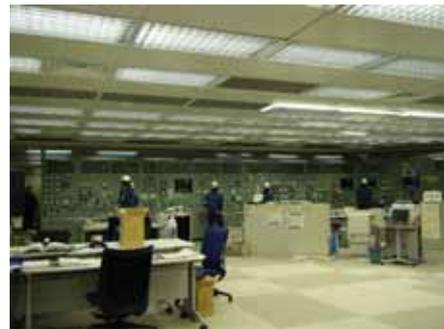
MCR after tsunami

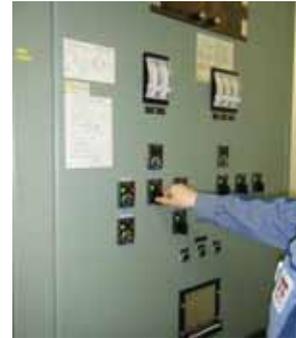
Valve operation with the MCR AM panels
(work conditions shown took place on later date)

impact rendering ECS Pumps unusable. Therefore, preparations for alternate injection via MUWC (introduced as Accident Management (AM)) were begun, in addition to reactor injection cooling for each Unit after RCIC shutdown. Line assembly via valve operation from MCR AM panels was performed at Units 2, 3 and 4. Since the drive power for valves necessary for line assembly at Unit 1 were lost due to tsunami, valves were manually opened in the field. After line assembly was completed, the intake valve was opened from the MCR and it was confirmed that injection was possible.

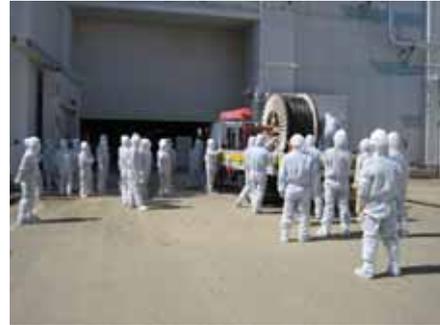
Temporary cable installation preparations
(work conditions shown took place on later date)

- Temporary cables were installed between various areas to restore power to necessary equipment. These included: from the radwaste building (hereinafter referred to as “RW building”) to the Hx/B of Units 1 and 2; from the Unit 3 Hx/B to the Hx/B of Units 2 and 4; from high voltage power supply cars to the Hx/B of Units 1 and 4 via the transformer temporarily stored in the Unit 3 T/B truck bay. The priority for power restoration was decided based on station status evaluations made upon consideration of trends in parameters at each Unit (e.g. D/W pressure). As a result, Unit 2 was initially given priority and cable installation began accordingly. However, due to evaluation based on later parameter trend changes, this was changed to prioritize Unit 1 power restoration.

- The temporary cables were each 2 to 3cm thick, bundled into groups of three. If length of these groups were approx. 200m, then the weight would be over 1t. Between the RW building and Hx/B, cables spanning a max. of approx. 800m had to be installed. Work that would normally be performed over several days using machinery had to be performed quickly using only manpower. The total length of installed temporary cable was 9km. Some of it was installed on March 12, and installation of the remaining majority on March 13.

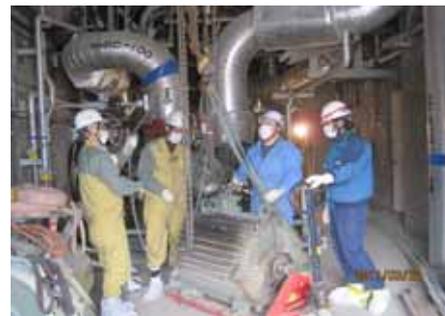
- Motor cleaning for certain Unit 1 ECS Pumps was performed, but their insulation resistance failed to recover. Therefore, motors were airlifted in by the Self Defense Force (SDF) from Mie Prefecture to Fukushima Airport. After the motors arrived at the station from the Airport, installation and connection to temporary cables began immediately. Work was

Pump motor restoration work
(work conditions shown took place on later date)
