Current Conditions of Unit 1-4 Seawater Heat Exchanger Building

Restoration status of the equipments in Unit 4 Seawater Heat Exchanger Building based on the restoration plan

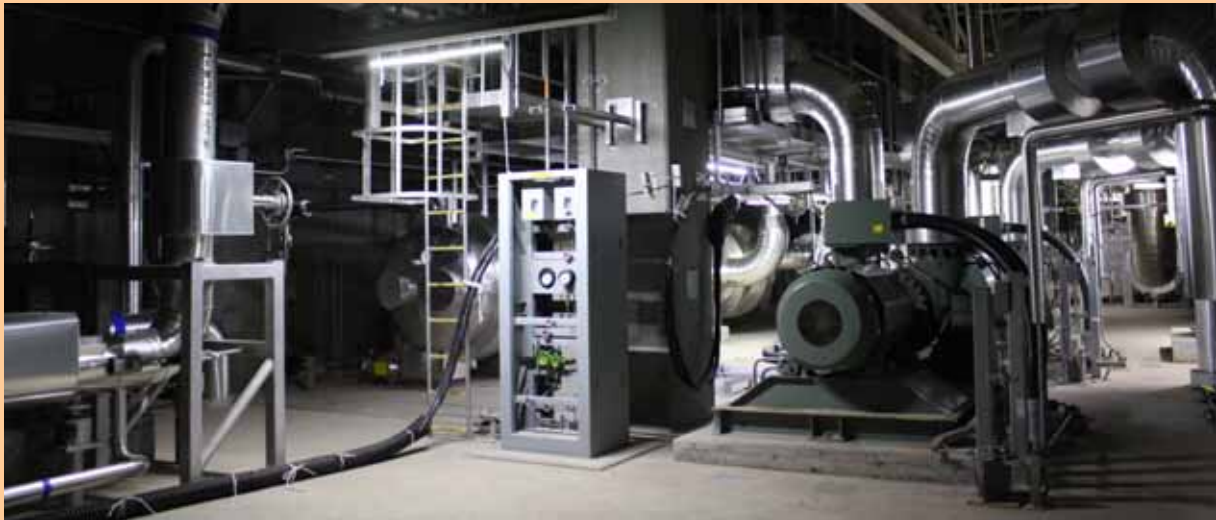
Unit 4 Seawater Heat Exchanger Building 1st Floor after restoration
(Photo taken on June 30, 2012)

For Unit 4, all the equipments/facilities necessary for maintaining the cold shutdown state have been restored on May 17, 2012. (As announced on May 31, 2012)
