Impact of Tsunami on the monitoring posts and the current situations

Impact of Tsunami on the monitoring posts and the current conditions (Chart)

MP6 exposed to the Tsunami

MP-7 washed away by the Tsunami

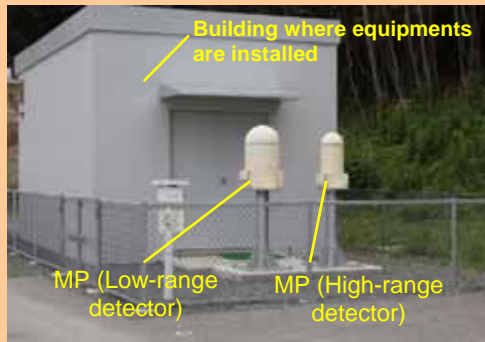
MP-7
(Photo taken on July 24, 2012)

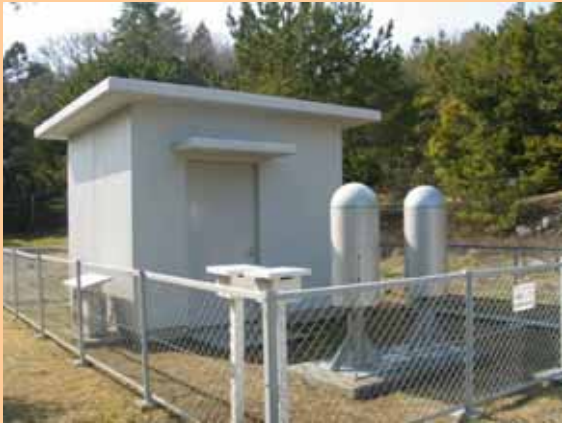
1. MP-7 before the earthquake
(Photo taken on March 17, 2004)

Since MP-7 was washed away by the Tsunami, measurement utilizing a portable monitoring post was started on March 21, 2011. Detectors were then installed and measurement utilizing a temporary monitoring post was started on June 13, 2011. The permanent installation was completed on December 21, 2011 allowing for measurement by the new monitoring post.
