Installation of the emergency diesel generator (A) in Unit 1 Reactor Building Annex (August 31)

As for the emergency diesel generator (A) in Unit 1 Reactor Building Annex which was damaged by the Tsunami, the control panel was removed on August 2. The generators* newly manufactured and repaired were installed on August 31.

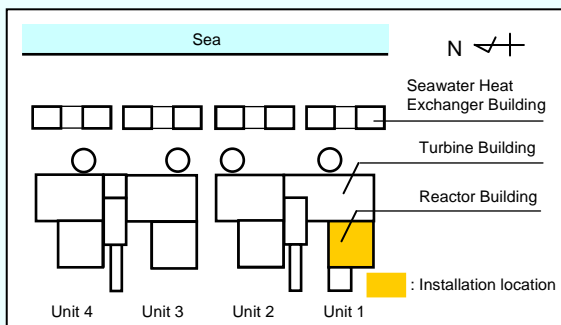
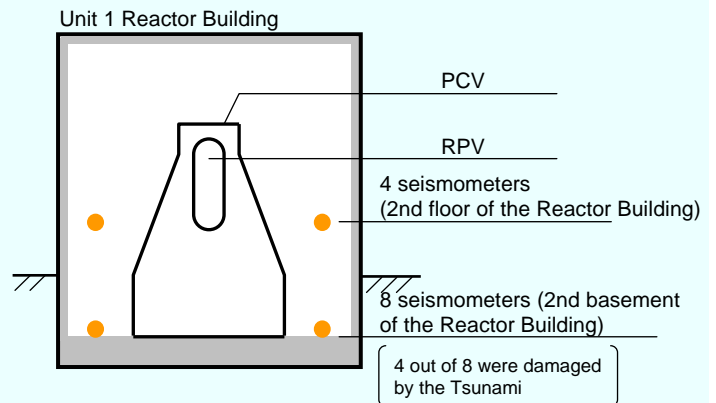
All the seismometers in Unit 1 Reactor Building (12 including 4 damaged by the Tsunami) newly manufactured by June 13 have been permanently installed after a function check was completed on August 6.

Function check (Second basement of Unit 1 Reactor Building)
(Photo taken on July 25, 2012)

A weight was placed on the seismometers to check for their proper operation.
