Status of investigation on estimating situation of cores and containment vessels

1. Introduction

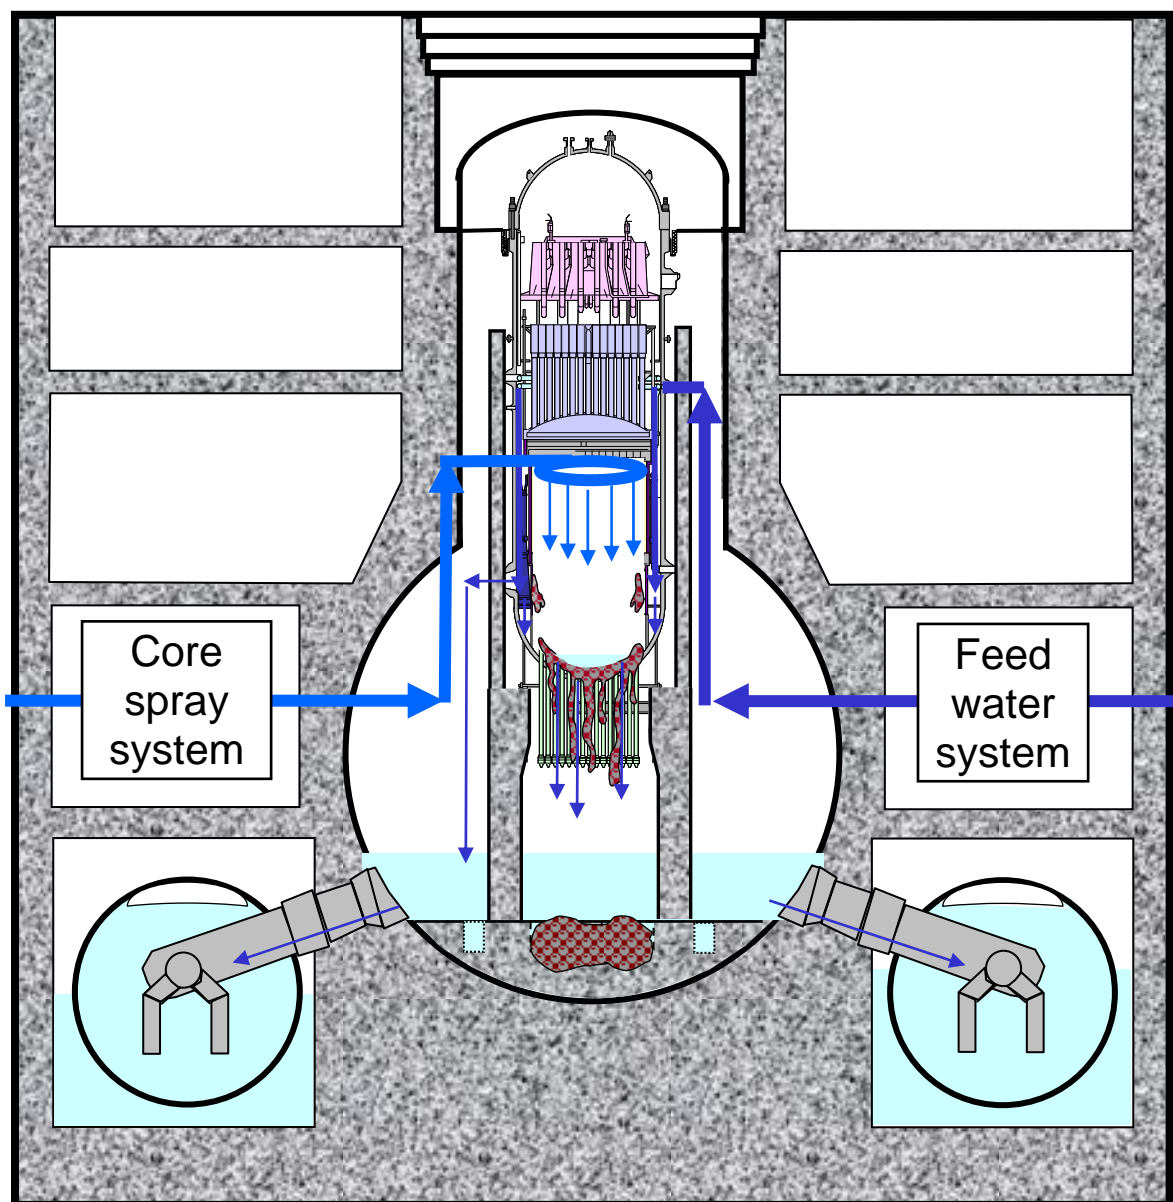
Figure 1-1 Estimated conditions of the core and PCV of Unit-1

(Note) Estimated conditions of the core and PCV are not updated from the previous report. The illustration does not accurately represent a quantitative image for the size, etc. of debris

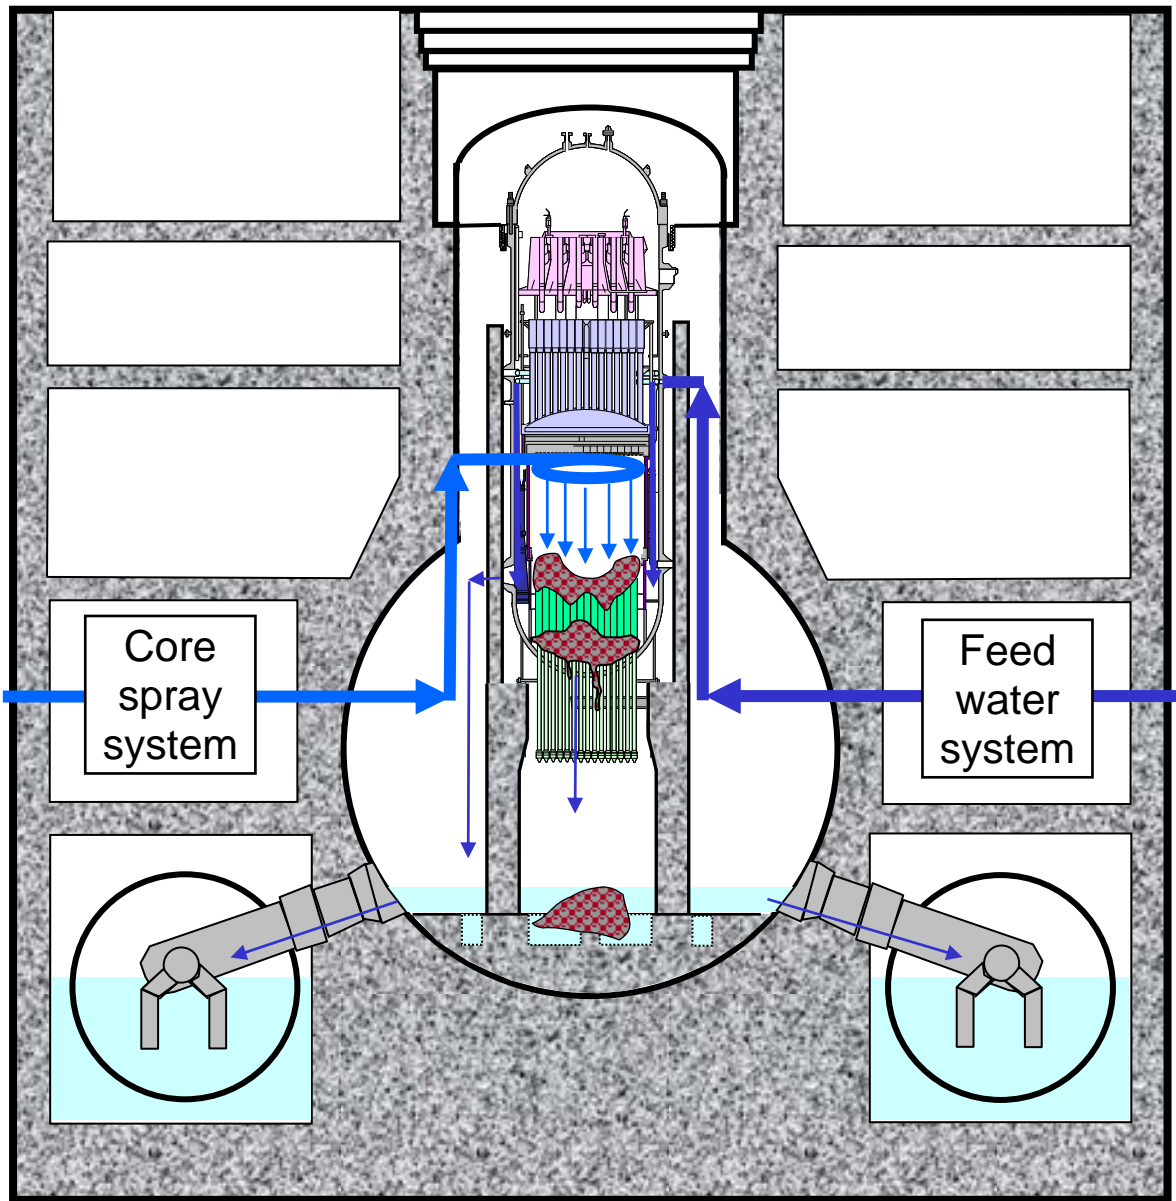
Figure 1-2 Estimated conditions of the core and PCV of Unit-2

(Note) Estimated conditions of the core and PCV are not updated from the previous report. The illustration does not accurately represent a quantitative image for the size, etc. of debris

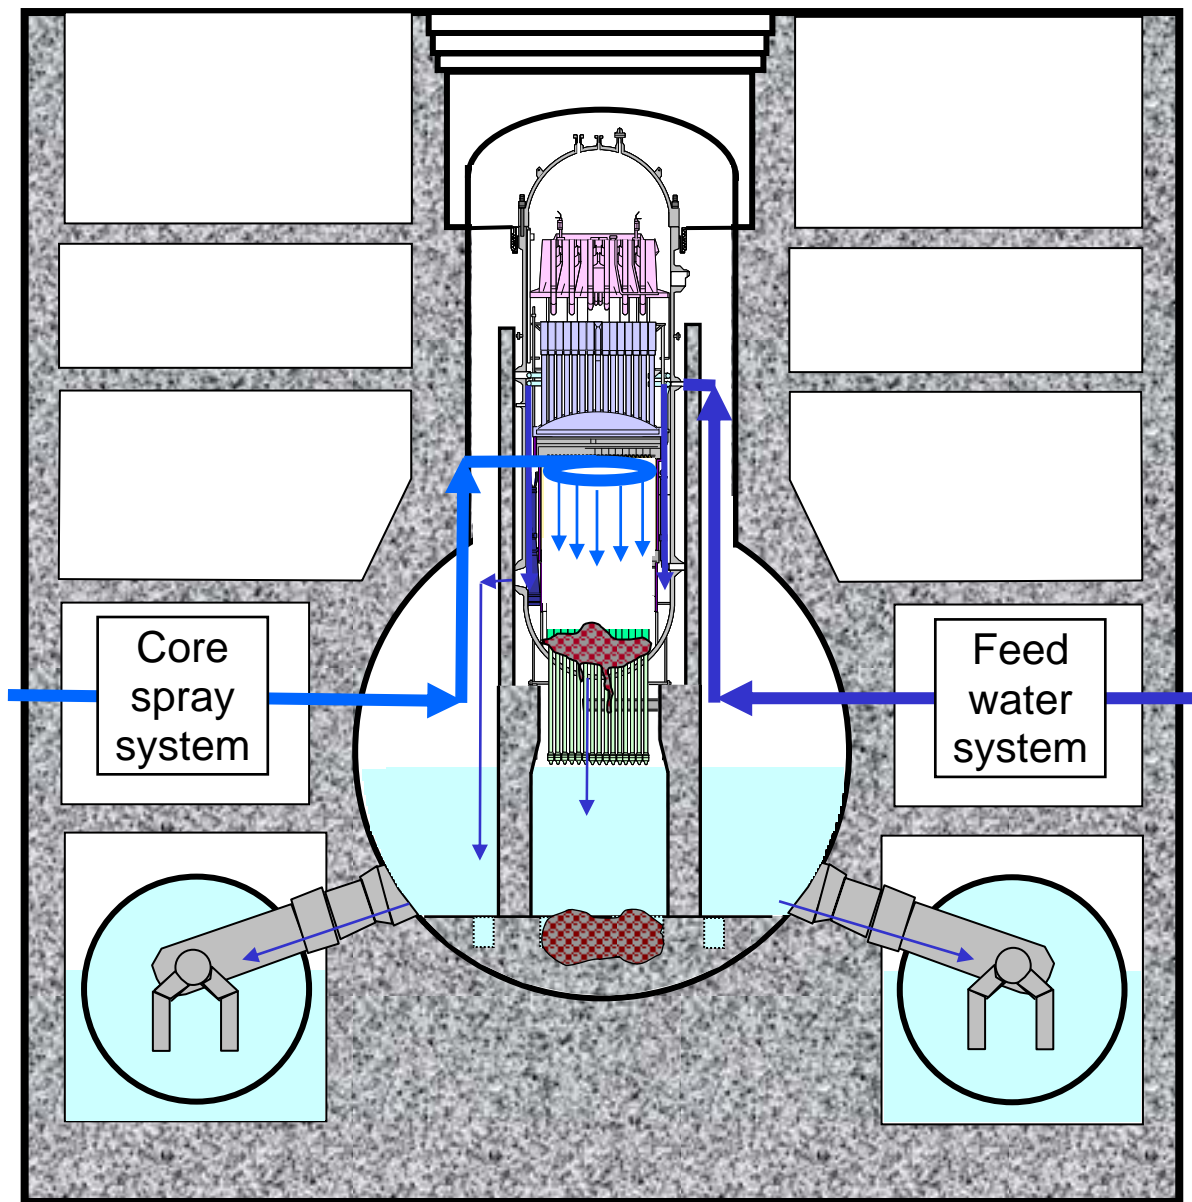
Figure 1-3 Estimated conditions of the core and PCV of Unit-3

(Note) The fallen debris on the PCV pedestal was shown larger this time, incorporating the analysis results of the case that sufficient water injection to the reactor had not been possible before the operator manually stopped the HPCI. The illustration does not accurately represent a quantitative image for the size, etc. of debris.

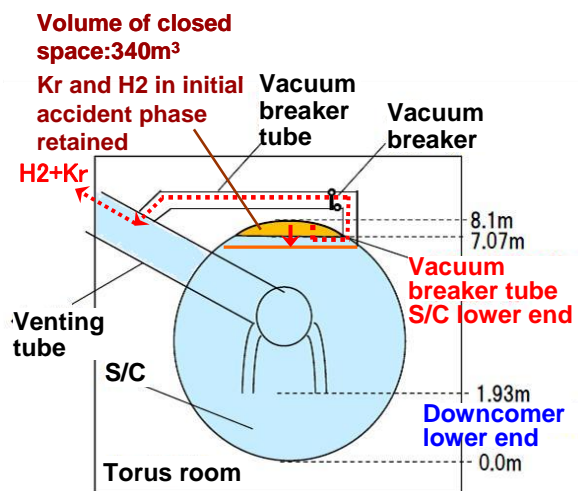
Figure 2-2 Closed space in gaseous phase inside S/C of Unit-1

In September 2012, a nitrogen gas injecting test was conducted into the suppression chamber (S/C), in which the theory was demonstrated that hydrogen gas and Kr-85 generated in the early stage of the accident and retained in the S/C upper space pushed down the S/C water level and were discharged to the D/W through the vacuum breakers. This helped to confirm that the S/C was currently almost filled with water (the level at around the lowest end of the vacuum breaker tube [2] (Figure 2-2).

level drops, residual gas left in the closed space in the upper S/C is discharged to the D/W through vacuum breakers, and then the S/C water level rises and stops the gas discharge. In this hypothesis, Kr-85 is understood to originate in the early phase of the accident, because Kr-85 is a long half-life fission product and its amount cannot be explained as being newly produced by spontaneous fission, etc.

In the test to verify the mechanism hypothesis, the S/C pressure (being monitored by the existing instrumentation) rose after the injection of nitrogen gas started into the S/C, the hydrogen gas concentration and Kr-85 radioactivity monitored by the containment gas control system started to increase, which decreased when nitrogen gas injection was halted. This is interpreted to be that the nitrogen gas injection pressurized the closed space of the S/C upper part, which lowered the S/C water level and formed a gas discharge channel to the D/W through the vacuum breakers, thus the retained gas in the space was discharged together to the D/W by the injected nitrogen gas.

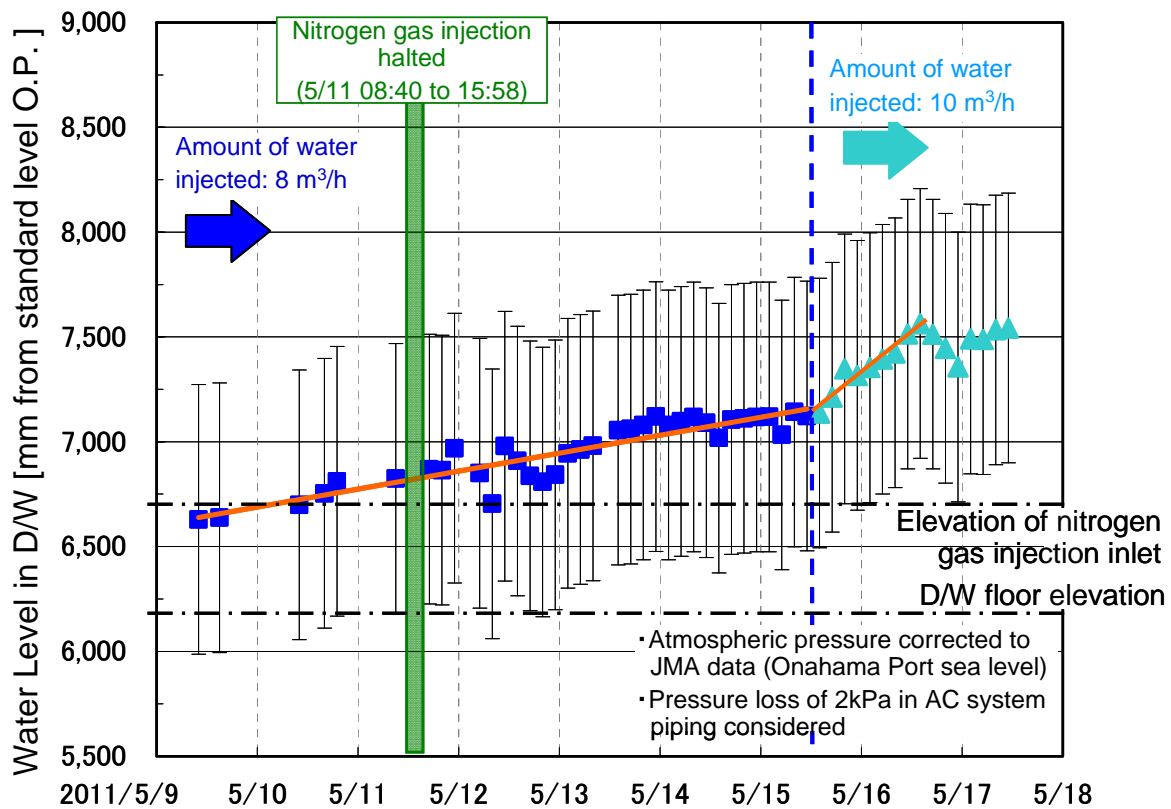
Figure 2-5 Estimated PCV water level changes during flooding operation of Unit 1 (May 2011)

Meanwhile, the water leakage down to the S/C surface around both sides of the vent tube X-5E indicates the possibility of water leaks from the vacuum breaker tube (its bellows, for example) immediately above the vent tube. This elevation of the vacuum breaker tube is about the same level as that of the upper limit of PCV water level which was reached in an attempt to flood the PCV by increasing the amount of water injected in May 2011; where the PCV water level was calculated from the injected nitrogen gas pressure. The nitrogen gas pressure was stopped from changing at a specified level, which means the PCV water level was leveled off, i.e., an indication of leak hole existence at the level (Figure 2-5) [5].

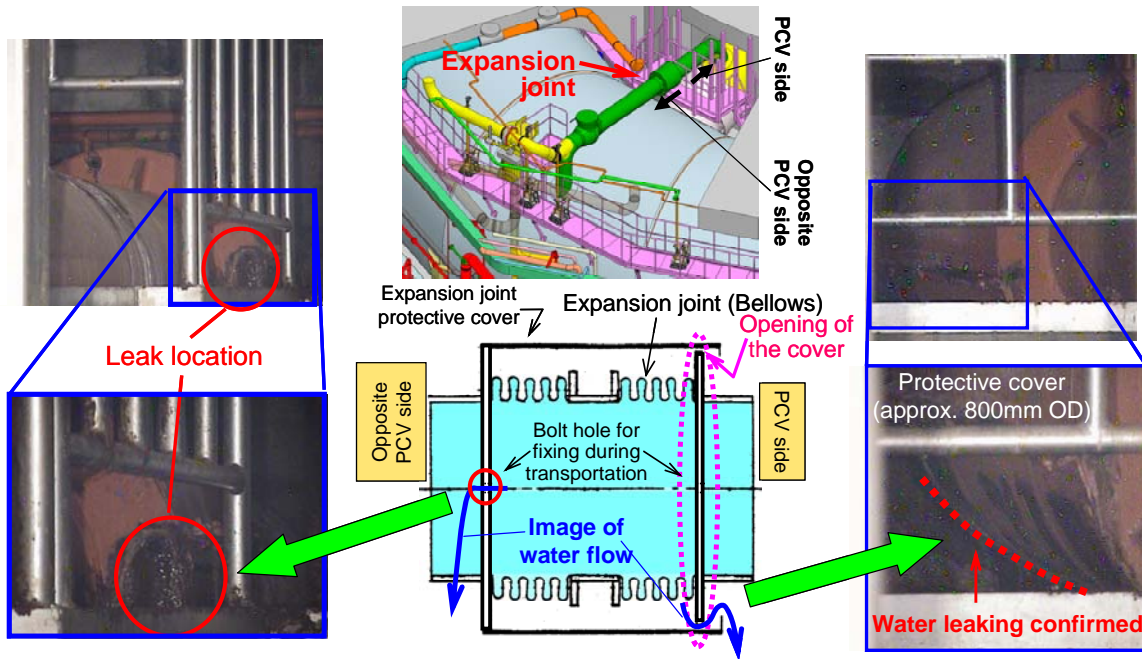
**Illustration of Expansion joint (Bellows) for vacuum breaker tube**

In May 2014, survey instrumentation robot was introduced through a drilled hole in the northwest area of the first floor of the Unit1 reactor building to explore the S/C top area in order to locate the leak source near the vent tube X-5E, where leaking had been confirmed. By using the outer catwalk, the instrumentation robot made a camera survey around the vent tube X-5E, and the water leak was confirmed to be from the protective cover of the expansion joint on the vacuum breaker line. No leaks were noticed from the vacuum breaker valve, torus hatch, Shutdown cooling system (SHC) piping or Atmospheric control system (AC) piping (Figure 2-7) [7].

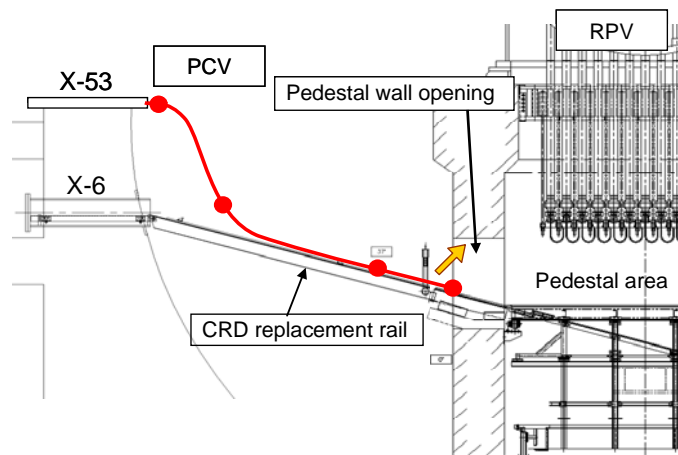
Figure 3-2 Survey areas inside Unit-2

In July and August 2013, a survey was conducted inside the PCV of Unit-2, when instrumentation was introduced through the PCV piping penetration X-53 (reactor building first floor) to take camera images and make dose and temperature measurements in the vicinity of the control rod drive mechanism (CRD) replacement rail and pedestal opening (Figure 3-2) [10].

Dosimeters measured the dose rates as far as the top of the CRD replacement rails. The values were about 45 – 80 Sv/h. As supplementary information, dose rates were estimated from the camera image noises; they were about 30 Sv/h near the landing point in replacement rail and

about 36 Sv/h near the pedestal opening. No clear indication was obtained about gaining access to fuel debris, even via the pedestal opening on the CRD replacement rail because access to fuel debris will result in rapid dose rate increase.

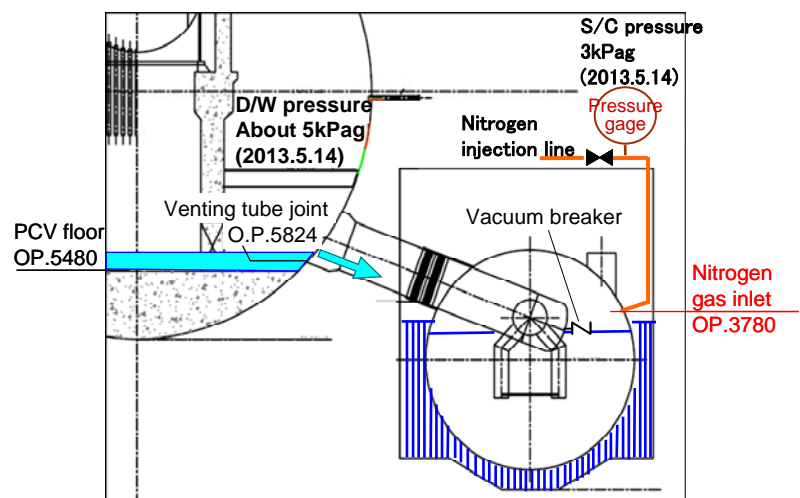
Figure 3-4 Closed space assumed in Unit-2 S/C

The S/C pressure was confirmed to be 3 kPag (as of May 14<sup>th</sup>, 2013) in a nitrogen gas injecting test into the S/C done in May 2013. The absolute water level in the S/C was not accurately known, but it was confirmed to be approximately on the level of the nitrogen gas inlet (O.P. 3780), because some reasonable pressure due to the water head should exist at the inlet if the S/C were almost filled with water. If the low water level in the

D/W is considered in combination, the water injected into the reactor vessel is considered to have reached the S/C via the D/W and venting tubes. If this hypothesis is correct, the current S/C water level will be on the same level as that of water retained in the torus room [11] (Figure 3-4).
