Report on the Investigation and Examination of
Unconfirmed/Unclear Matters
on the Development Mechanism of the Fukushima Nuclear Accident
Progress Report No.3

May 20, 2015

Tokyo Electric Power Company, Inc.

Progress Report No.3

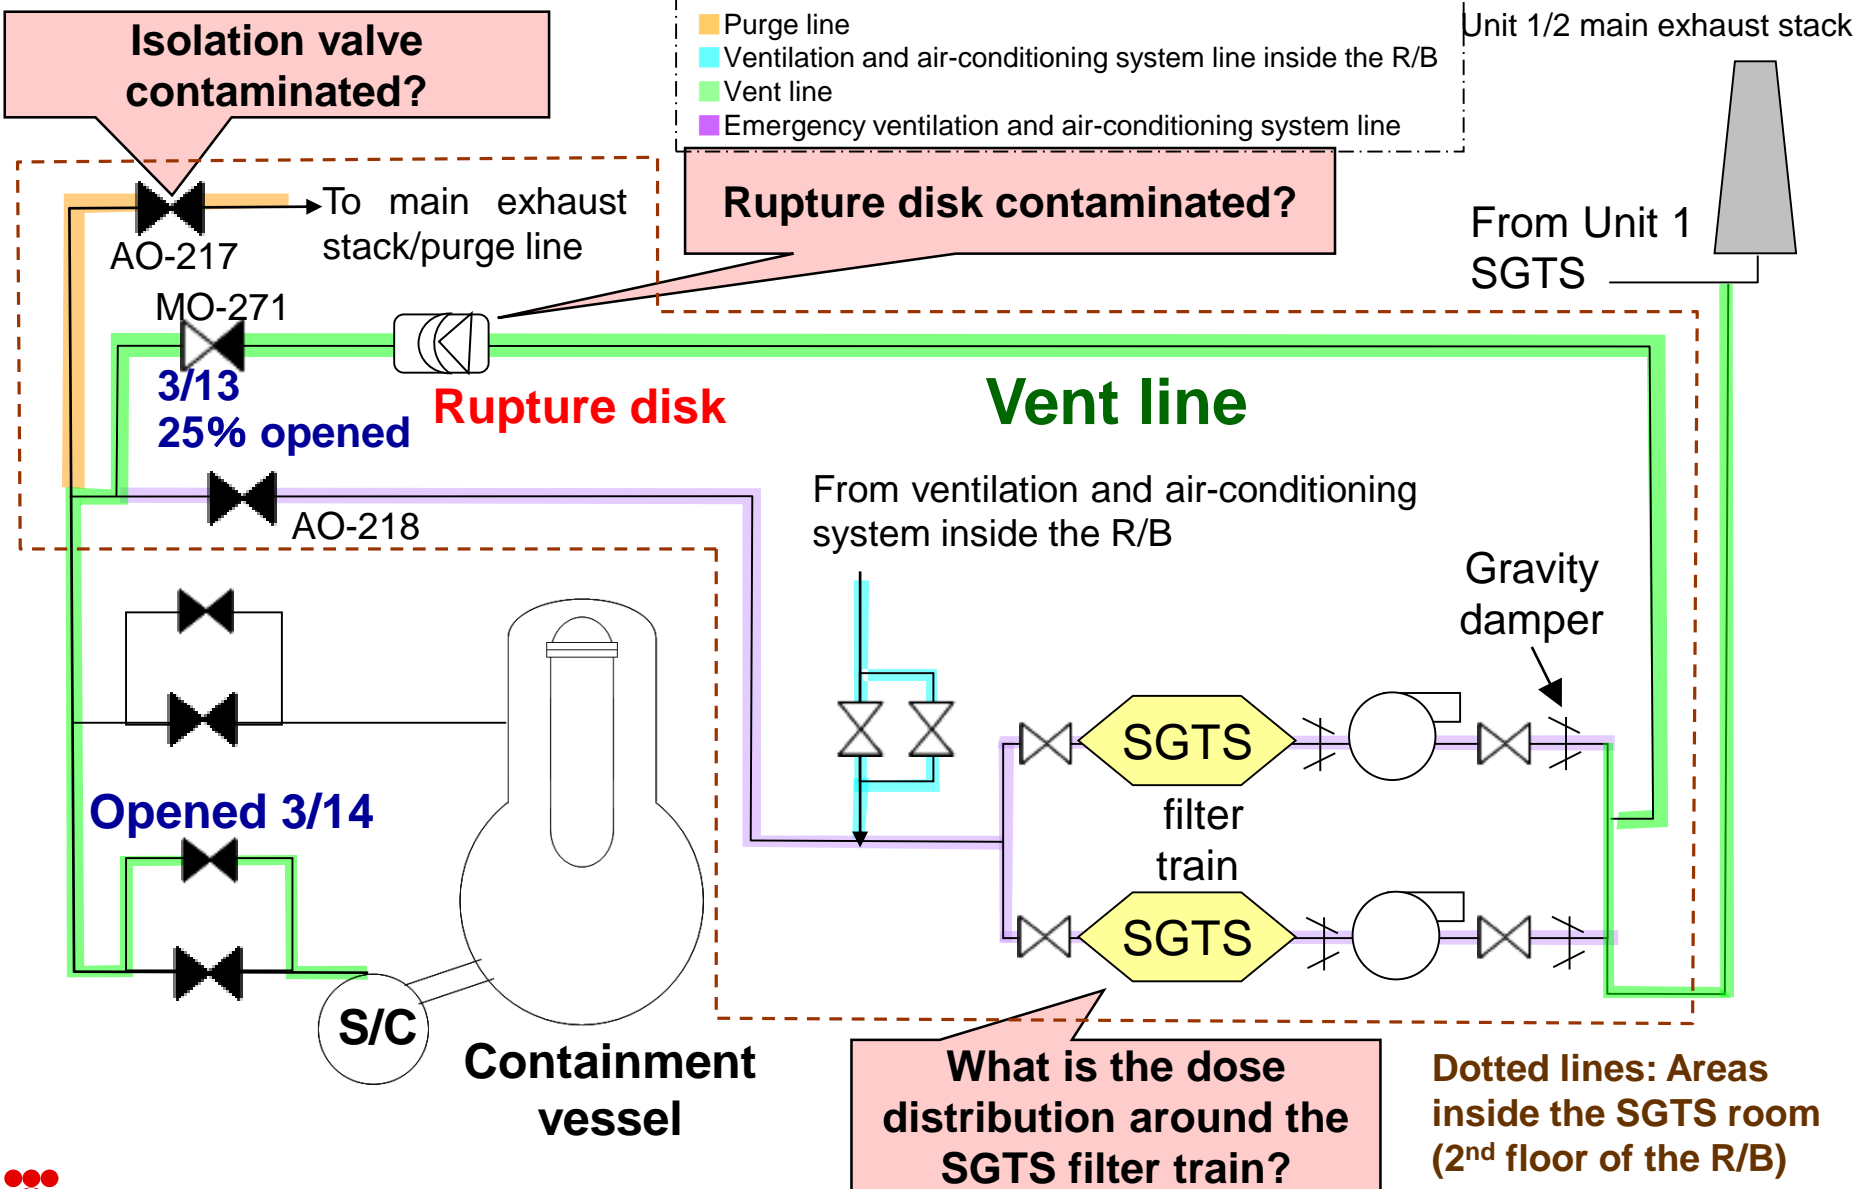
(2) Unit 2 SGTS system schematic and survey location

The SGTS filters (downstream side) were highly contaminated even though contamination was not found on the piping around the rupture disks

High levels of contamination were found on the SGTS filter (downstream side)
⇒ It is possible that gases containing radioactive materials flowed back into the SGTS. This may have been caused by the following factors.

No contamination was found near the rupture discs.

⇒ It is highly likely that the rupture discs did not function

The condition of the rupture disks shall be checked in order to shed light on issue Unit 2-9 (whether or not the Unit 2 rupture disks worked) and the cause of contamination of the STGS filters, and the examination of radioactive substance release routes shall continue

Further investigation into success and failure of Unit 2 containment vessel venting will be continued

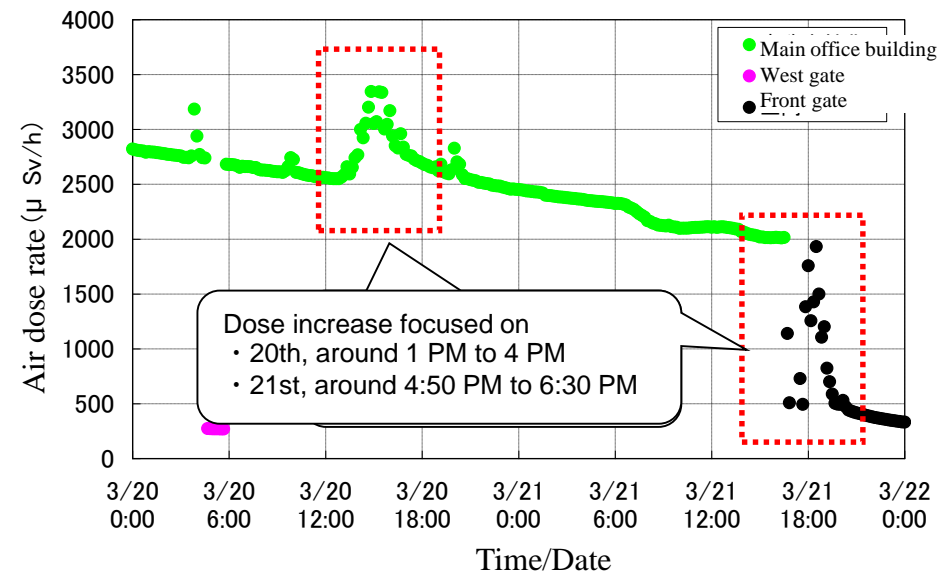
Fukushima Daiichi NPS site dose measurement results

On or around March 28 an increase in dose rate is on site at the Fukushima Daiichi NPS were measured. However, the cause of the aforementioned dose rate increase has yet to be identified

Dose rate increases inside the Fukushima Daiichi NPS site are caused by release of radioactive substances from the containment vessel, so maintaining the integrity of the containment vessel is vital

⇒ Various countermeasures for preventing loss of the containment vessel integrity shall be deliberated and implemented

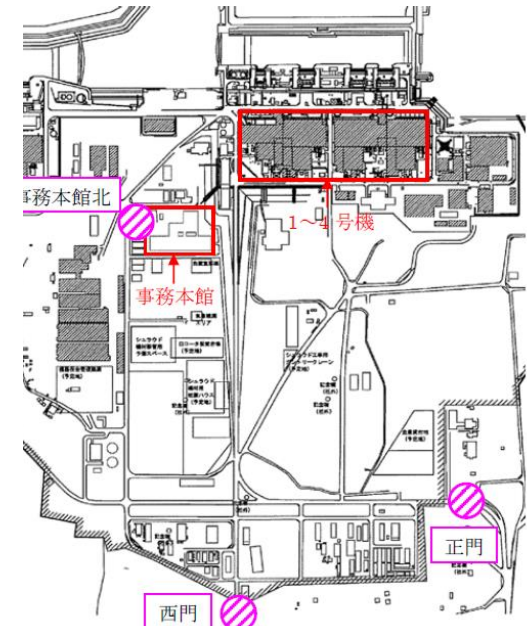
Dose measurement point diagram

Analysis of the percentage of measurement points that were downwind during the dose increase, and the percentage of measurement points that were in directions other than downwind thereafter when dose levels decreased.

Fukushima Daiichi NPS Site Dose Measurement Results and Wind Direction at Each Measurement Point

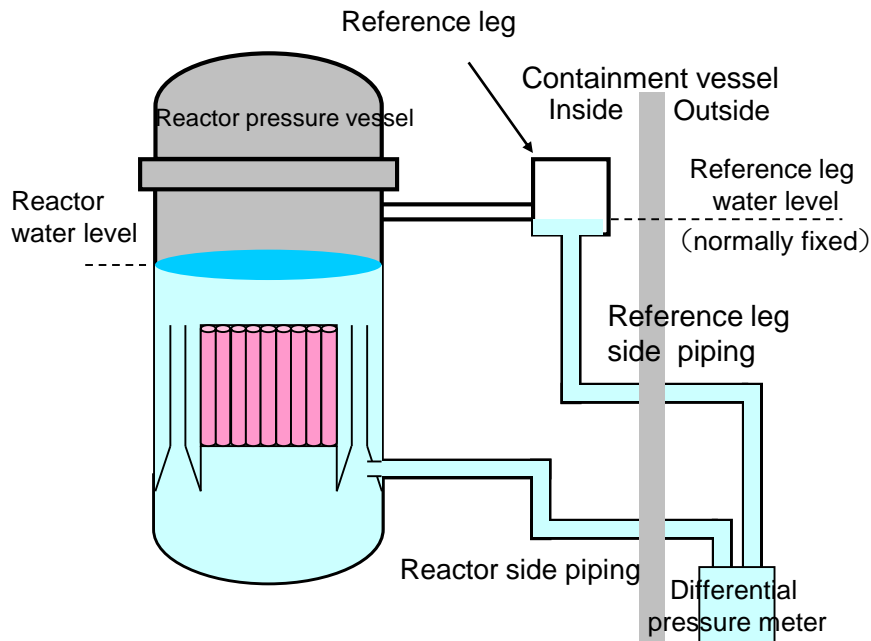
Water level meter diagram

- Reactor water level is calculated by the difference in head pressure between the reference leg side piping and the reactor side piping.
- Normally the reference leg side piping water level is kept at a fixed level. Changes in reactor water level are detected by changes in head pressure in the reactor side piping.
- Under harsh circumstances like those seen during the Fukushima Daiichi NPS accident when the temperatures inside the containment vessel become extremely hot, the water inside the reference leg side piping, which is normally at a fixed level, evaporates thereby causing the amount of water inside the pipe to decrease.
- As a result, it becomes impossible to accurately measure water levels inside the reactor. (If the water inside the reference leg side piping evaporates reactor water levels are estimated to be a little higher (they are overestimated))

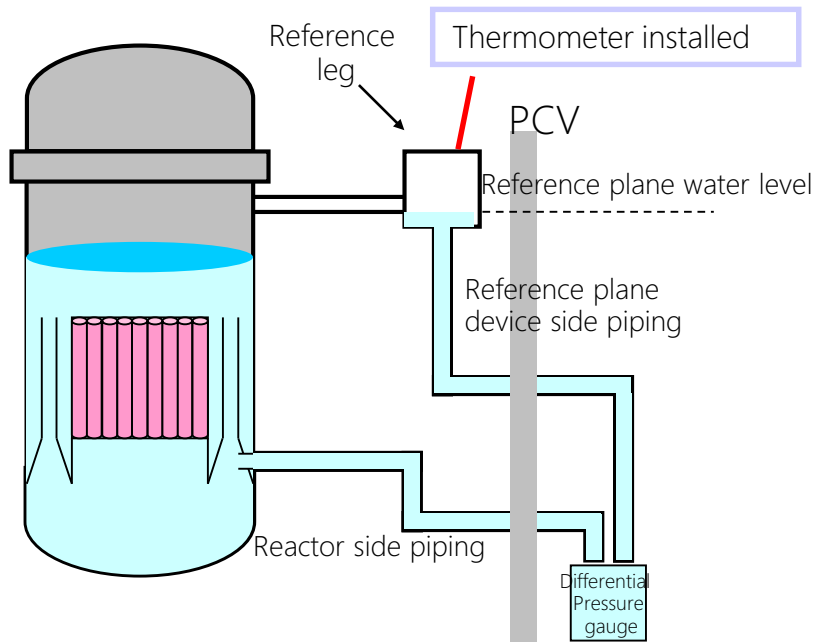
Enhancement of reactor water level measurements

Being able to accurately measure plant parameters during an accident is vital. In light of the inability to accurately measure water levels during the Fukushima Daiichi NPS accident due to a decrease in water levels in the reference leg piping, the following countermeasures will be implemented in order to increase the reliability of reactor water level measurements.

- A thermometer was installed in the reference leg in order to enable it to be determined if reactor water level meters are giving accurate readings during a severe accident.
- Even prior to the accident operation procedures stipulated that the reactor is to be filled completely with water if water levels are unclear, but methods for estimating reactor water levels if reactor water levels are unclear shall also be added.

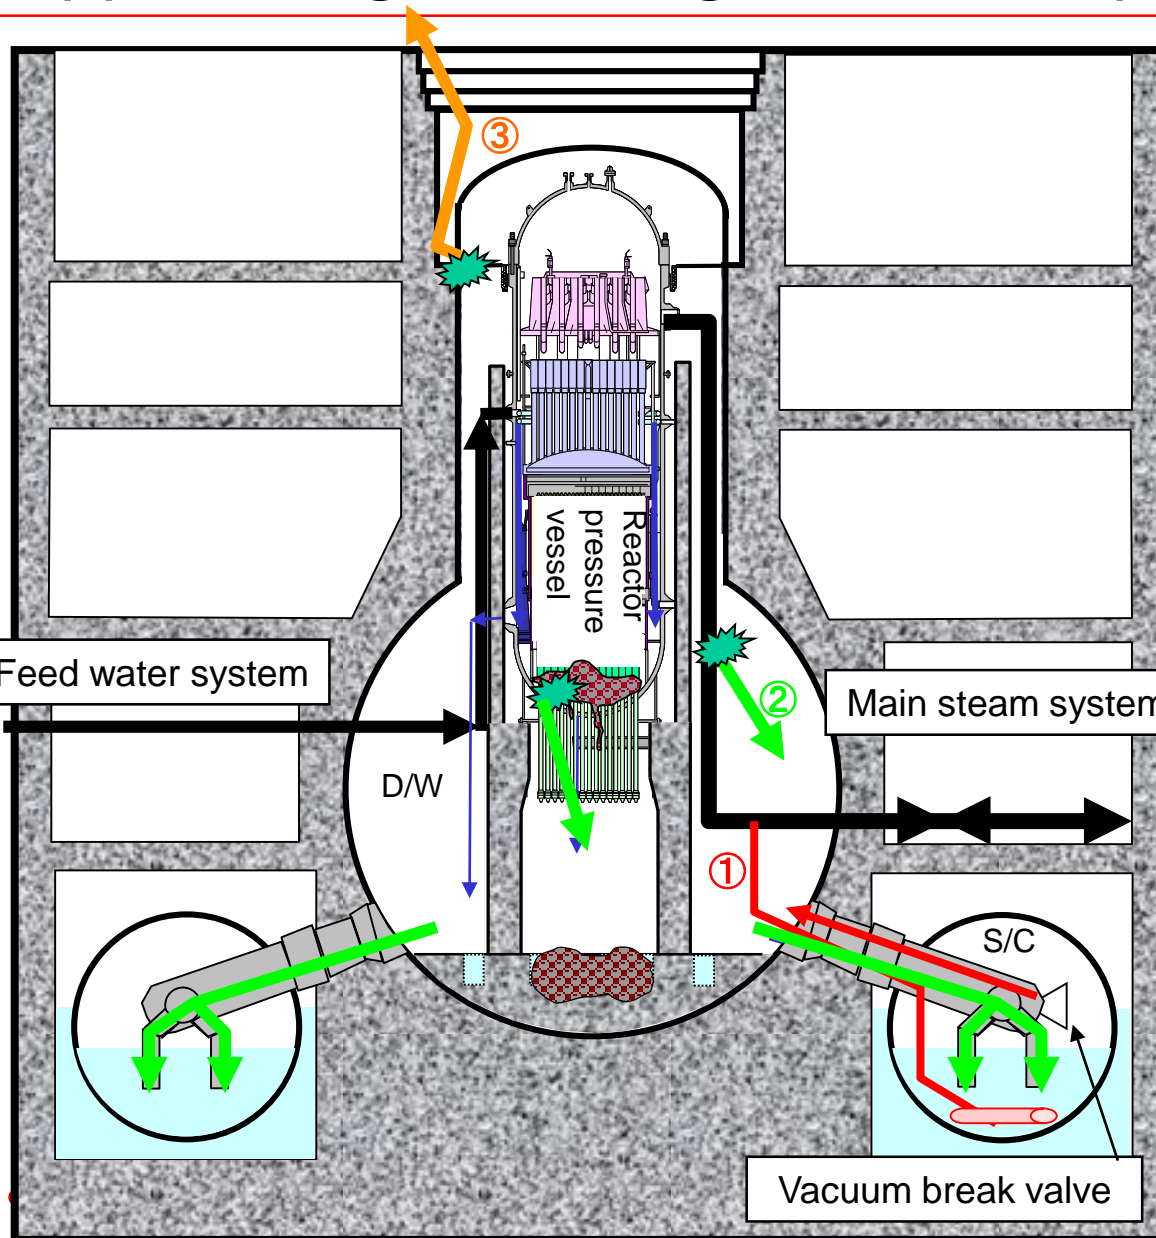
(2) Flow of gases during the accident (concept drawing)

① Under normal reactor isolation condition steam generated inside the reactor pressure vessel during reactor isolation would pass through the main steam relief safety valve (SRV) into the S/C. If a pressure differential with the D/W exceeds a certain amount the vacuum brake valve would open causing gases inside the S/C to flow into the D/W.
<Flow of gases>
Reactor pressure vessel \Rightarrow S/C \Rightarrow D/W

② If there is a leak from the reactor pressure vessel into the D/W the gases inside the reactor pressure vessel would flow directly into the D/W. As D/W pressure increases the gases inside the D/W would flow into the S/C via the vent pipes.
<Flow of gases>
Reactor pressure vessel \Rightarrow D/W \Rightarrow S/C
