List of issues to be investigated

Reference [1] "Safety measures at the Kashiwazaki-Kariwa Nuclear Power Station of Tokyo Electric Power Company (First version, March 2013)"

List of issues

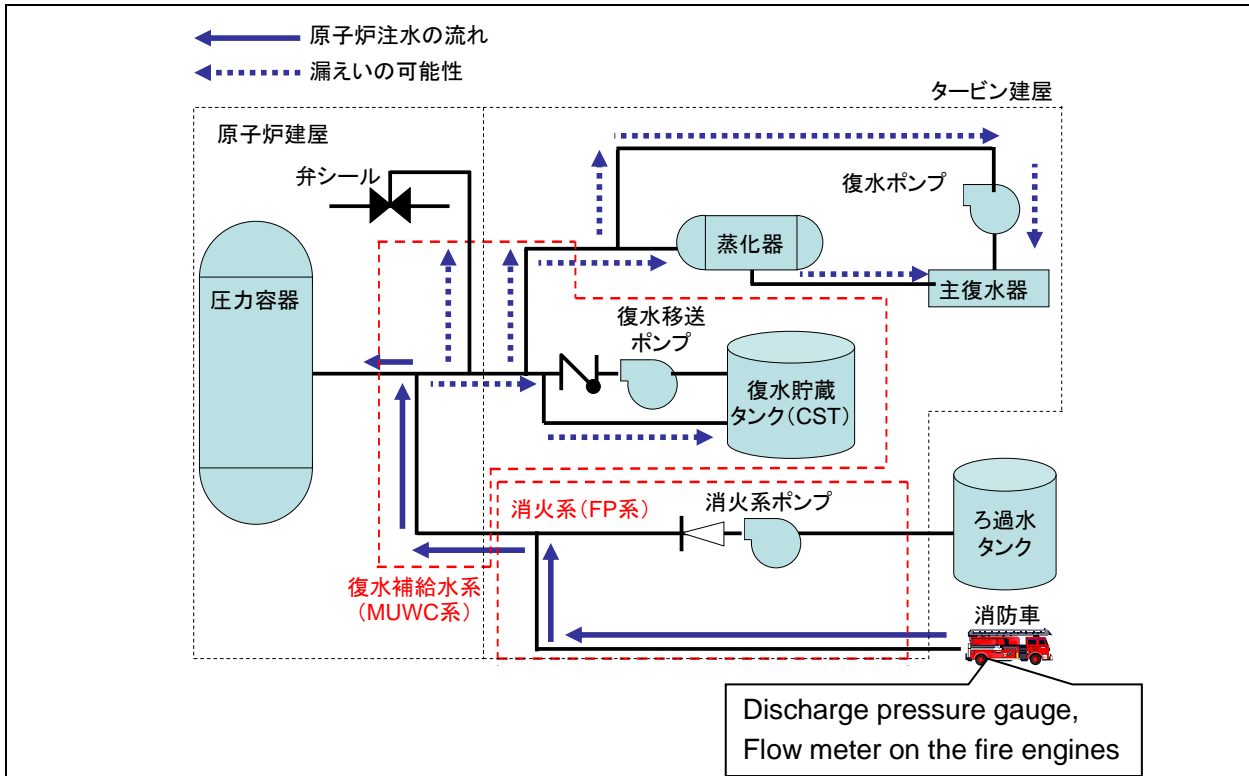
Common/Issue-2	Common	Category A③	Class (1)	Safety measures in [1]: p36
Amounts of water injected to the reactor by fire engines				Results: Attachment 1-4, 1-5
<p>Ultimately, Unit-1 to Unit-3 lost all their water injection functions which had been expected to work in an accident, and fire engines were alternatively used for the emergency water injection.</p> <p>The information relevant to the amount of water injected was compiled as the estimated amount (daily average of the amount injected) based on the discharge pressure of fire engines and flow rate indicator readings at the time of the accident. But their accuracies are not satisfactory, and part of the water injected is considered to have flowed to other systems and equipment, bypassing the water injection line to each reactor unit.</p> <p>At Unit-1, for instance, water injection was interrupted at 01:10 on March 14<sup>th</sup>. At 20:00 on the same day, water injection was resumed (via the reactor core spray system), but no reactor pressure increase was observed, indicating a possibility of no water, or only a small amount, being injected. At 02:33 on March 23<sup>rd</sup>, when the reactor feedwater system started to inject water, the reactor and PCV pressure increased, probably due to steam generation. This indicates a possibility of no water, or only a small amount, having been injected before.</p> <p>In the MAAP analysis, the amount of water injected to the reactor was set substantially less than the amount of water injected by fire engines, in order to simulate the observed PCV pressure changes. The amount of water injected to the reactor is of critical importance in examining the accident progression. Therefore, the actual amount of water injected to the reactor needs to be clarified because it has a big uncertainty.</p>

Figure Schematics of alternative water injection lines using fire engine pumps

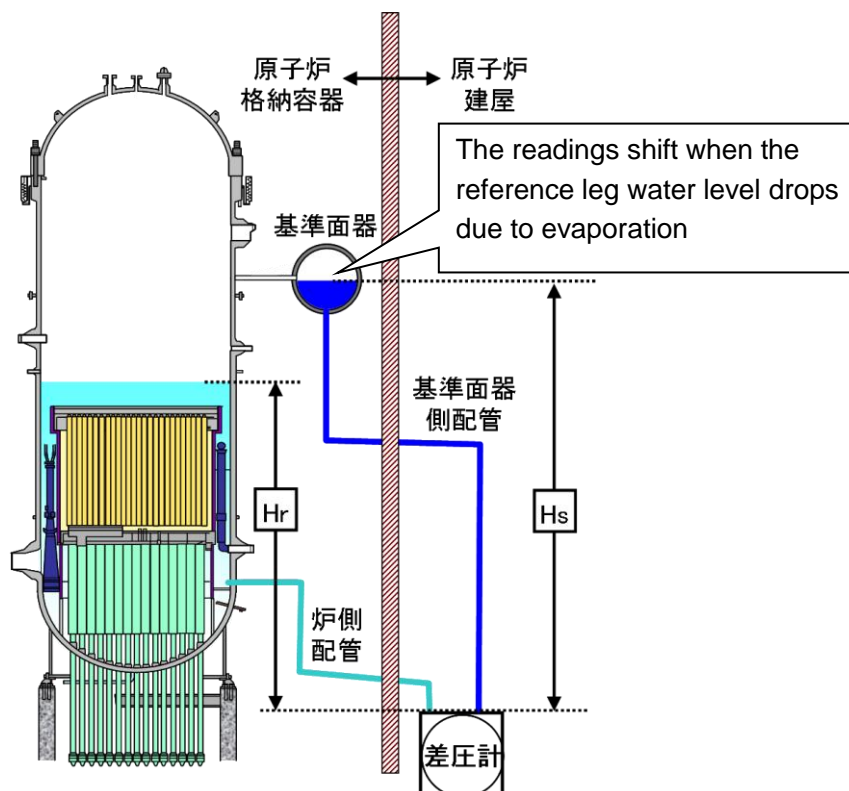
At Unit-1, the reactor water level could not be temporarily measured after the station blackout caused by the tsunami. When the reactor water level indicators were restored by temporary battery supplies at 21:19 on March 11<sup>th</sup>, the water level indicators showed an increase despite the fact that no water was being injected into the reactor. In view of the measurement principle of water level indicators, the apparent increase of the water level is considered to be due to incorrect readings caused by water evaporation in the reference leg (piping on the reference water level side) of the water level indicators. Ultimately it is considered that Unit-2 and Unit-3 also experienced similar incorrect readings of the water level indicators.

Examination is to be done to clarify when and why the water level indicators began to give incorrect readings, because it may provide some clues to estimate the reactor situations at those times.

Figure Working principle of reactor water level indicators

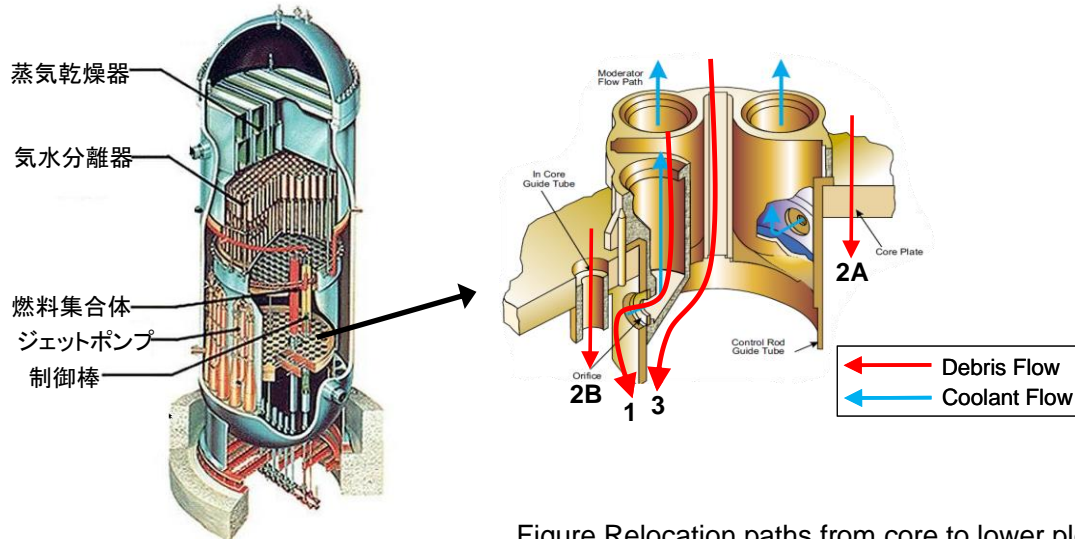
Common/Issue-6	Common	Category B②	Class (2)	Safety measures in [1] -
Molten core behavior on falling to the lower plenum				Results: -
<p>MAAP employs basically Three Mile Island (TMI) knowledge in simulating the molten fuel relocation mechanism to the lower plenum, in which molten fuel destructs the core support plate and reaches the lower plenum. On the other hand, BWRs have complex lower structures, which could configure other molten fuel relocation paths to the lower plenum: via the coolant flow paths through a side entry orifice at the fuel support; or via the surrounding bypass region (whereto the molten fuel could migrate in the radial direction from the core) and, by damaging the shroud, further through the outer shroud region (downcomer region).</p> <p>In the MAAP analysis of Unit-1 to date, the reactor pressure showed a sharp peak at around 22:00 on March 11<sup>th</sup>. This comes from the model in the analysis that the molten fuel stayed temporarily on the core support plate for a while and, as soon as the core support plate was damaged, the molten fuel dropped instantaneously to the lower plenum, generating a large amount of hydrogen gas.</p> <p>It is necessary to clarify the molten fuel behavior during relocation to the lower plenum in order to contribute to understanding of the accident progression and estimation of the situation in the core and PCV.</p>

Figure Relocation paths from core to lower plenum

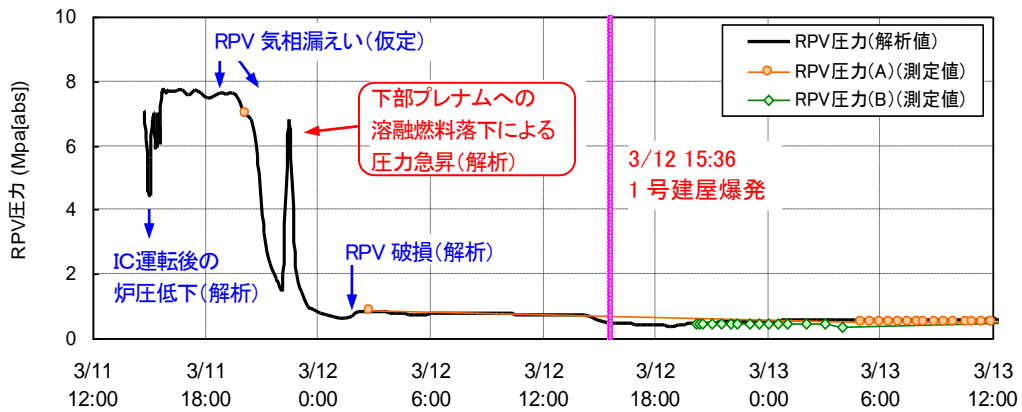
RPV 気相漏えい(仮定)	Gaseous leak from RPV (assumed)
下部プレナムへの溶融燃料落下による圧力急昇(解析)...	Sharp pressure increase due to debris slumping to lower plenum
IC運転後の炉圧低下(解析)	Pressure decrease after IC operation (anal.)
RPV 破損(解析)	RPV failure (anal.)
3/12 15:36 1号建屋爆発	At 15:36 March 12 <sup>th</sup> Unit-1 R/B exploded

Figure Reactor water level and PCV pressure changes in Unit-1

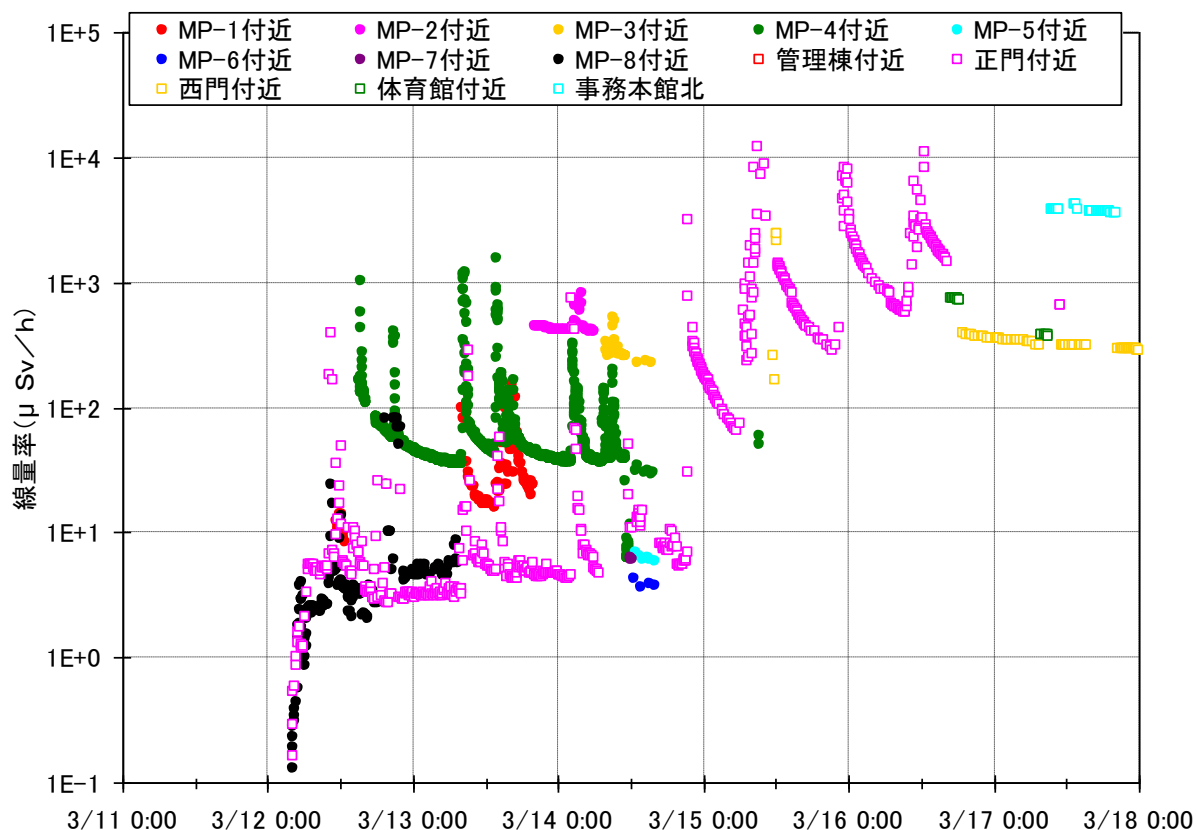
However, not every correlation is clear yet between the air dose rate changes measured on the site boundary measured by the monitoring cars, etc. and the radioactive materials release behavior from their origin. The air dose rates do not tell everything about the release situation from the origin of the radioactive materials but these rates provide information that is useful in interpreting the release conditions. The attenuation behavior of air dose rates may provide some information relevant to the contribution of deposits of radioactive materials released or their nuclear species.

In order to interpret the accident progression resulting in the release of radioactive materials, it is necessary to evaluate the air dose rate changes and the correlation of these rates with the timings, origin and paths of the radioactive materials released.

Figure Air dose rate changes on the site during March 11<sup>th</sup> to 18<sup>th</sup>.

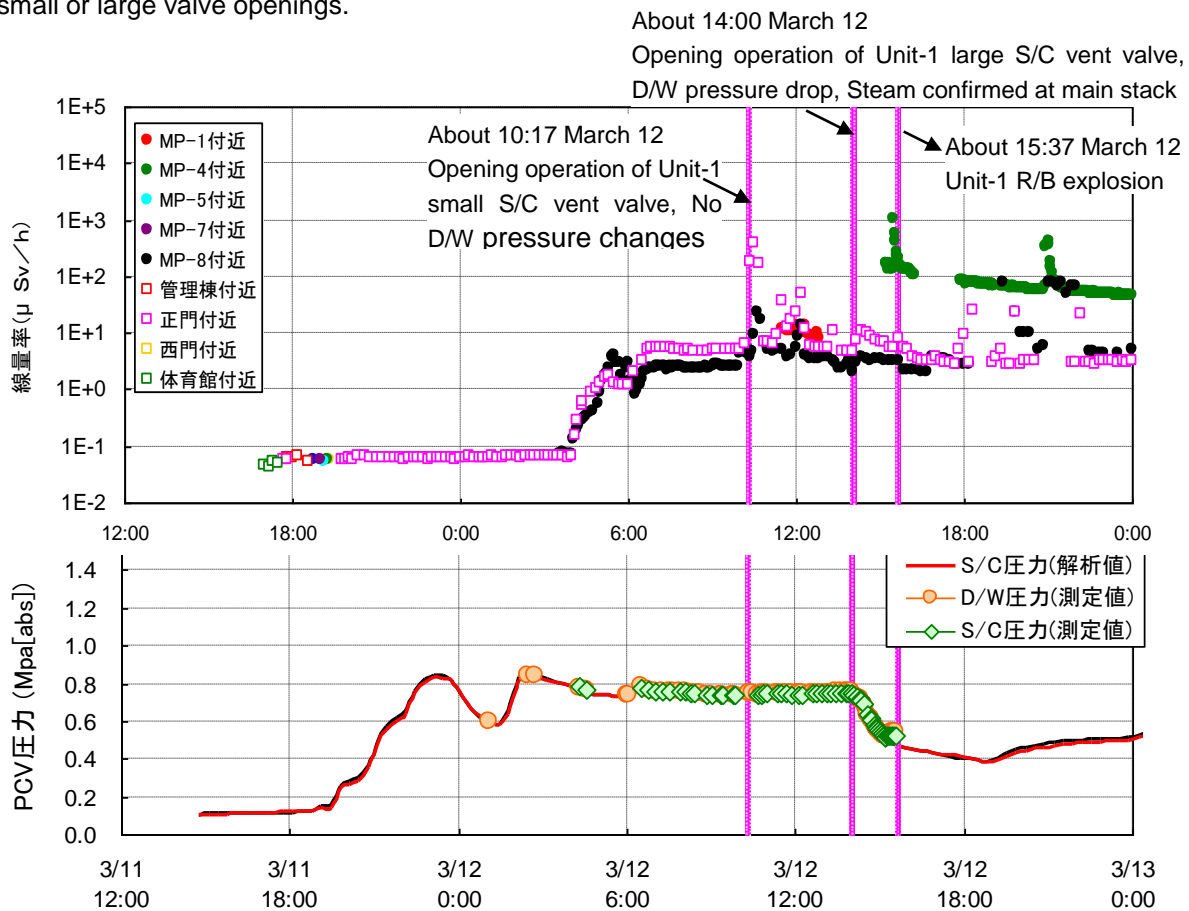
At Unit-1, three attempts were made from the MCR to open the small S/C vent valve, at 10:17, 10:23 and 10:24 on March 12<sup>th</sup>. No clear decrease was noticed in the D/W pressures, but the air dose rates near the main gate showed a short increase at 10:40. Thereafter, a temporary air compressor was connected to open the large S/C vent valve and it was activated at about 14:00 on the same day. Steam exhaust from the stack was observed on the live camera monitor and the D/W pressure showed a decrease through 14:30 to about 14:50. At this timing, no increase was noticed in the air dose rates measured by the monitoring car near the main gate (southwest) and near Monitoring Point 8 (south).

As seen in these incidents, the D/W pressures and the air dose rates at the monitoring car occasionally responded to the S/C vent valve operations, but occasionally they did not. This may indicate a possibility that a small release of radioactive materials through the small vent valve, not sufficient to cause noticeable D/W pressure changes, might have occurred, or a possibility that a direct release to the air from the reactor building might have occurred. The opening of the small vent valve causes only a small vent flow rate change and the D/W pressure decrease may be too limited to notice. It is necessary to clarify the radioactive materials release behavior in detail upon PCV venting by the small or large valve openings.

Figure Air dose rate changes from March 11<sup>th</sup> to 12<sup>th</sup>, and the changes of D/W and S/C pressures

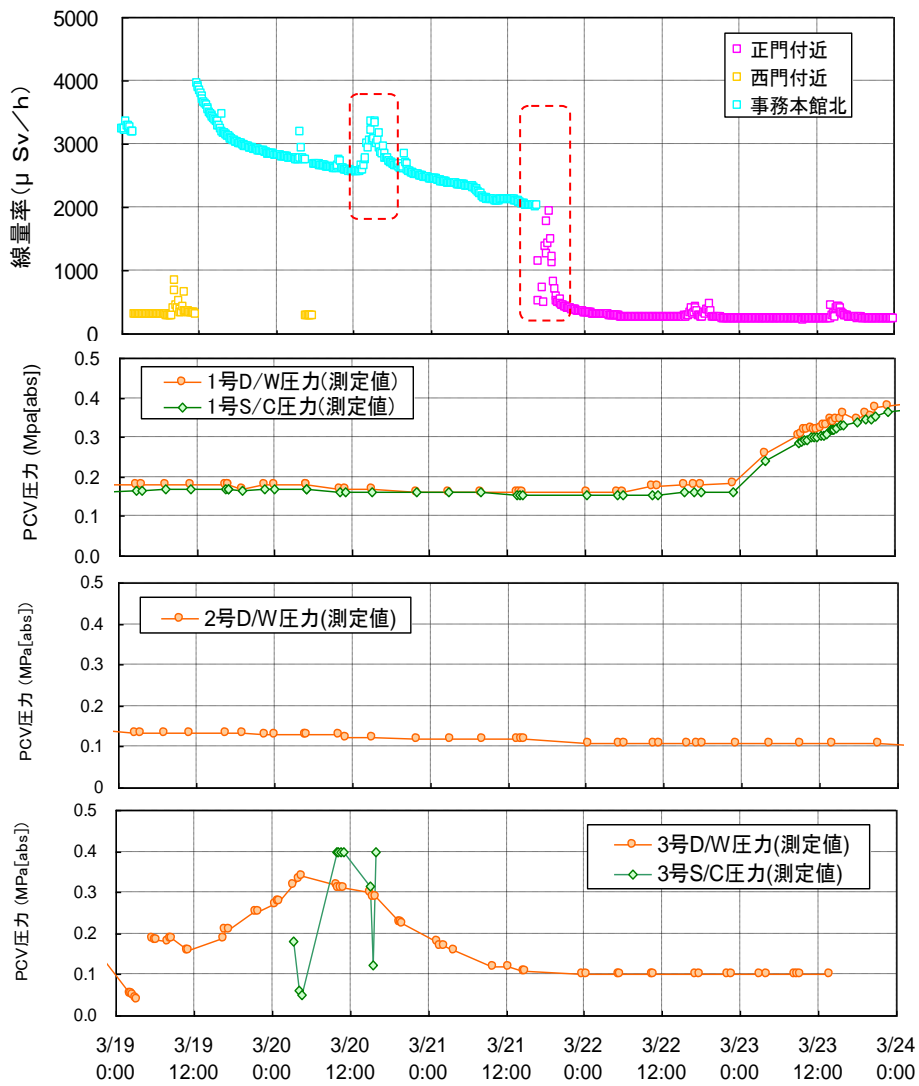
Common/Issue-9	Common	Category B⑤	Class (2)	Safety measures in [1]: -
Air dose increases on around March 20 <sup>th</sup>				Results: Attachment: 3-6
<p>At Unit-1 and Unit-3, the water injection rate observed on the Accident Management (AM) panel showed a big decrease from March 20<sup>th</sup> and 21<sup>st</sup> for several days. This may indicate that the reactor cooling was not sufficient to prevent the release of radioactive materials. Further, at about 16:00 on March 21<sup>st</sup> when black smoke rose at Unit-3, a sharp increase was observed in the air dose rate near the main gate, although no significant changes were noticed in the DW pressures and the RPV pressures.</p> <p>The analysis using MAAP is terminated in about a week at the maximum after the earthquake. This is because the uncertainties of the analysis become larger with the extended time of analysis and the reliabilities of the results are significantly lowered.</p> <p>Fission products released around March 20<sup>th</sup> and 21<sup>st</sup> from the Fukushima Daiichi NPS might have caused radiation dose increases in parts of the Kanto region, depending on the wind directions, and might have led to some recommendations to refrain from tap water intake due to increased radioiodine concentration levels. Details of radioactive materials release behavior need to be clarified.</p>

Figure Air dose rates at the Fukushima Daiichi NPS from March 19<sup>th</sup> to 23<sup>rd</sup>

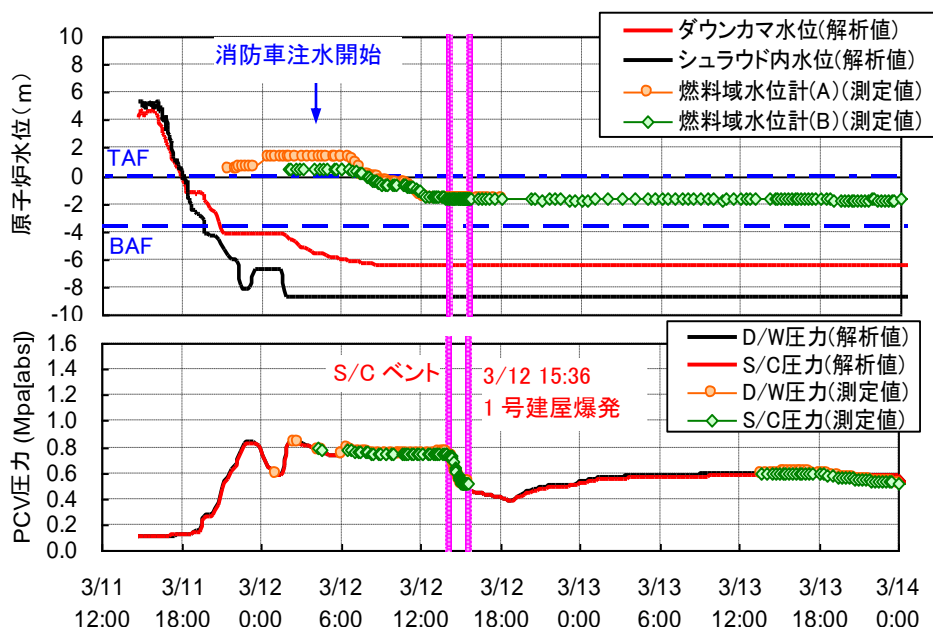
At Unit-1, the D/W pressure decrease was confirmed from 14:30 through around 14:50 on March 12<sup>th</sup> following the large S/C vent valve opening operation. At 15:36 on that day, hydrogen exploded in this reactor building and the roof and the outer walls of the top floor were heavily damaged.

These hydrogen explosions are considered to have been caused by hydrogen gas generated mainly by zirconium-water reactions which leaked out with steam to the reactor buildings. It is necessary to clarify the amounts of hydrogen gas generated and leak paths.

Figure RPV water level and PCV pressure changes at Unit-1 until the hydrogen explosion occurred

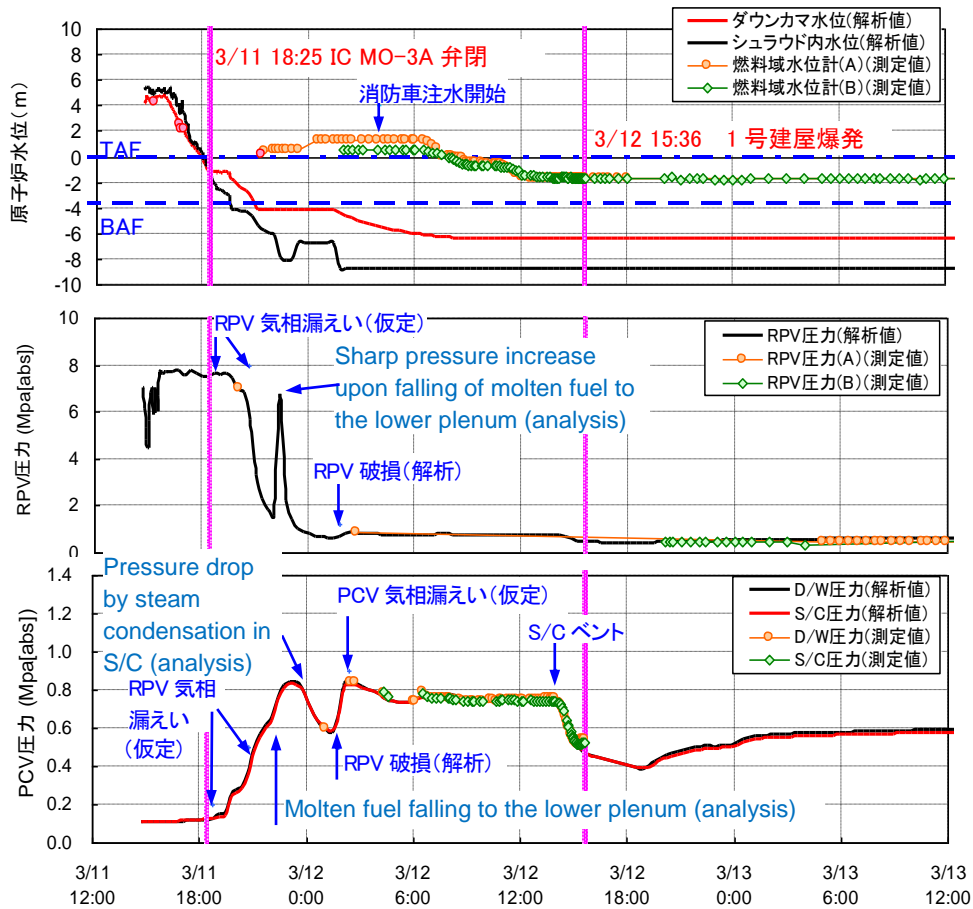
Unit-1/Issue-2	Unit-1	Category A⑤	Class (2)	Safety measures in [1]:
Plant behavior if the Unit-1 ICs had functioned				Results: Attachment 1-7
<p>At Unit-1, the reactor pressure was being controlled after the earthquake by intermittent operation of the emergency isolation condensers (ICs). Immediately before all power supplies were lost due to tsunami, the IC operation had been incidentally in a halted situation. In the station blackout condition, the shift operators in the MCR noticed the display lamps indicating the IC (Sub-system A) isolation valves (MO-2A, MO-3A) as “Closed” outside the PCV at around 18:00 on March 11<sup>th</sup>. They took action to open the valves at 18:18 on March 11<sup>th</sup>, and confirmed the steam generating sounds and saw the steam when looking above the reactor building, but the amount of steam was limited and it stopped a while later. Concerned about the water inventory left in the IC shell side tank, at 18:25 the operators closed the isolation valve (MO-3A) on the return line.</p> <p>Post-accident surveys of the water level in the IC shell side tank showed that the water level of Sub-system A had been 65% (normal level was 80%) and the water in the tank had been sufficient. If the isolation valve (MO-3A) on the return line had not been closed at 18:25 on March 11<sup>th</sup>, the reactor cooling by the IC might have been continued.</p> <p>Therefore, the reason why the amount of steam generation was limited upon the opening of the IC Sub-system A isolation valves outside the PCV and why it stopped after a while (Unit-1/Issue-1) will be investigated. In addition the effect on the accident progression will be investigated, if the isolation valve of IC (Sub-system A) outside the PCV had been kept open after 18:25 on March 11<sup>th</sup>.</p>

Figure Changes of Unit-1RPV water level, RPV pressure and PCV pressures

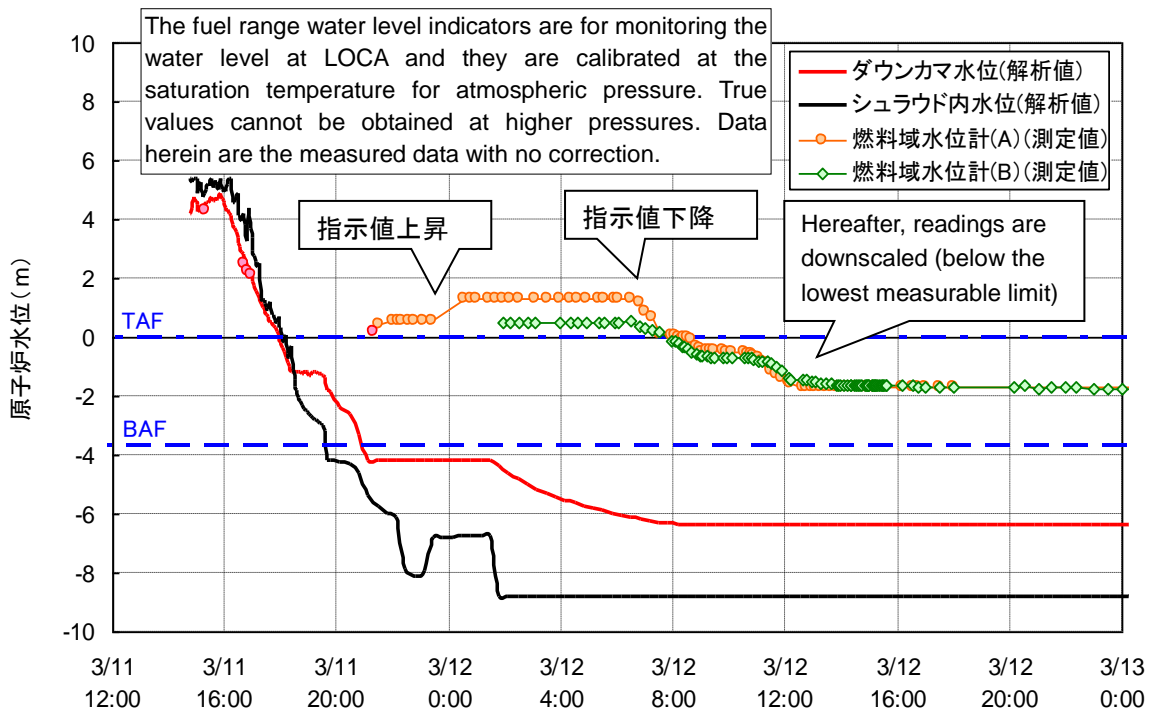
The fuel range water level indicators of the condensing water chamber type cannot show true values when the PCV temperature rises or the reactor pressure decreases, because the water in the piping in the condensation chamber evaporates. Therefore, the fuel range reactor water level indicators seem to have been already malfunctioning when restored by the temporary power supply.

But the water levels indicator readings tell the pressure difference between the reference leg and variable leg. It is possible that some information might be obtained on the reactor depressurization timings or reactor water levels.

Figure Reactor water level changes at Unit-1

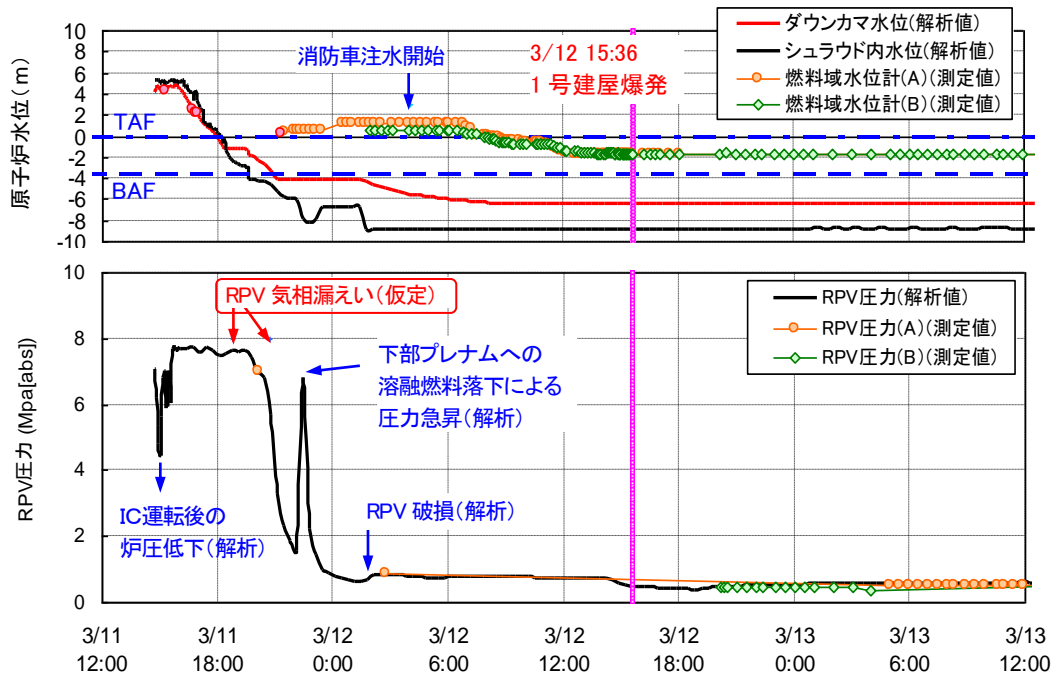
Unit-1/Issue-5	Unit-1	Category B③	Class (2)	Safety measures in [1]: pp27-36
Leaks in gaseous phase from Unit-1 RPV				Results: Attachment -
<p>At Unit-1, the RPV pressure measured 7.0MPa[abs] at 20:07 and the D/W pressure measured 0.6MPa[abs] at about 23:50 on March 11<sup>th</sup>, while the D/W pressure was 0.84MPa[abs] at 02:30 and the RPV pressure was 0.9MPa[abs] at 02:45 on March 12<sup>th</sup>. Although the exact timings are unclear, it was confirmed that the PCV pressure showed a big increase. And the RPV pressure decreased despite no depressurization operation.</p> <p>If the reactor water level drops and the core starts to be uncovered, the heat transfer from the overheated core and the overheated steam heat up the RPV pressure boundary above its normal temperatures. There may be a possibility that leak holes form for leaks in the gaseous phase at some of these upper locations before the molten fuel penetrates the RPV bottom, and the RPV pressure may decrease if the leak holes are big enough. Should that have occurred, it would affect the timings of RPV damage and the thermal and mechanical loads to the PCV after the RPV damage.</p> <p>The MAAP analysis assumed that the core temperatures were elevated by the overheating of the uncovered core and molten fuel, resulting in gaseous leaks from the RPV to the D/W through the in-core instrumentation dry tubes or the SRV flanges on the main steam line.</p> <p>But there is no direct evidence of measured plant parameters or observations that confirms leaks through these leak paths. Clarification is needed for grasping the core and PCV conditions.</p>

Figure RPV and PCV pressure changes at Unit-1

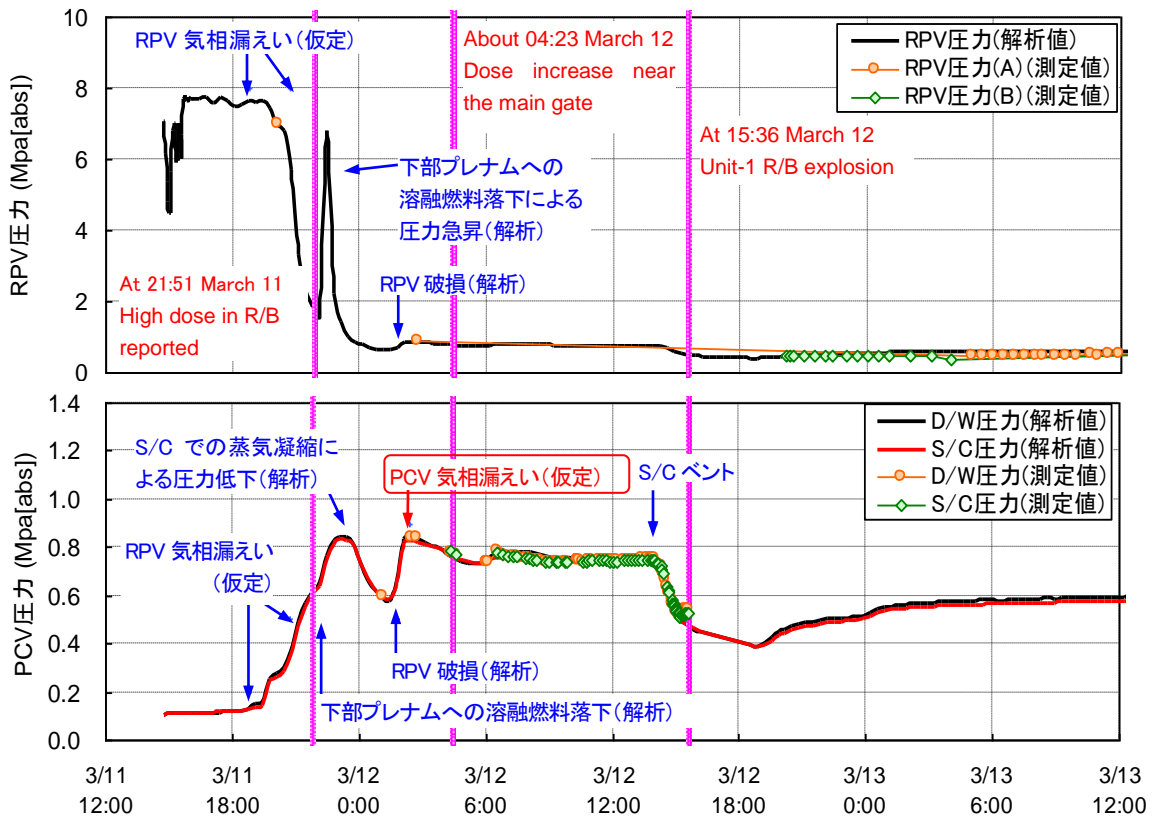
Unit-1/Issue-6	Unit-1	Category B④	Class (1)	Safety measures in [1]: pp.27-43
Leaks in gaseous phase from Unit-1 PCV				Results: Attachment -
<p>The Unit-1 DW pressure measured 0.6MPa[abs] at about 23:50 on March 11<sup>th</sup>, 0.84MPa[abs] at about 02:30 on March 12<sup>th</sup> and then stayed between 0.7MPa[abs] and 0.8MPa[abs] until it decreased at about 14:30 by the venting operation.</p> <p>Steam generation by water injection, the PCV temperature increases, the gas production by core-concrete reactions, etc. are likely to increase the PCV pressures. Nevertheless, it remained at a level which may indicate possible leaks from the PCV.</p> <p>In the meantime, shift operators entered the reactor building at about 21:00 on March 11<sup>th</sup>, when their APDs measured 0.8mSv instantaneously. They reported it upon return to the MCR at 21:51. At about 04:00 on March 12<sup>th</sup> and onward, the dose rates increased in wide areas near the main gate.</p> <p>The MAAP analysis assumed gaseous leaks from the PCV to the reactor building at about 03:10 on March 12<sup>th</sup>, about 12 hours after the earthquake. It was so assumed to roughly simulate the measured PCV pressure changes. But there is no direct evidence of measured plant parameters or observations that confirms the timing of leaks and their paths.</p> <p>Clarification is needed for grasping the PCV conditions.</p>

Figure RPV and PCV pressure changes at Unit-1

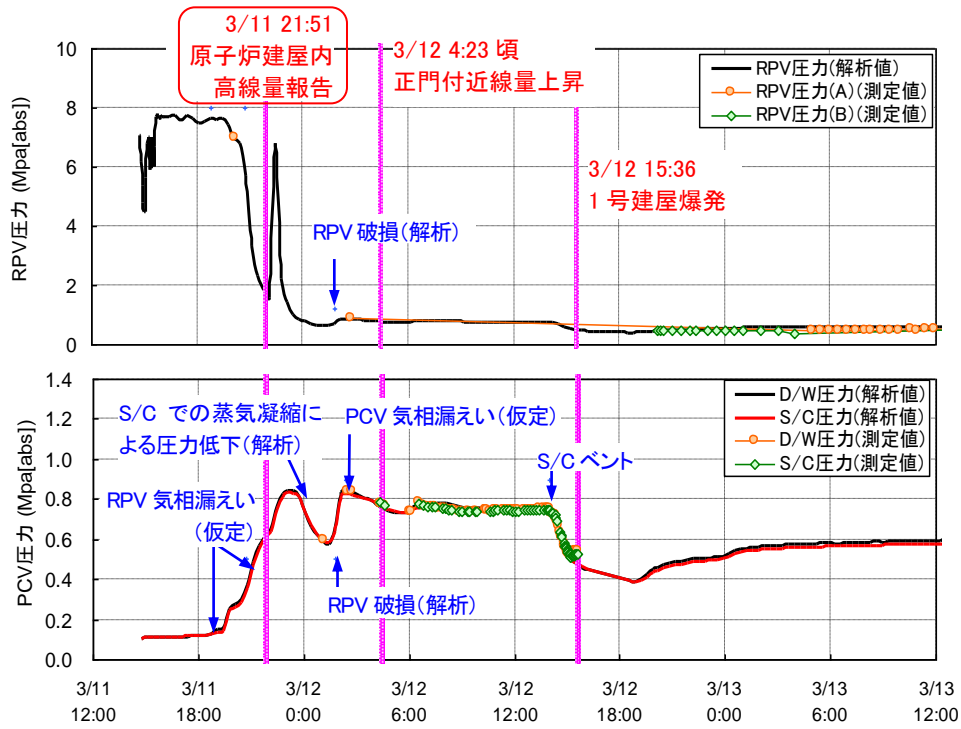
Unit-1/Issue-7	Unit-1	Category B⑤	Class (2)	Safety measures in [1]: pp.27-36 (strengthening of water injection means)
Dose rate increase in Unit-1 reactor building on March 11 <sup>th</sup>				Results: Attachment -
<p>At 17:19 on March 11<sup>th</sup>, shift operators approached the Unit-1 reactor building, carrying a GM survey meter for contamination inspections, in order to check the RPV pressure indicators and the IC shell side remaining water levels. When they opened an outer airlock door, their GM survey meter gave a value higher than normal (recording 300cpm, about three time the usual background). They returned to the MCR to report this at 17:50.</p> <p>There is a further record that at about 21:00 on March 11<sup>th</sup>, when shift operators entered the reactor building, their APDs measured 0.8mSv instantaneously and they reported it upon return to the MCR at 21:51.</p> <p>By referring to the written records on the MCR whiteboard for consideration, the dose rate at the spot could be 288mSv/h, <i>if</i> "instantaneously" were assumed as 10 seconds. When compared to the dose limit 100mSv for emergency operations, this dose rate (288mSv/h) is high enough to impede the accident management operations.</p> <p>It is not clear whether the dose rates in the reactor building were high, when shift operators entered the reactor building at 20:07 on March 11<sup>th</sup> to check the RPV pressure indicators. It has been confirmed that, later at 23:00, the dose rates before the airlock doors of the reactor building were high (1.2mSv/h in front of the outside of the north airlock door, and 0.52mSv/h in front of the outside of the south airlock door).</p> <p>Thus, the high dose rates are recognized at an early stage of the accident at Unit-1, but there is no direct evidence which shows the exact timings and paths of fission product leaks. It is necessary to clarify them, in combination with the Unit-1/issue-8 and 9, in order to assess the accessibility to the reactor building for accident management operations as well as to estimate the conditions of the core and the PCV.</p>

Figure RPV and PCV pressure changes at Unit-1

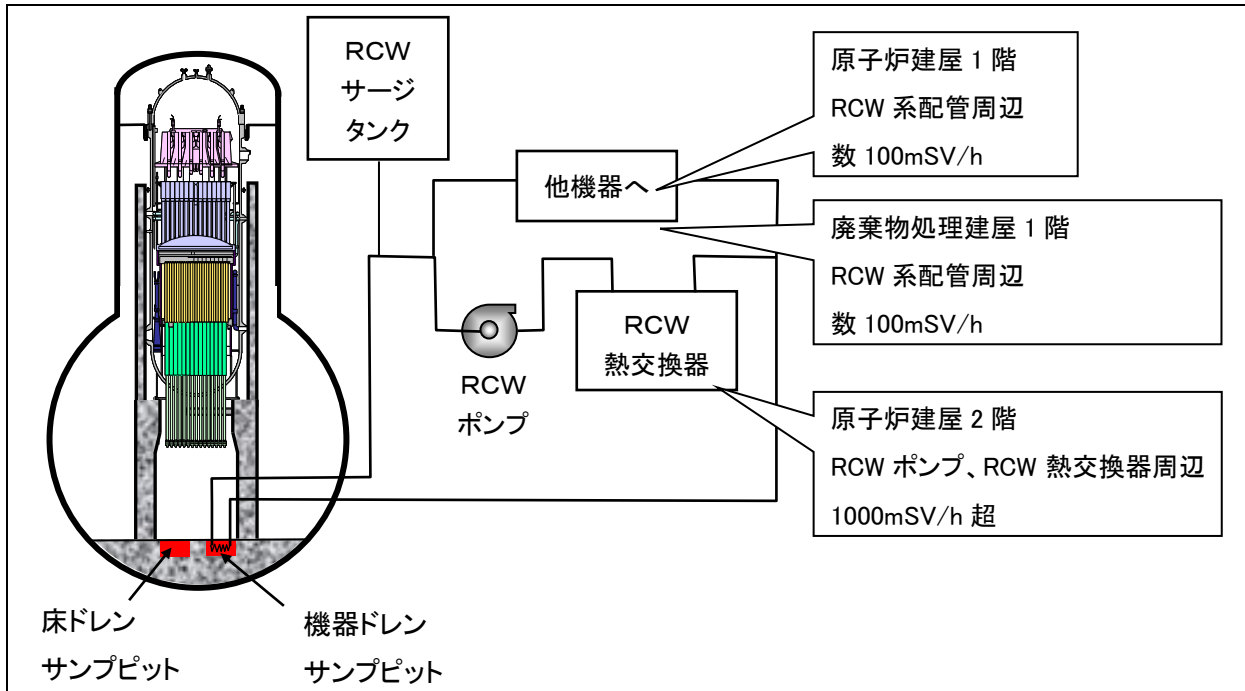
Unit-1/Issue-9	Unit-1	Category B⑤	Class (2)	Safety measures in [1]: pp.40, 43, 44 (strengthening of venting means)
Causes of high dose contamination around the Unit-1 RCW piping				Results: Attachment -
<p>The investigation of Unit-1 in May 2011 confirmed high dose rate contamination of several hundred to several thousand mSv/h near the RCW piping. No such high dose rate has been noticed near the RCW piping at Unit-2 and Unit-3.</p> <p>The RCW is a closed-loop system to cool auxiliary equipment and is unlikely to experience such high contamination in normal situations. However, the RCW also has a role to cool the equipment inside the PCV and it has piping to cool the drain in the equipment drain sump at the bottom of the pedestal.</p> <p>Therefore, there may be a possibility that part of the molten fuel fell into the equipment drain sump and damaged the RCW piping, allowing the transfer of high dose rate steam or water containing radioactive materials into the RCW piping. Identification of the causes of high dose rates in the RCW piping may help to estimate the conditions of the core and the PCV.</p>

RCWサージタンク	RCW surge tank
他機器へ	To other systems/equipment
RCW熱交換器	RCW heat exchanger
RCWポンプ	RCW pump
原子炉建屋 1階 RCW 系配管周辺数 100mSV/h	R/B first floor Several hundred mSv/h around RCW piping
廃棄物処理建屋 1階 RCW 系配管周辺数 100mSV/h	RW/B first floor Several hundred mSv/h around RCW piping
原子炉建屋 2階 RCW ポンプ、RCW 熱交換器周辺 1000mSV/h 超	R/B 2nd floor More than several hundred mSv/h around RCW pump and heat exchanger
床ドレンサンプピット	Floor drain sump pit
機器ドレンサンプピット	Equipment drain sump pit

Figure Schematic diagram of RCW system

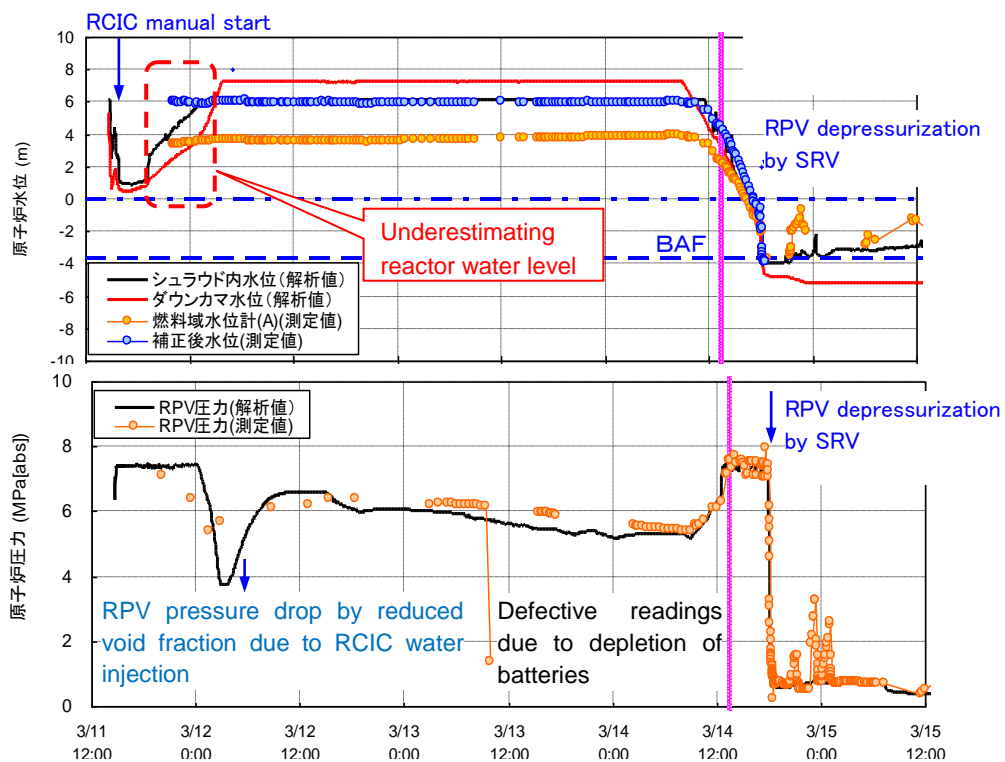
On the other hand, the plant behavior before the reactor water level reached the main steam line level is unknown still. The MAAP analysis assuming 30% of the rated flow rate underestimates the reactor water level. But the actual amount of water injected by the RCIC can be considered to have been more than the assumed 30m<sup>3</sup>/h on the following grounds: the RCIC turbine steam regulator valve is designed to fully open upon the loss of the control power supply; and the amount of decrease of water inventory in the condensate storage tank (CST), which was used as the water reservoir for water injection by the RCIC.

The RCIC operational conditions need to be clarified after the loss of the control power supply due to the tsunami.

Figure Reactor water level and pressure changes at Unit-2

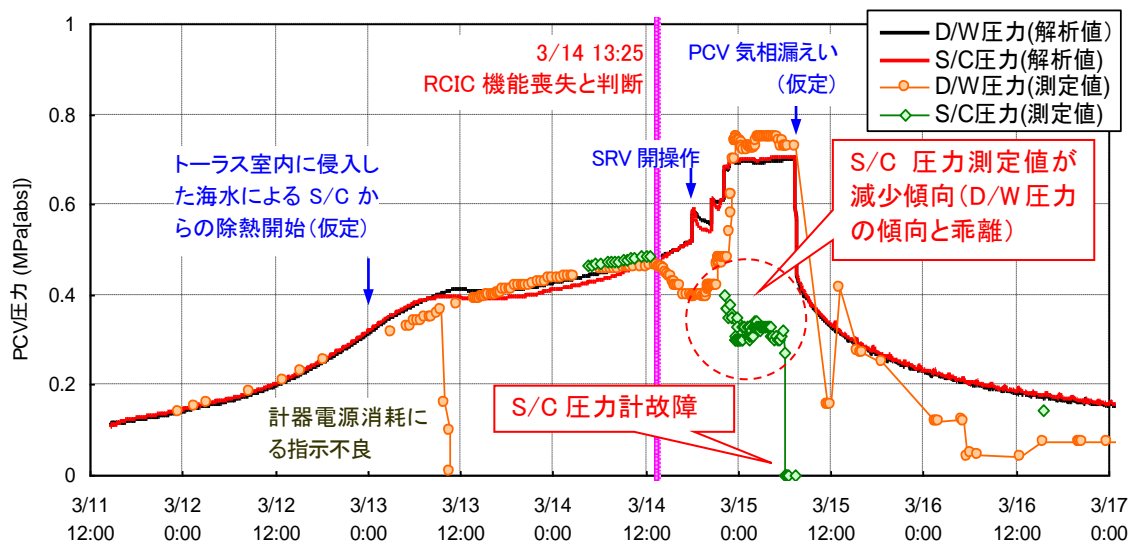
Unit-2/Issue-3	Unit-2	Category A⑤	Class (2)	Safety measures in [1]: -
Behavior of S/C pressure of Unit-2 after 21:00 on March 14 <sup>th</sup>				Results: Attachment -
<p>The D/W pressure of Unit-2 gradually increased while the RCIC was in operation, and after the RCIC was shut down it began to decrease at about 13:00 on March 14<sup>th</sup>. Thereafter it increased at about 20:00, about 21:00, about 23:00 and reached about 0.75MPa[abs] probably due to incondensable gas accumulation in the D/W because of hydrogen generation and the SRV opening.</p> <p>In the meantime, the S/C pressure measured about the same value as that of the D/W from 04:30 to about 12:30 on March 14<sup>th</sup> by the pressure indicator originally installed to this plant. The measurement was interrupted thereafter by defective readings. When the measurement was resumed at 22:10 by an S/C pressure indicator introduced for accident management (AM), it showed a lower value than that of the D/W. The S/C pressure indicator for AM was to measure the reference leg pressure of the S/C water level indicator mounted on a branch line off the S/C venting line.</p> <p>Such a discrepancy between the D/W and S/C pressures is very unrealistic for the PCV structural reasons. These pressure indicators should indicate consistent values. For this reason, the S/C pressure indicator is likely to have indicated wrong values. Eventually, the S/C pressure indicator downscaled at 06:00 on March 15<sup>th</sup> and the instrumentation system seems to have gone out of service. There is a possibility that the behavior of these pressure indicators and the timing of their failure may provide some meaningful information.</p>

3/14 13:25 RCIC 機能喪失と判断	At 13:25 March 14 <sup>th</sup> , loss of function of RCIC concluded
トラス室内に侵入した海水による S/C からの除熱開始 (仮定)	Heat removal from S/C started by the seawater inundating the torus room (assumed)
計器電源消耗による指示不良	Defective readings due to depletion of batteries
S/C 圧力計故障	S/C pressure gage failed
PCV 気相漏えい (仮定)	Gaseous leak from PCV (assumed)
SRV 開操作	SRV opening operation
S/C 圧力測定値が減少傾向 (D/W 圧力の傾向と乖離)	S/C pressure readings started to decrease (deviating from D/W pressure readings)
S/C 圧力計故障	S/C pressure indicator failed

Figure PCV pressure changes in Unit-2

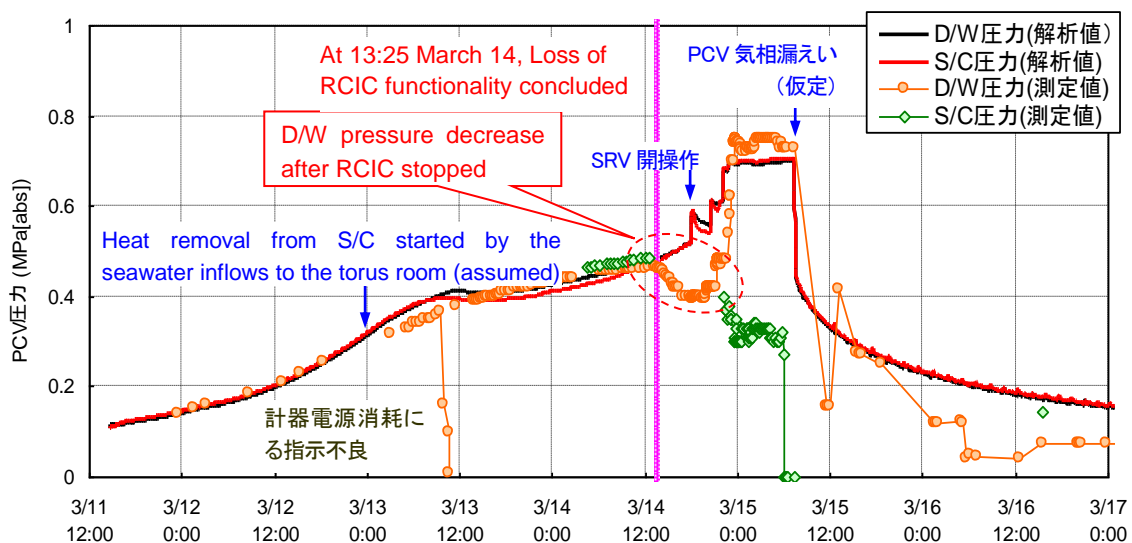
The D/W pressure of Unit-2 increased gradually while the RCIC was in operation. It began to decrease at about 13:00 on March 14<sup>th</sup> after the RCIC had been shut down. Theoretically, the decay heat in the RPV is transferred to the S/C by steam whether the RCIC is in operation or shutdown, and the D/W pressure is anticipated to increase gradually.

The above-mentioned D/W pressure decrease could be explained by possible leaks from the PCV. But it cannot explain the pressure increase afterward. Another possible interpretation was that the D/W pressure decrease was due to the continued total S/C energy inventory decrease by the heat removal by the water accumulated in the torus room, because the energy could not be transferred to the PCV (D/W) via the S/C by the RCIC turbine until starting energy transfer via SRV. However, the latest MAAP analysis could not reproduce the phenomena of the PCV pressure decrease. There is another inconsistency: the PCV pressure decrease started more than 1 hour later than 12:00 noon when the RCIC is estimated, from the RPV pressure increasing trend, to have completely stopped. This timing almost coincides with the timing when the energy transfer from the SRV to the S/C started; therefore, the scenario of continued heat removal through the S/C walls combined with the energy flow (to the S/C from the RCIC turbine) termination cannot be explained.

Figure PCV pressure changes in Unit-2

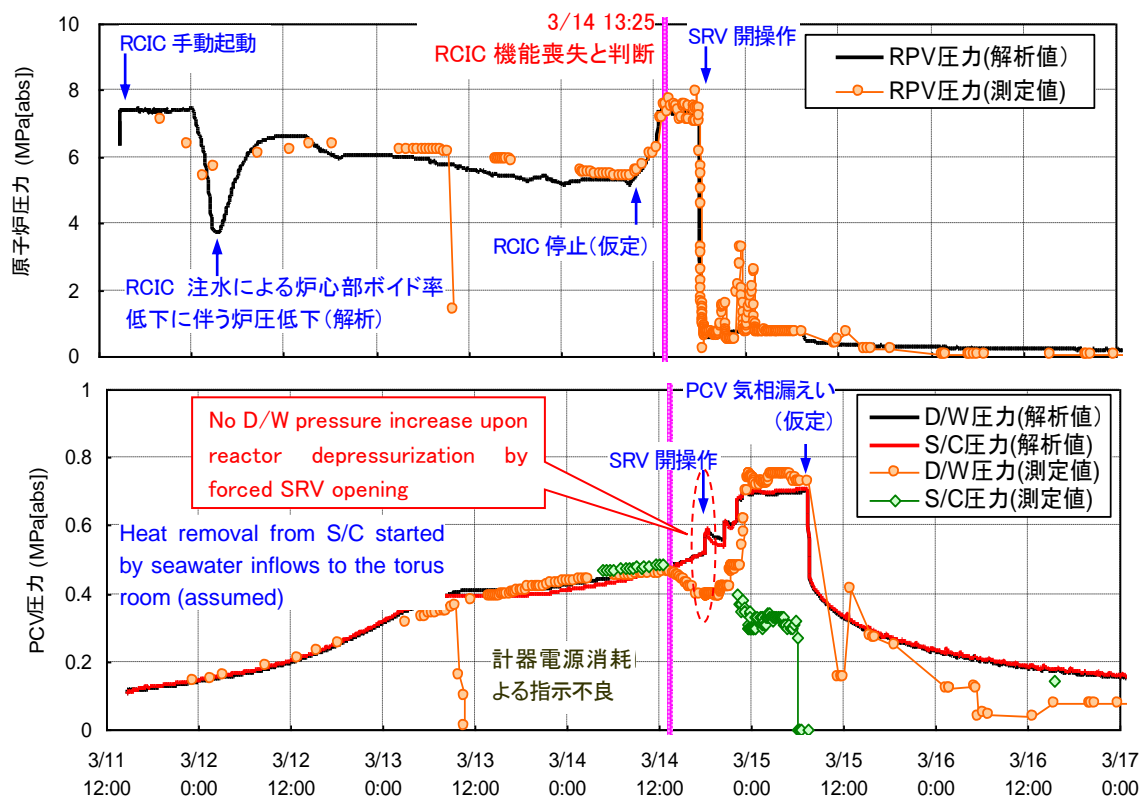
Figure Pressure changes of RPV and PCV at Unit-2

Unit-2/Issue-6	Unit-2	Category B①	Class (2)	Safety measures in [1]: -
PCV pressure behavior upon forced SRV opening at Unit-2				Results: Attachment -
<p>At Unit-2 the manual forced depressurization of the reactor was successfully completed at 18:02 on March 14<sup>th</sup> by the opening operation of the SRV(s). Theoretically, the D/W pressure should increase by a large amount of steam (energy) flow into the S/C upon forced depressurization by the SRV(s). Nevertheless, it remained at about 0.4MPa[abs] from 17:00 through 20:00.</p> <p>It should be noted that, thereafter at about 20:00, 21:00 and 23:00 on March 14<sup>th</sup>, the D/W pressure showed an increase and reached about 0.75MPa[abs], probably due to the accumulation of the incondensable gases.</p> <p>The MAAP analysis predicted the pressure increase upon forced depressurization. It is necessary to clarify the pressure change behavior upon forced depressurization by the SRV(s).</p>

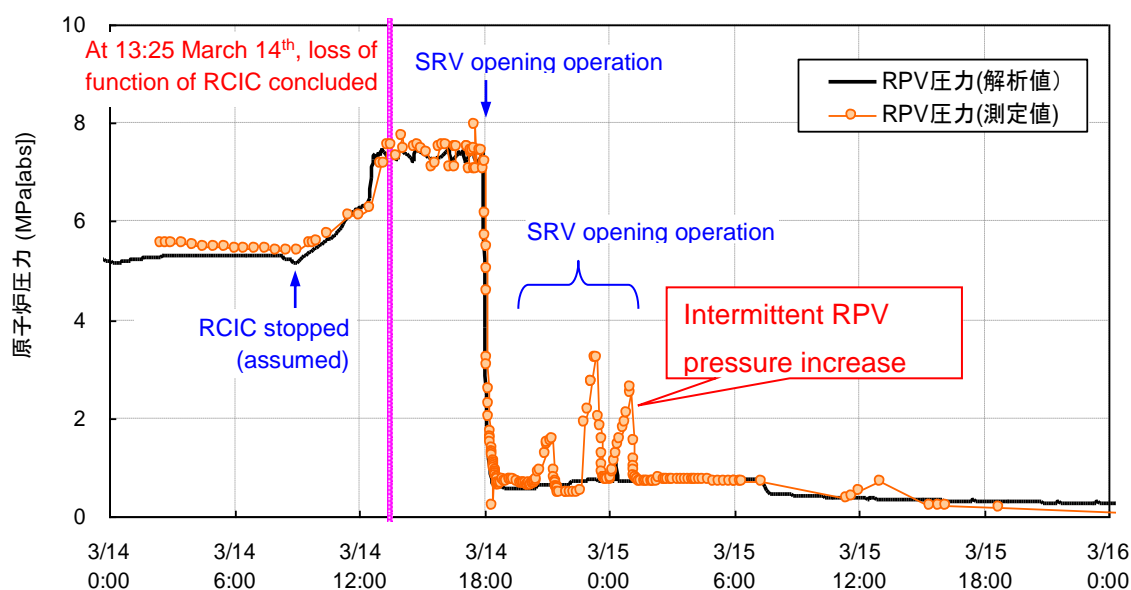
Figure RPV pressure changes at Unit-2

At Unit-2 the manual forced depressurization of the reactor was successfully completed at 18:02 on March 14<sup>th</sup> by the opening operation of the SRV(s). The SRV(s) were repeatedly opened thereafter in order to control the intermittent reactor pressure increase. But the operation records of SRV opening and the RPV pressure decrease do not always coincide. For instance, the operations of manual opening are recorded twice at 21:20 on March 14<sup>th</sup> and at 01:10 on March 15<sup>th</sup>, but no record of confirming the SRV manual opening exists at the time of reactor pressure increase and decrease at about 23:00 on March 14<sup>th</sup>.

After the forced depressurization of the reactor, fire engines continued to inject water. Therefore, possible causes of the pressure increase are: steam production due to the increased water level; steam production due to corium slumping to the lower plenum; steam production by the zirconium-water reactions; or even the SRV closures. RPV and PCV pressure behavior after the reactor forced depressurization is to be examined.
