List of issues to be investigated

Reference [1] "Safety measures at the Kashiwazaki-Kariwa Nuclear Power Station of Tokyo Electric Power Company (First version, March 2013)"

List of issues

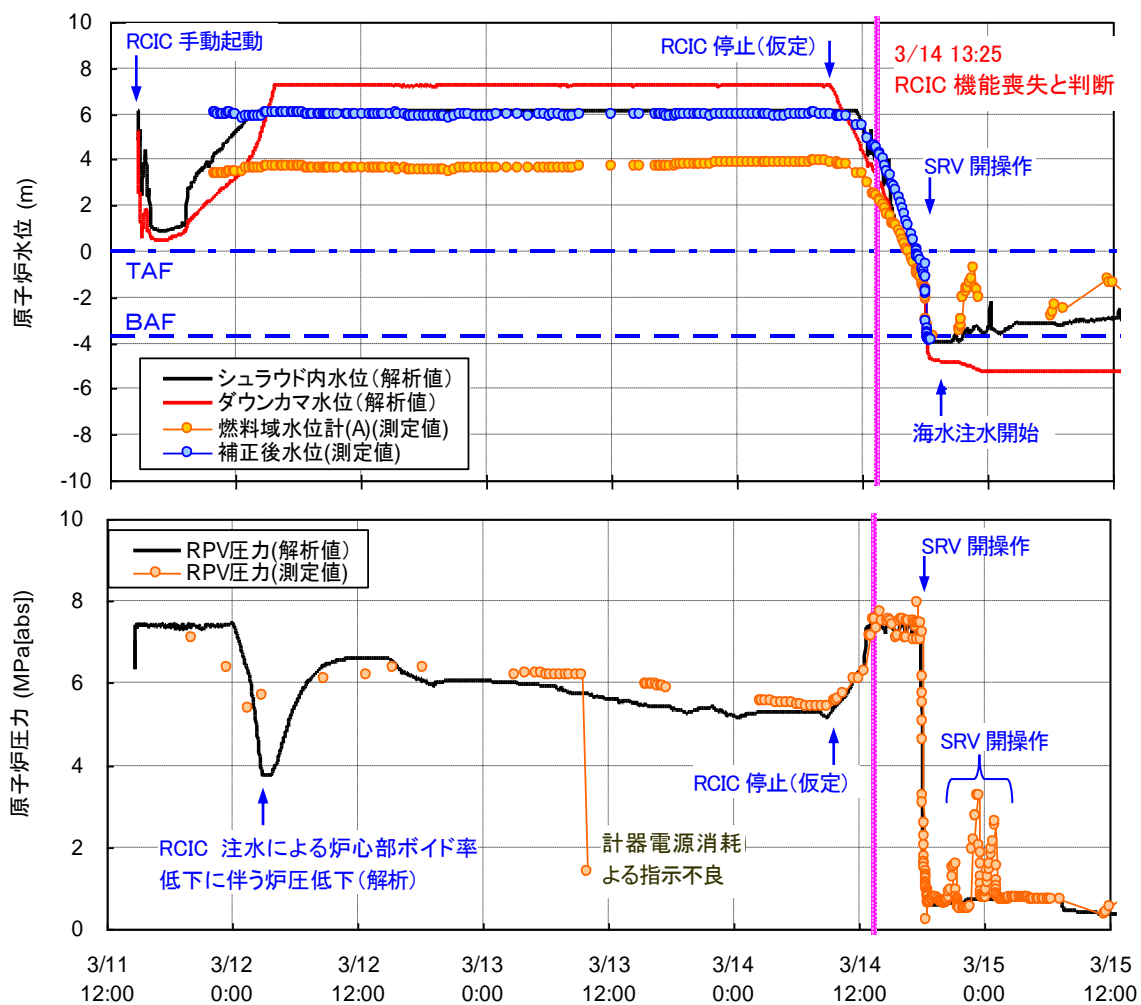
Figure RPV water level and pressure changes at Unit-2

Unit-2/Issue-8	Unit-2	Category B③	Class (1)	Safety measures in [1]: pp.27^36
Leaks in gaseous phase from Unit-2 RPV				Results: Attachment -
<p>At Unit-2 the forced depressurization of the reactor was successfully completed at 18:02 on March 14<sup>th</sup> by the opening operation of the SRV(s).</p> <p>The SRV(s) were repeatedly opened thereafter in order to control the intermittent reactor pressure increase. But the operation records of SRV opening and the RPV pressure decrease do not always coincide. For instance, the operations of manual opening are recorded twice at 21:20 on March 14<sup>th</sup> and at 01:10 on March 15<sup>th</sup>, but no record of confirming the SRV manual opening exists at the time of reactor pressure increase and decrease at about 23:00 on March 14<sup>th</sup>.</p> <p>The reactor water level indicator readings showed about the BAF level at the time of the forced depressurization, and the core melting progressed thereafter. In view of this, gaseous leaks might have occurred from the reactor vessel, due to, for example, damage of TIP tubes, which composed the pressure boundary. In addition, no further operations of SRV opening for depressurization were taken after a certain time.</p> <p>But there is no direct evidence in the measured plant parameters or observed events which shows when and from where the leaks actually occurred. Clarification is needed.</p>

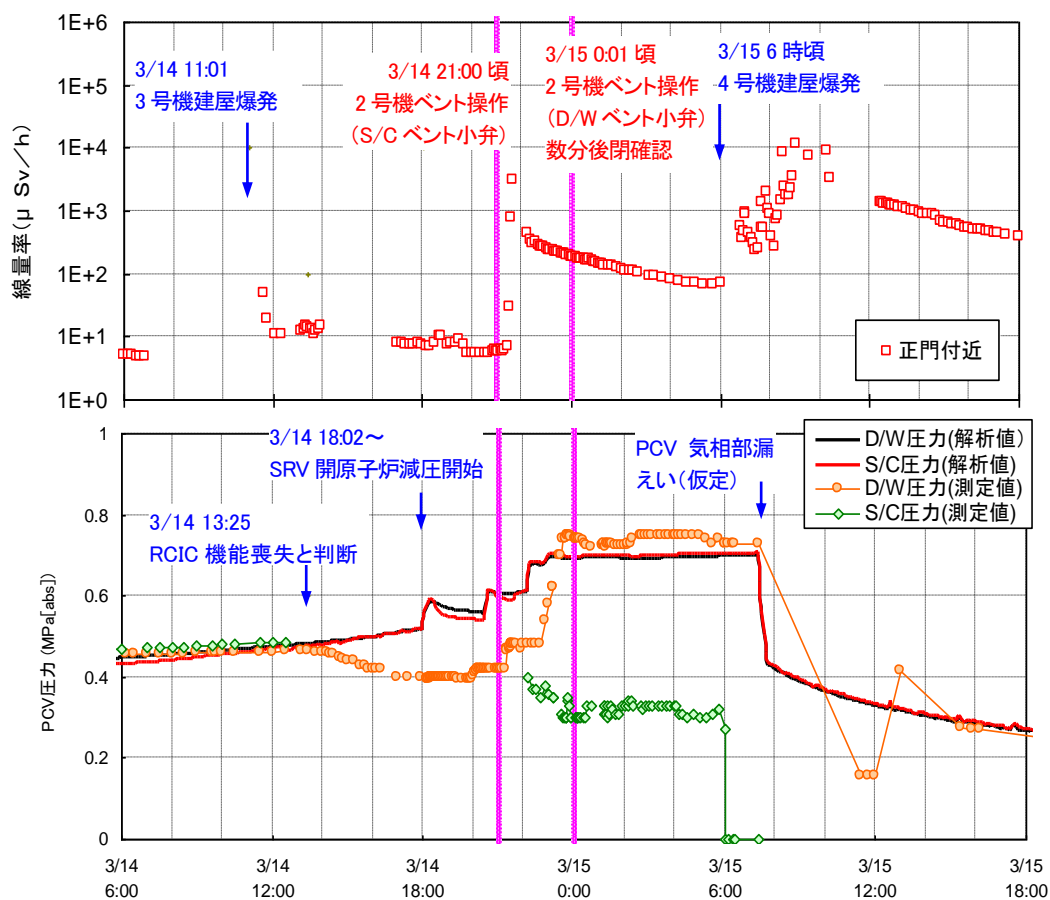
Figure Radiation dose near the main gate and PCV pressure changes upon Unit-2 venting  
[Back to List of Issues/Unit-2](#)

Unit-2/Issue-9	Unit-2	Category B①	Class (2)	Safety measures in [1]: p.40
Consideration of possible rupture disc actuation at Unit-2				Results: Attachment 4
<p>At Unit-2 the RCIC could continue injecting water with no power source for control, which had been lost due to the tsunami. But, since the need to vent the PCV was foreseen in due course, the venting line was configured by 11:00 on March 13<sup>th</sup> except for the rupture disc actuation.</p> <p>However, the large S/C vent valve (AO-valve) was confirmed to have been closed by the impacts of the explosion of the Unit-3 reactor building. Finally, the valve is considered to have become inoperable for opening actions due to the defective solenoid valve.</p> <p>At about 21:00 on March 14<sup>th</sup>, the small S/C vent valve was slightly opened by activating its solenoid valve. The venting line configuration was completed again except for the rupture disc actuation, but it was reported that the small S/C valve had been in the “Closed” position at 23:35 on March 14<sup>th</sup>.</p> <p>The S/C venting was thus being prepared for, but no clear evidence exists whether it actually was successful. Even if the S/C pressure indicators did not provide true values, the measured D/W pressure exceeded the rupture disc working pressure (528kPa[abs]) at about 23:00 on March 14<sup>th</sup> (540kPa[abs]). The S/C venting flow rate with the opened small S/C vent valve is limited, and so the D/W pressure decrease also will be limited. On the other hand, the monitoring car measured a sharp radiation dose increase near the main gate at about 21:20 on March 14<sup>th</sup> when the SRV opening was recorded.</p> <p>Clarification is needed to interpret the causes of the radiation dose increase, including the possibilities of PCV venting being implemented and the rupture disc actuation.</p>

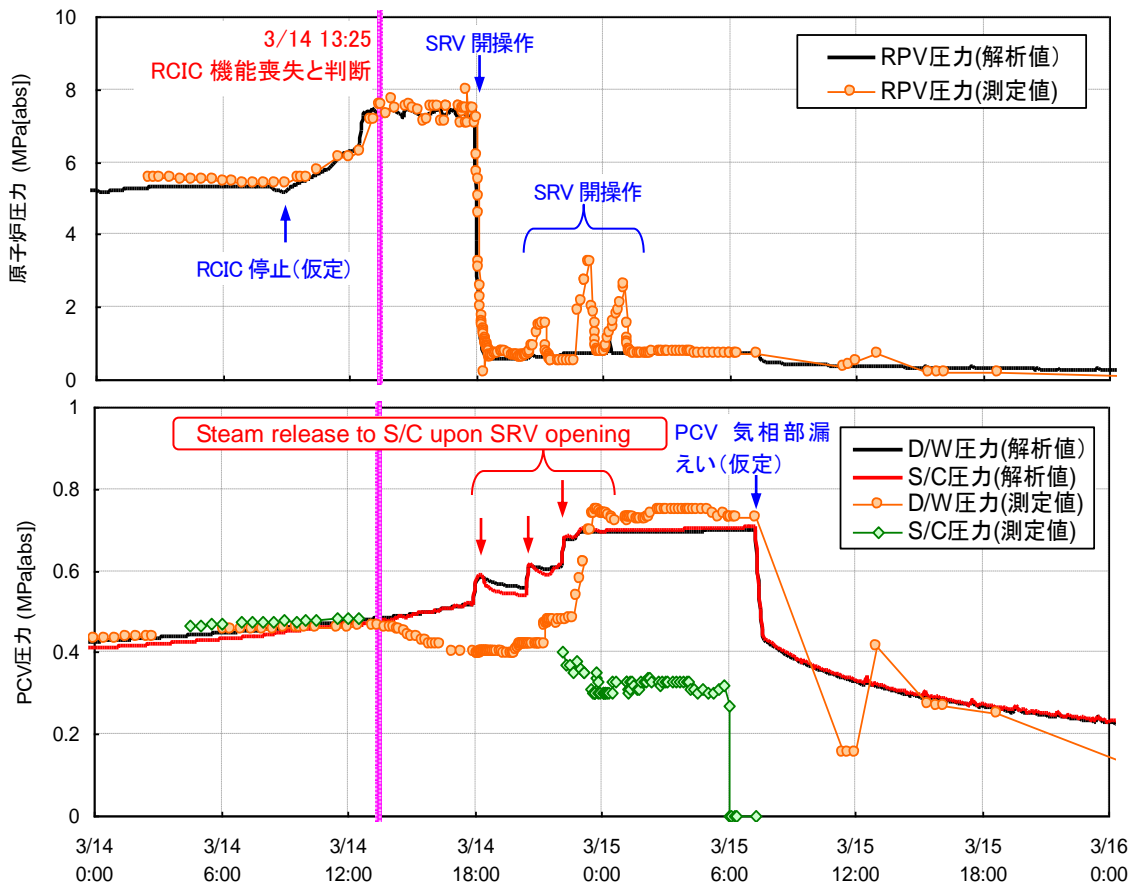
Figure RPV and PCV pressure changes at Unit-2

Unit-2/Issue-10	Unit-2	Category B①	Class (2)	Safety measures in [1]: -
Condensation behavior upon hydrogen-rich steam release at Unit-2				Results: Attachment 2-8
<p>At Unit-2 the forced depressurization of the reactor was successfully completed at 18:02 on March 14<sup>th</sup> by the opening operation of the SRV. Further at about 21:00 on March 14<sup>th</sup>, an attempt was made to open another SRV because the reactor pressure had increased, but the pressure did not decrease. Further a third SRV was then actuated and the reactor pressure decreased at 21:20.</p>				
<p>The reactor pressure was about 1.5MPa when it increased at about 21:00, when the core melting is considered to have been already progressing. Therefore, the exhaust upon reactor depressurization would have contained a large amount of hydrogen gas, a non-condensable gas. The non-condensable gas in the exhaust will cause pressure increase behavior different from that due to only steam in the exhaust. Clarification is needed concerning possible impacts on the S/C integrity due to hydrogen-rich steam release.</p>

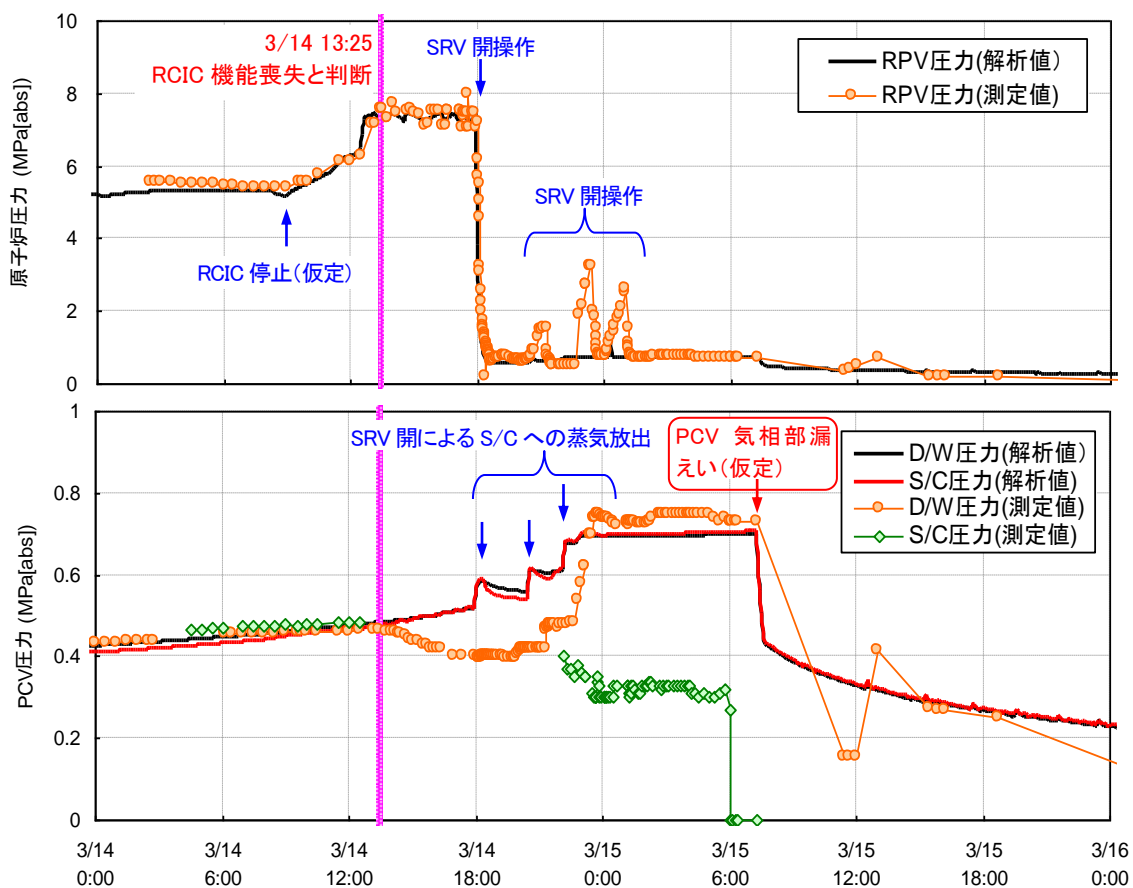
Figure RPV and PCV pressure changes at Unit-2

It can be further considered that the leaks had started sometime between about 23:30 on March 14<sup>th</sup>, when the PCV pressure had changed above 0.7MPa[abs], and about 07:20 on March 15<sup>th</sup>.

But no direct evidence has been identified from the measured plant parameters or observed facts concerning at what time and at what point the leaks actually occurred. Clarification is needed.

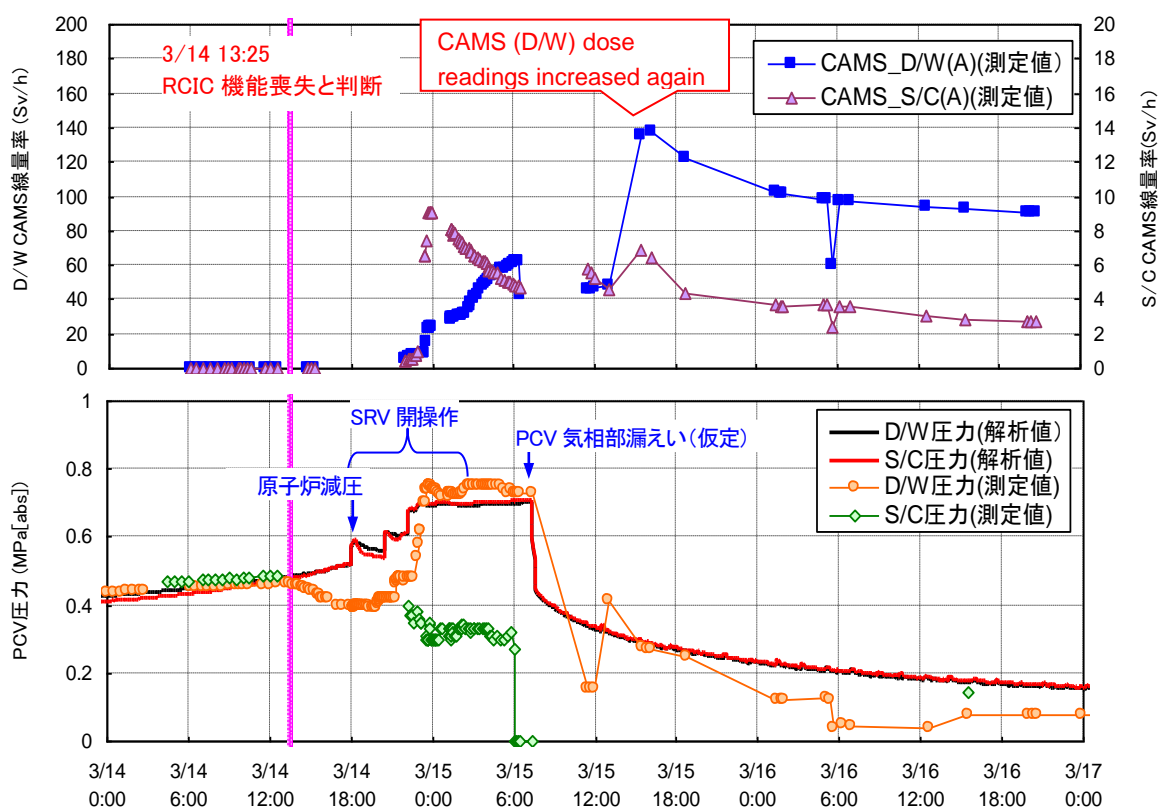
Figure Changes of CAMS readings and PCV pressures at Unit-2

The CAMS (D/W) readings of Unit-2 recorded from the morning of March 15<sup>th</sup> were monotonically increasing before around 06:00 (63Sv/h at 06:20). After about a 6-hour blank period, it read 46Sv/h at 11:25. This can be interpreted as having reflected the dose rate decrease in the PCV as the result of FP release to the environment.

Thereafter, the CAMS (D/W) recorded a rapid increase to 135Sv/h at 15:25 on March 15<sup>th</sup>. This rapid increase may have been caused by some unknown changes of the situation in the RPV and PCV. It will be investigated what phenomena could have occurred around this time period.

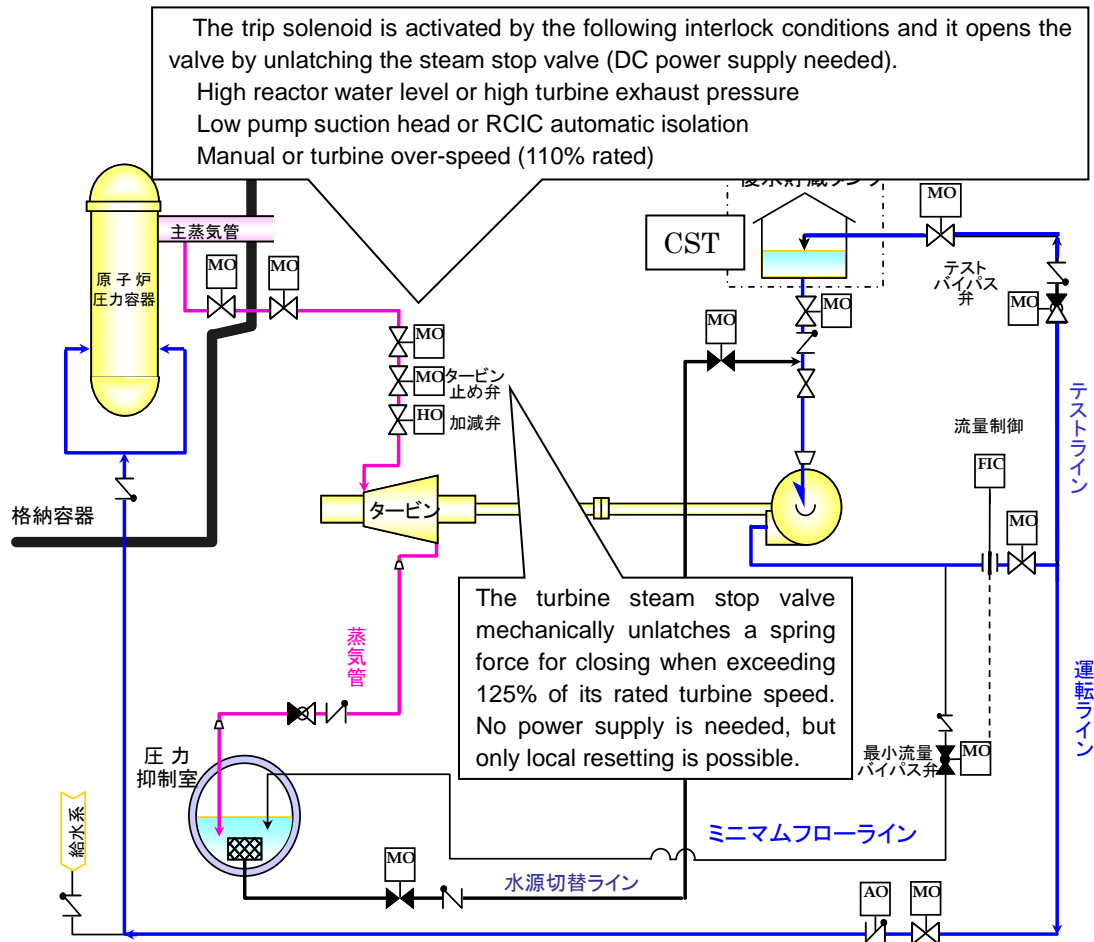
Figure Schematic RCIC line configuration

At 11:36 on March 12<sup>th</sup>, the status indicator lamp on the MCR control panel showed shutdown of the RCIC, and the flow meter and discharge pressure indicator readings all became zero. The RCIC was thus confirmed to have shut down. The shutdown condition was locally confirmed in the RCIC room, too, afterward. It was attempted to restart the RCIC after resetting it from the MCR control panel, but immediately after attempting the restart, the steam stop valve trip mechanism was unlatched, the steam stop valve was closed and the RCIC was shut down.

On the next day after the HPCI stopped operating, it was attempted to restart the RCIC again at 05:08 on March 13<sup>th</sup> after the steam stop valve mechanism had been properly latched, adjusted, and the pre-service status had been checked, but again the steam stop valve was closed and the RCIC restart attempt failed.

The RCIC could continue working beyond its design condition of 8 hours, but, in order to increase the RCIC system reliability, it is necessary to clarify the battery capacities and real loads, and the reason why the stop valve mechanism was unlatched.

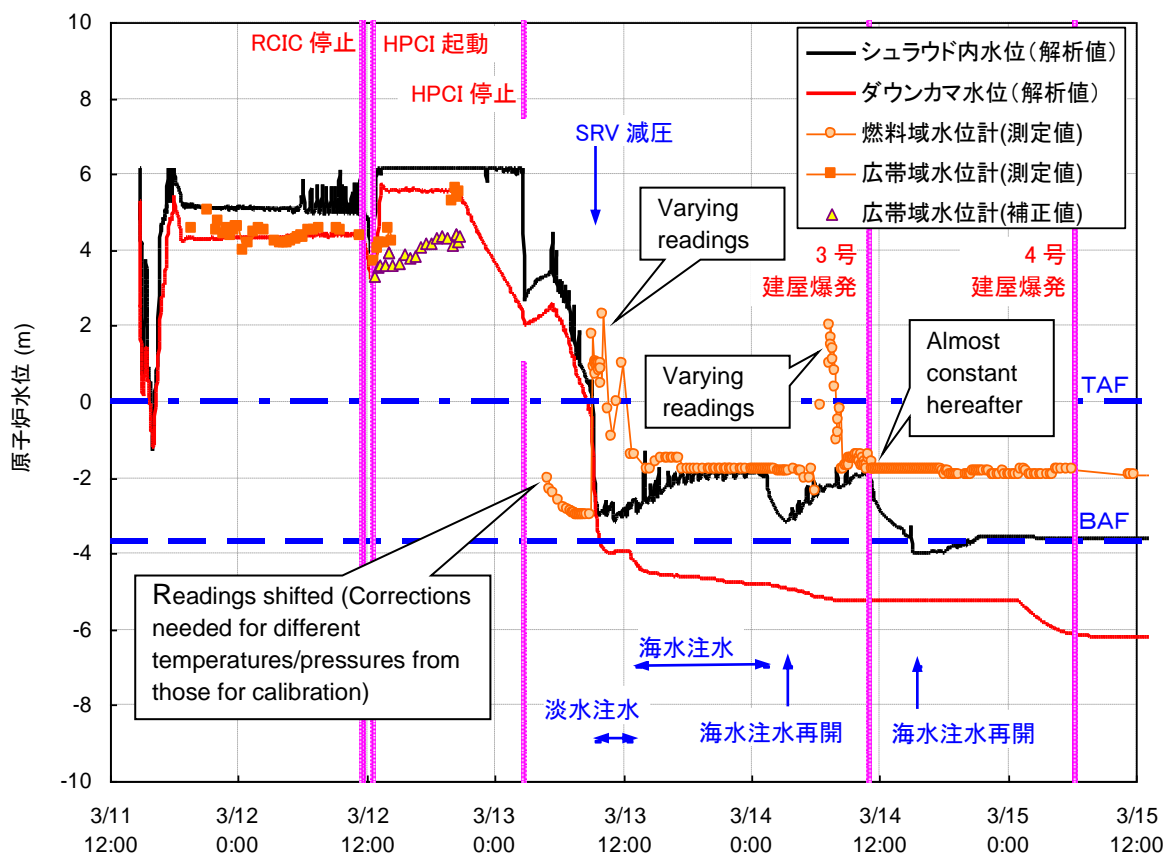
Figure Reactor water level changes at Unit-3

Unit-3/Issue-2	Unit-3	Category A⑤	Class (2)	Safety measures in [1]: -
RPV water level indicator readings at Unit-3 after loss of true value indications				Results: Attachment -
<p>The reactor water level indicators of Unit-3 showed roughly constant values after about 12:00 on March 13<sup>th</sup>, irrespective of the water injection conditions. It can be considered that the water level indicators were out of order, like those of Unit-1, because of the water level decrease both in their reference leg and variable leg.</p> <p>The condensing chamber type water level indicators installed in the Fukushima Daiichi NPS reactors lose their water in their internal piping (reference leg and variable leg) by evaporation, causing them to show wrong values, when the PCV temperatures increase or the reactor pressures decrease.</p> <p>But, the water level indicator readings represent the pressure difference between the reference leg and the variable leg. This may provide some relevant information concerning the timing of reactor pressure decrease and/or reactor water level</p>

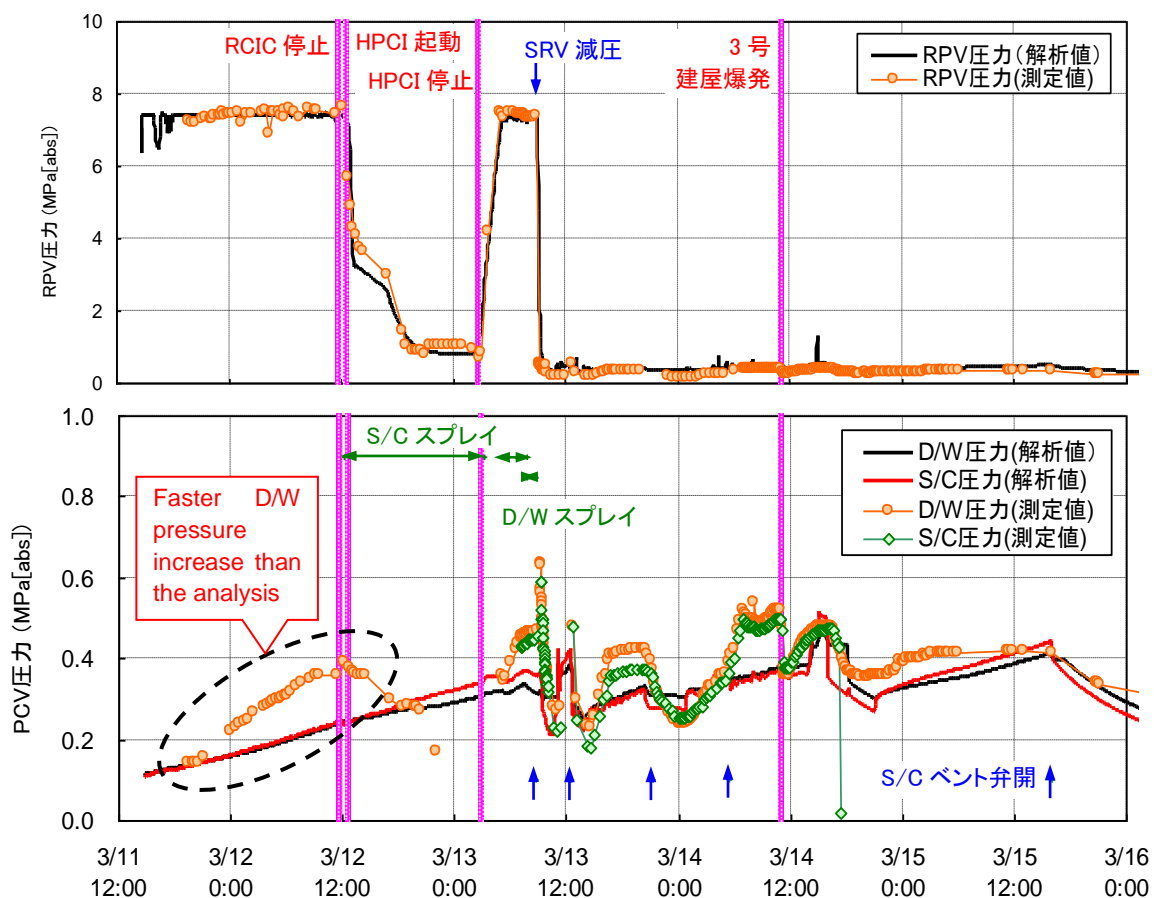
Figure Pressure changes of RPV and D/W of Unit-3

Unit-3/Issue-3	Unit-3	Category B①	Class (1)	Safety measures in [1]: pp. 17, 18, 39, 40
Thermal stratification in the S/C of Unit-3				Results: Attachment -
<p>The D/W pressure of Unit-3 was in an increasing trend due to the exhaust steam from the RCIC and SRV(s), while the RCIC was in operation after the tsunami arrival.</p> <p>When compared with the MAAP analysis results with the use of design conditions, the observed pressures until about 22:00 of March 12<sup>th</sup> showed a larger and faster increase. The MAAP analysis could not simulate this pressure behavior (the D/W pressures increases were much larger as compared with the MAAP results until about 12:00 when the HPCI started operation, and the analysis pressures by MAAP continued to increase afterward while the observed pressures decreased rapidly).</p> <p>JNES suggested a possibility (*) of thermal stratification in the upper part of the S/C pool water causing a local temperature rise which led to the larger D/W pressure increase as compared with the uniform temperature rise of the S/C pool water. The thermal stratification would have been generated by the high temperature exhaust steam from the RCIC turbine only heating the S/C pool surface water.</p> <p>Further examination is due into the D/W pressure changes until about 22:00 on March 12<sup>th</sup>.</p> <p>(*) “Examinations into the impacts of thermal stratification in the suppression chamber water on the containment vessel pressures, and other parameters”, issued Feb. 1<sup>st</sup>, 2012, by the Japan Nuclear Energy Safety Organization (in Japanese)</p>

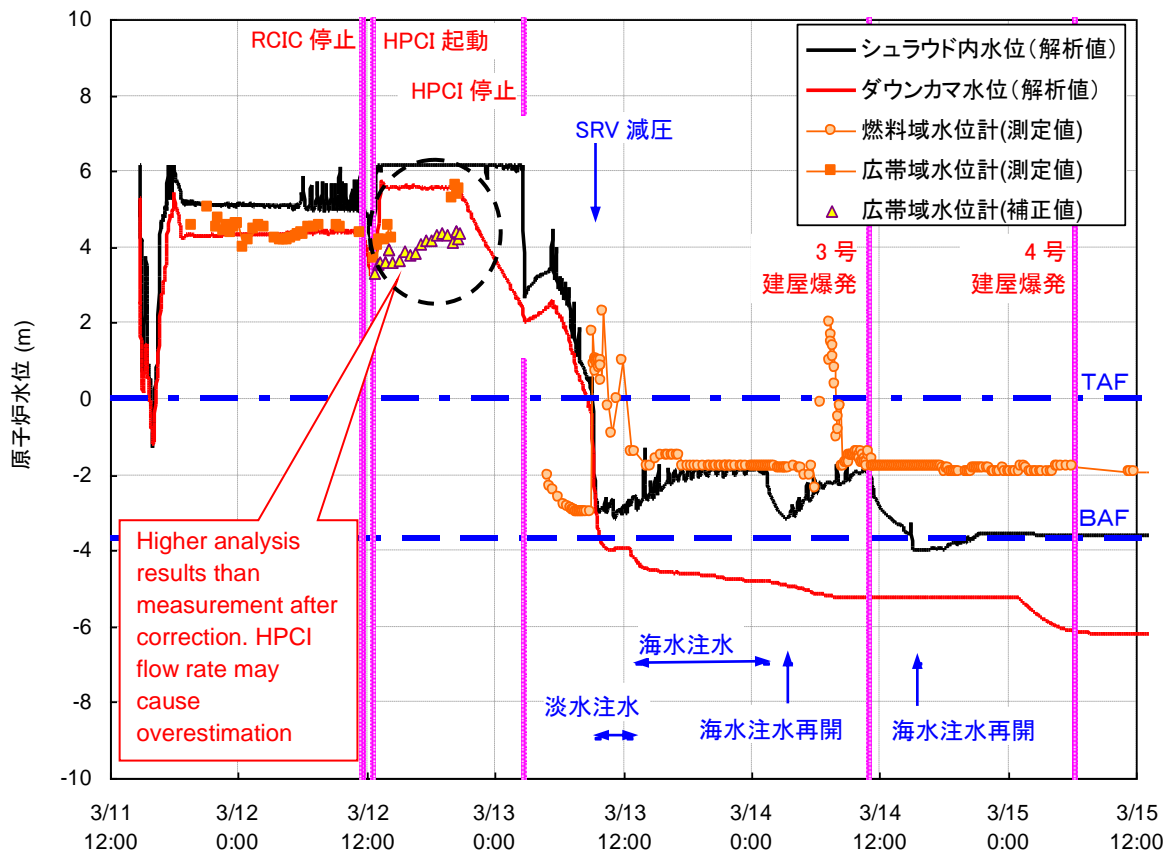
Figure Reactor water level changes at Unit-3

Unit-3/Issue-4	Unit-3	Category B①	Class (2)	Safety measures in [1]: p. 26 (for strengthened monitoring)
Reactor water level behavior during HPCI operation at Unit-3				Results: Attachment 3-3
<p>At Unit-3, the HPCI was adjusting the amount of water injection into the reactor by both using its return line to the CST water source and adjusting the set points of the flow controller while confirming the water level indicator to prevent the HPCI from being shut down by the high reactor water level signal (L-8). At 20:36 on March 12<sup>th</sup>, while the HPCI was in operation, the power supply to the reactor water level indicators was lost preventing the reactor water level from being monitored. The HPCI water injection flow rate of the flow controller was reset at a slightly increased level, and the reactor pressures, the HPCI discharge pressures, etc. were used to monitor the HPCI operation status.</p> <p>In the earlier MAAP analysis results, which TEPCO had disclosed in March 2012, the amount of water injection by the HPCI had been set to simulate the reactor water levels observed by the water level indicators (wide range). In the simulation, the reactor water levels measured until 20:36 on March 12<sup>th</sup> were used without corrections corresponding to the reactor pressures and PCV pressures. This caused the overestimation of the amount of water injected to the reactor in the MAAP analysis (The water level in the analysis is about 1m higher than that of measurement after such corrections). In consequence, it is likely that the amount of water actually injected by the HPCI was less than that assumed in the MAAP analysis.</p> <p>The amount of HPCI water injection will be reviewed and the real progression of the accident will be examined for estimating the core and PCV status.</p>

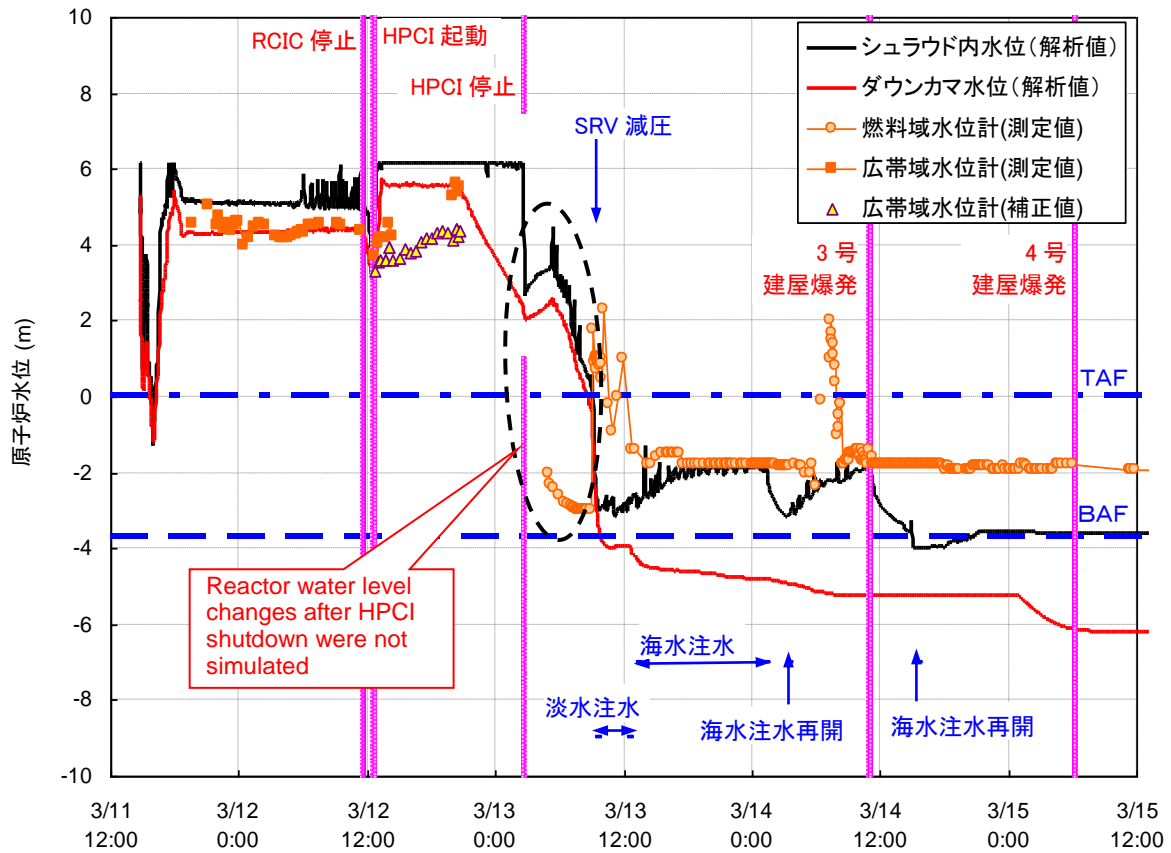
Figure Reactor water level changes at Unit-3

Unit-3/Issue-5	Unit-3	Category B①	Class (2)	Safety measures in [1]: -
Reactor water level behavior after the loss of function of HPCI at Unit-3				Results: Attachment 3-3, 3-4
<p>At Unit-3, the HPCI was adjusting the amount of water injection into the reactor by both using its return line to the CST water source and adjusting the set points of the flow controller while confirming the water level indicator to prevent the HPCI from being shut down by the high reactor water level signal (L-8). At 20:36 on March 12<sup>th</sup>, while the HPCI was in operation, the power supply to the reactor water level indicators was lost preventing the reactor water level from being monitored. The HPCI water injection flow rate of the flow controller was reset at a slightly increased level, and the reactor pressures, the HPCI discharge pressures, etc. were used to monitor the HPCI operation status.</p> <p>From 20:36 on March 12<sup>th</sup> to about 04:00 on March 13<sup>th</sup> the reactor water levels were not measured. When the reactor water level indicators were restored, the fuel range water level indicator read about TAF-2m. But, the MAAP analysis maintained the water level higher than the TAF level until about 09:00 on March 13<sup>th</sup> when the Unit-3 was depressurized, overestimating the water level.</p> <p>This discrepancy indicates that the water actually injected by the HPCI after 20:36 on March 12<sup>th</sup> was less than that assumed in the MAAP analysis. It further indicates a possibility that the water injection by HPCI had actually ended before the HPCI was manually shut down at 02:42 on March 13<sup>th</sup>.</p> <p>In view of a high likelihood of a smaller amount of water actually being injected than that assumed in the analysis, the overestimated amount of HPCI water injection will be reviewed and the actual progression of the accident will be investigated for estimating the core and PCV status.</p>

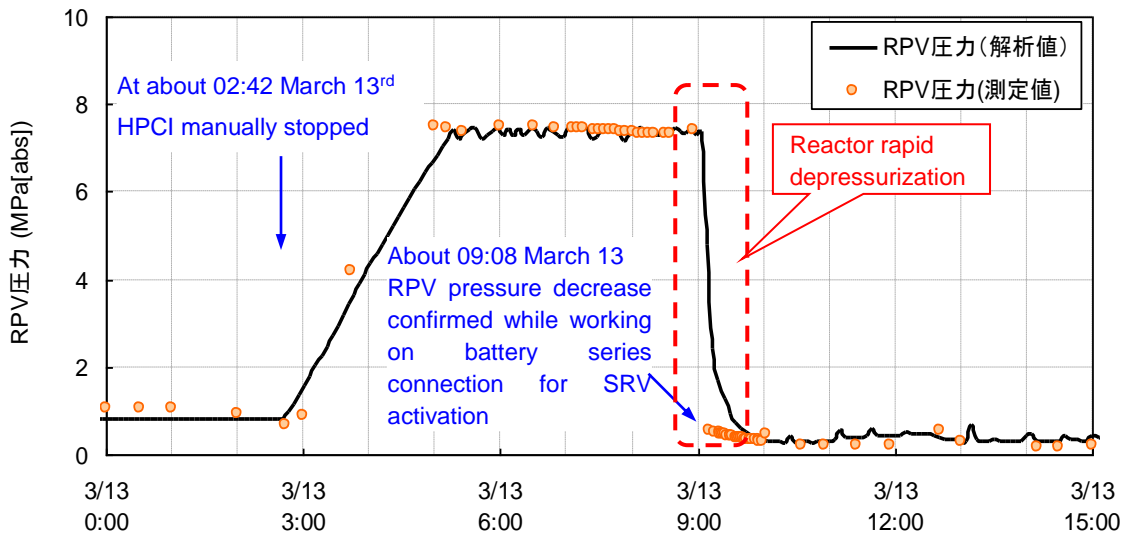
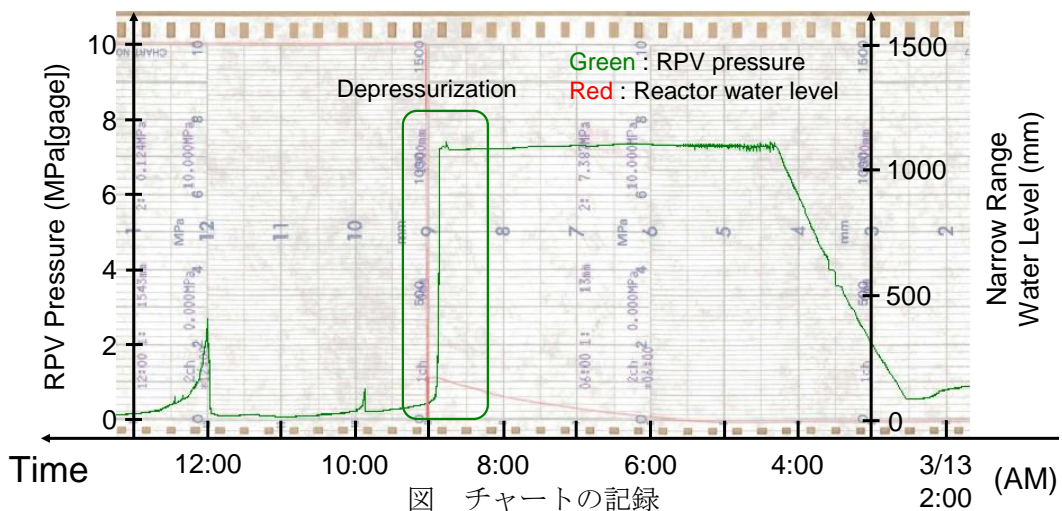
Figure Reactor pressure changes at Unit-3

This pressure decrease can be confirmed in two types of observed data: measured values recorded by the operators and the chart records. From the chart records, continuous transient behavior can be read, although the exact values are not known. The pressure decrease rate thus read is as large as about 7MPa[abs] down to about 1MPa[abs] in 2 to 3 minutes.

At this time, the battery connection work to the SRV control panel was not completed. The pressure decrease did not occur by the SRV manual actuation. It is necessary to investigate the depressurization mechanism.

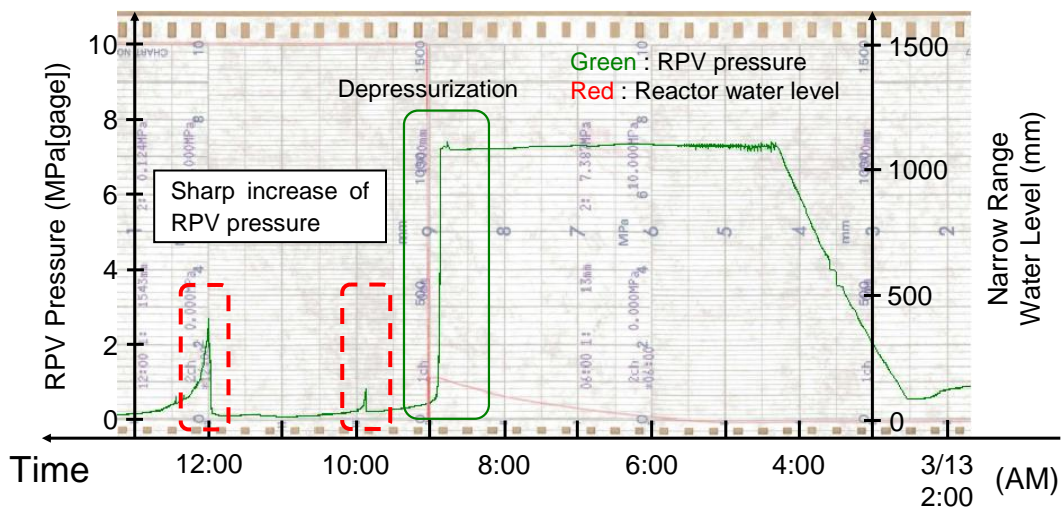
Figure Strip chart records (March 13<sup>th</sup>, 2011)

This pressure behavior, especially the pressure decrease, was considered and reported to be the responses to the SRV opening operations at 09:50 on March 13<sup>th</sup> upon the completion of battery connection and at about 12:00 upon the recovery from having found disconnected wiring. However, the pressure rise at these two times is very sharp as compared with the pressure increase at 02:42 on March 13<sup>th</sup>, when the HPCI had stopped operation.

The pressure behavior should be similar in the two cases, when the HPCI turbine steam regulator valve is closed upon the HPCI being shut down and when the SRV(s) are closed, because both cases are equivalent in having lost the steam discharge paths. But the observed pressure increase behavior is actually different. The sharp pressure increase might have been caused by the relocation of molten fuel down to the lower plenum or the generation of a large amount of hydrogen.

The pressure change mechanism and its relevance to the accident progression will be investigated.

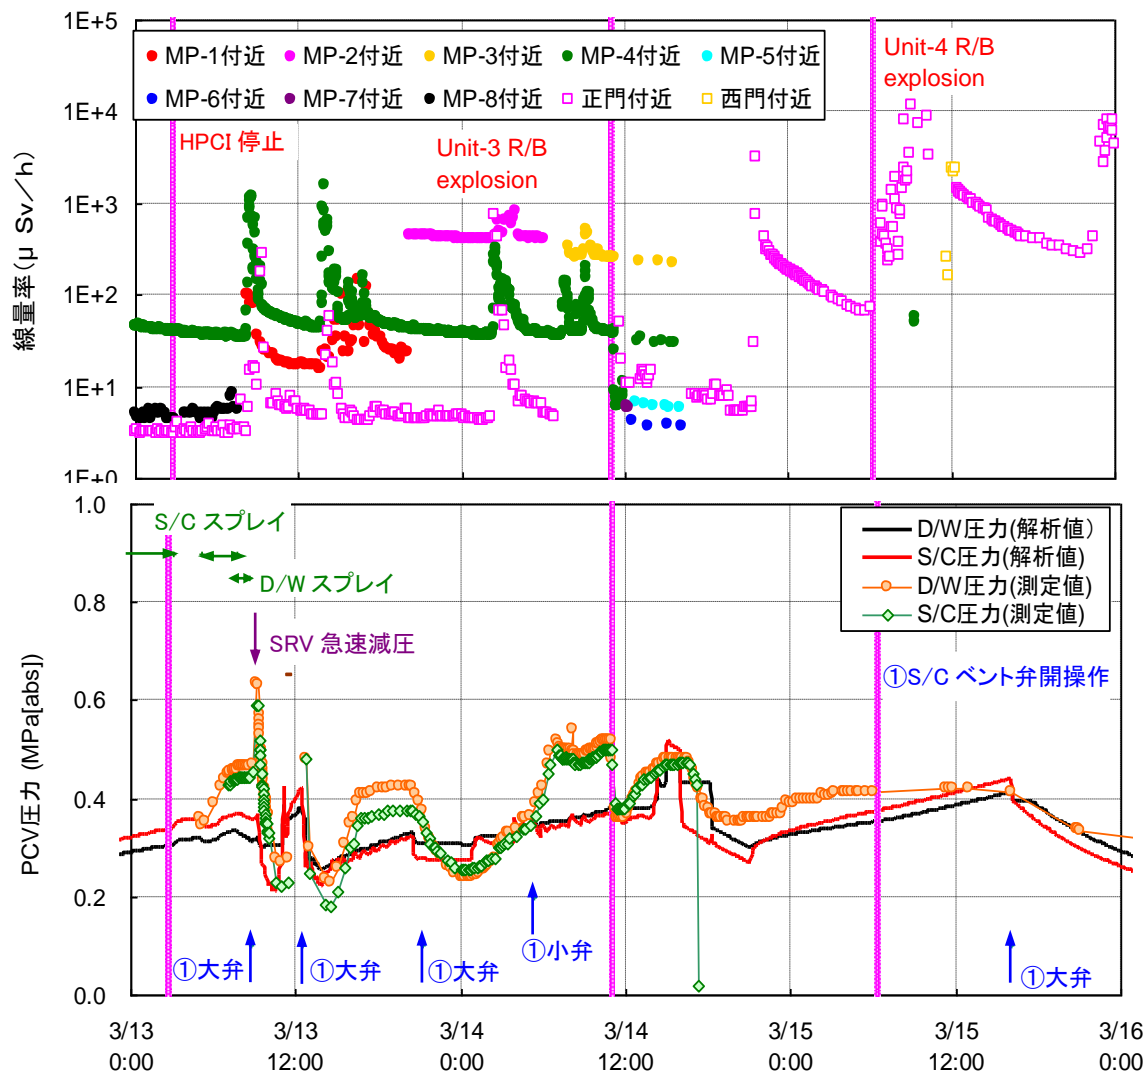
Figure Dose rate changes at the NPS (upper) and D/W pressure changes at Unit-3 (lower)

The Emergency Response Center at the Fukushima Daiichi NPS concluded that the PCV had been vented once at Unit-3 when the D/W pressure decrease had been observed at 09:24 on March 13<sup>th</sup> following the completion of S/C venting line configuration at 08:41 on March 13<sup>th</sup>. Thereafter, the large S/C vent valve (air-operated) was closed several times due to problems of driving air pressure or the actuation circuit using a temporary small generator. Each time it was attempted to open the large S/C vent valve by solving the problem causes.

The D/W pressures observed during this period repeatedly went up and down, but their timings were mostly not consistent with the timings of repeated opening operations of the large S/C vent valve. The flow rate changes anticipated by the small S/C vent valve opening operations seem too limited to explain the measured D/W pressure changes.

The causes of the D/W pressure changes during the series of venting operations will, therefore, be investigated.

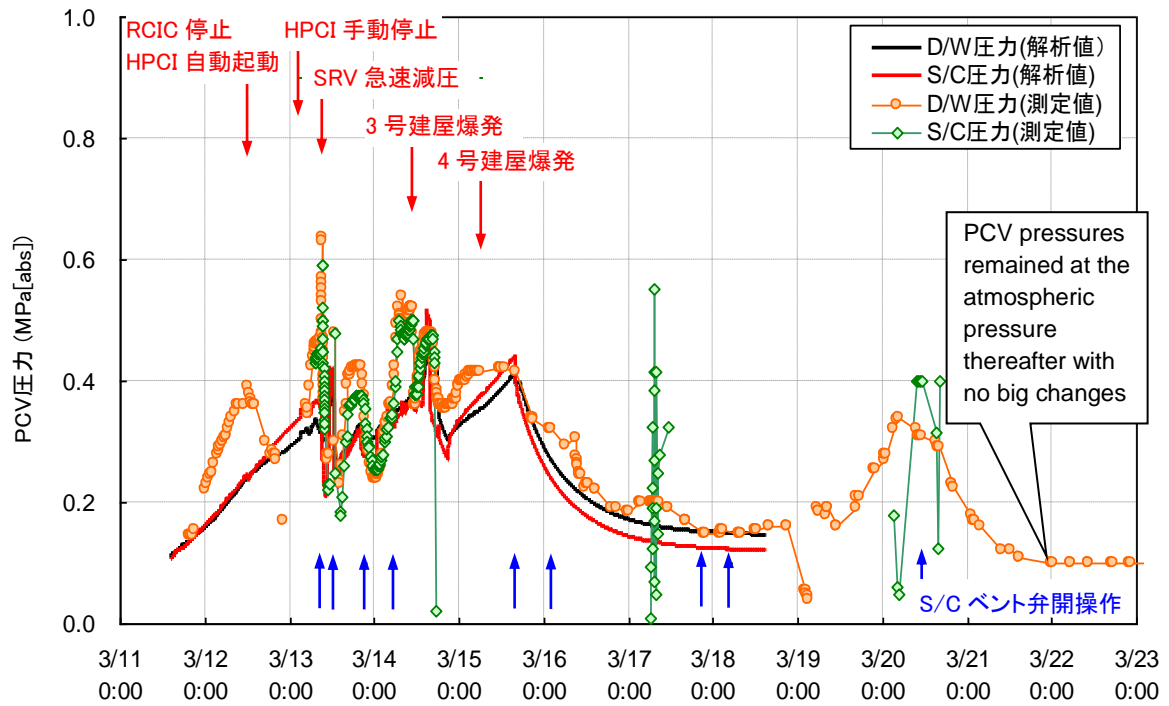
Figure PCV pressure changes at Unit-3

Unit-3/Issue-10	Unit-3	Category B③	Class (1)	Safety measures in [1]: pp.27-43
Leaks in gaseous phase from Unit-3 PCV				Results: Attachment -
<p>At Unit-3, the D/W pressure increase due to the rapid reactor depressurization at about 09:00 on March 13<sup>th</sup> led to the S/C pressure increase big enough to exceed the rupture disk working pressures. Thereafter the D/W pressure decrease at 09:24 on March 13<sup>th</sup> was confirmed and the PCV venting was concluded to have been implemented.</p> <p>It was considered that the D/W pressure repeated thereafter ups and downs corresponding to the steam generation by water injection and to the venting operations. After it increased for a while on March 21<sup>st</sup>, it stayed at around atmospheric pressure, with no big changes.</p> <p>The MAAP analysis assumed no PCV leaks in Unit-3, but the steam leak from the PCV seems probable because the steam explosion occurred in the Unit-3 reactor building, steam release was observed near the reactor well in the reactor building, and the D/W pressure showed no big changes after March 21<sup>st</sup> at around atmospheric pressure.</p> <p>Adding to that, when nitrogen gas was injected into the PCV, Unit-3 showed no pressure changes in the PCV, while Unit-1 and -2 showed pressure increases in their PCVs. There is another relevant observation concerning the oxygen concentrations in the PCV air, when measured by the PCV gas control system, i.e., it was almost zero in Unit-1 and -2, while it was high in Unit-3, indicating the possibility of air inflow into the PCV.</p> <p>It is considered, therefore, Unit-3, for which the operators attempted to repeat venting operations, would have had the largest leaks in the gaseous phase. Further investigation is needed to clarify when and from where the leaks in the gaseous phase actually occurred.</p>

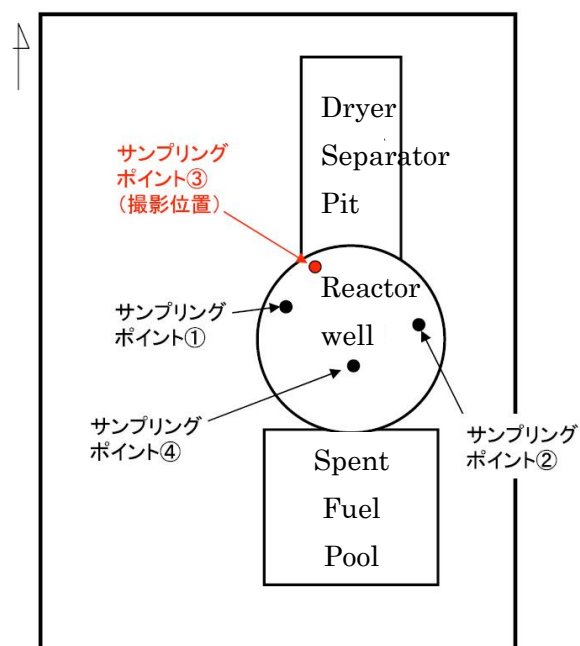
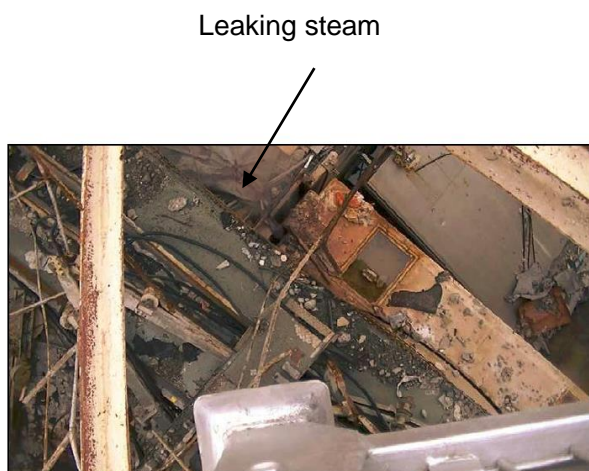
At Unit-3 a large amount of steam was observed to be blowing upward above the reactor building: dark smoke was observed on March 21<sup>st</sup>; and steam rising was observed on March 29<sup>th</sup> from the top and west side of the reactor building. Even after the spent fuel storage pool temperature was lowered sufficiently, steam release above the building was repeatedly observed.

Movie sequences on August 24<sup>th</sup>, 2011, taken at the time of dust sampling above the reactor building, show steam leaking from the shield plug margin and the periphery of the deformed dryer separator (DS) pit gates.

Steam thus observed seems to be leaking from the PCV and it may provide some useful information to identify the leak locations.
