Dose increase around March 20th, 2011

1. Background

With this background, this report examines the cause of the dose increase observed on March 20th and 21st, based on the plant parameters at that time, conditions of the plant surroundings and responses to the accident.

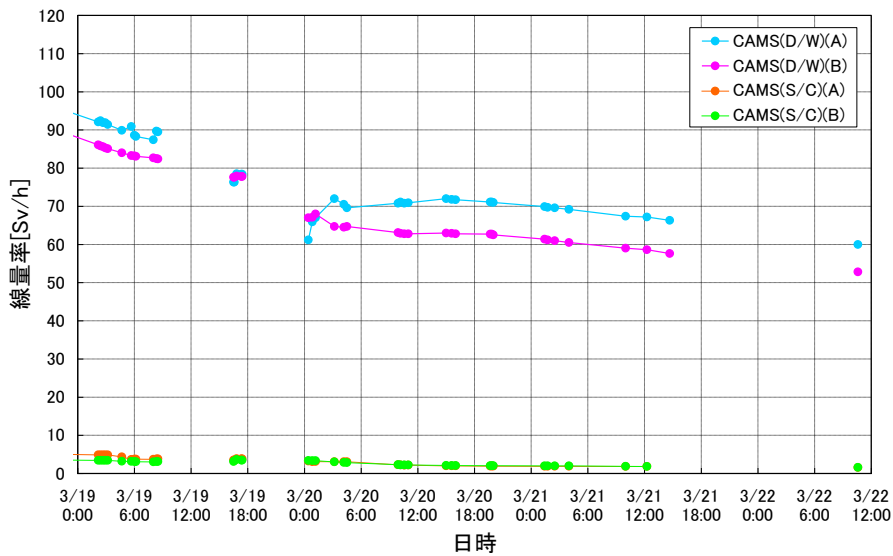
Figure 11 CAMS readings of Unit-3

Concerning Unit-3, Figure 9 and Figure 10 show a slight increase in the reactor water level and a slight decrease in the reactor pressure and D/W pressure during the time period when the dose increase was observed on March 20th. During this time period, the reactor temperature and PCV temperature showed a decreasing tendency [1]: the temperature of the feedwater nozzle (N4B) decreased from 210 deg C (at 11:00) to 140 deg C (at 15:00), that of reactor vessel bottom head from 244 deg C (at 11:00) to 220 deg C (at 15:00), and that of D/W HVH return line from 220 deg C (at 11:00) to 187 deg C (at 15:00). This leads to the understanding that the temperature decrease caused the pressure decrease of the reactor and PCV. In Figure 11 CAMS readings show no changes during the period of interest. From these considerations a new incident releasing radioactive materials during this time period of interest at Unit-3 seems unlikely to have occurred.
