Evaluation of the situation of
cores and containment vessels of
Fukushima Daiichi Nuclear Power Station
Units-1 to 3 and examination into unsolved
issues in the accident progression

Progress Report No. 4

December 17, 2015

Tokyo Electric Power Company, Inc.

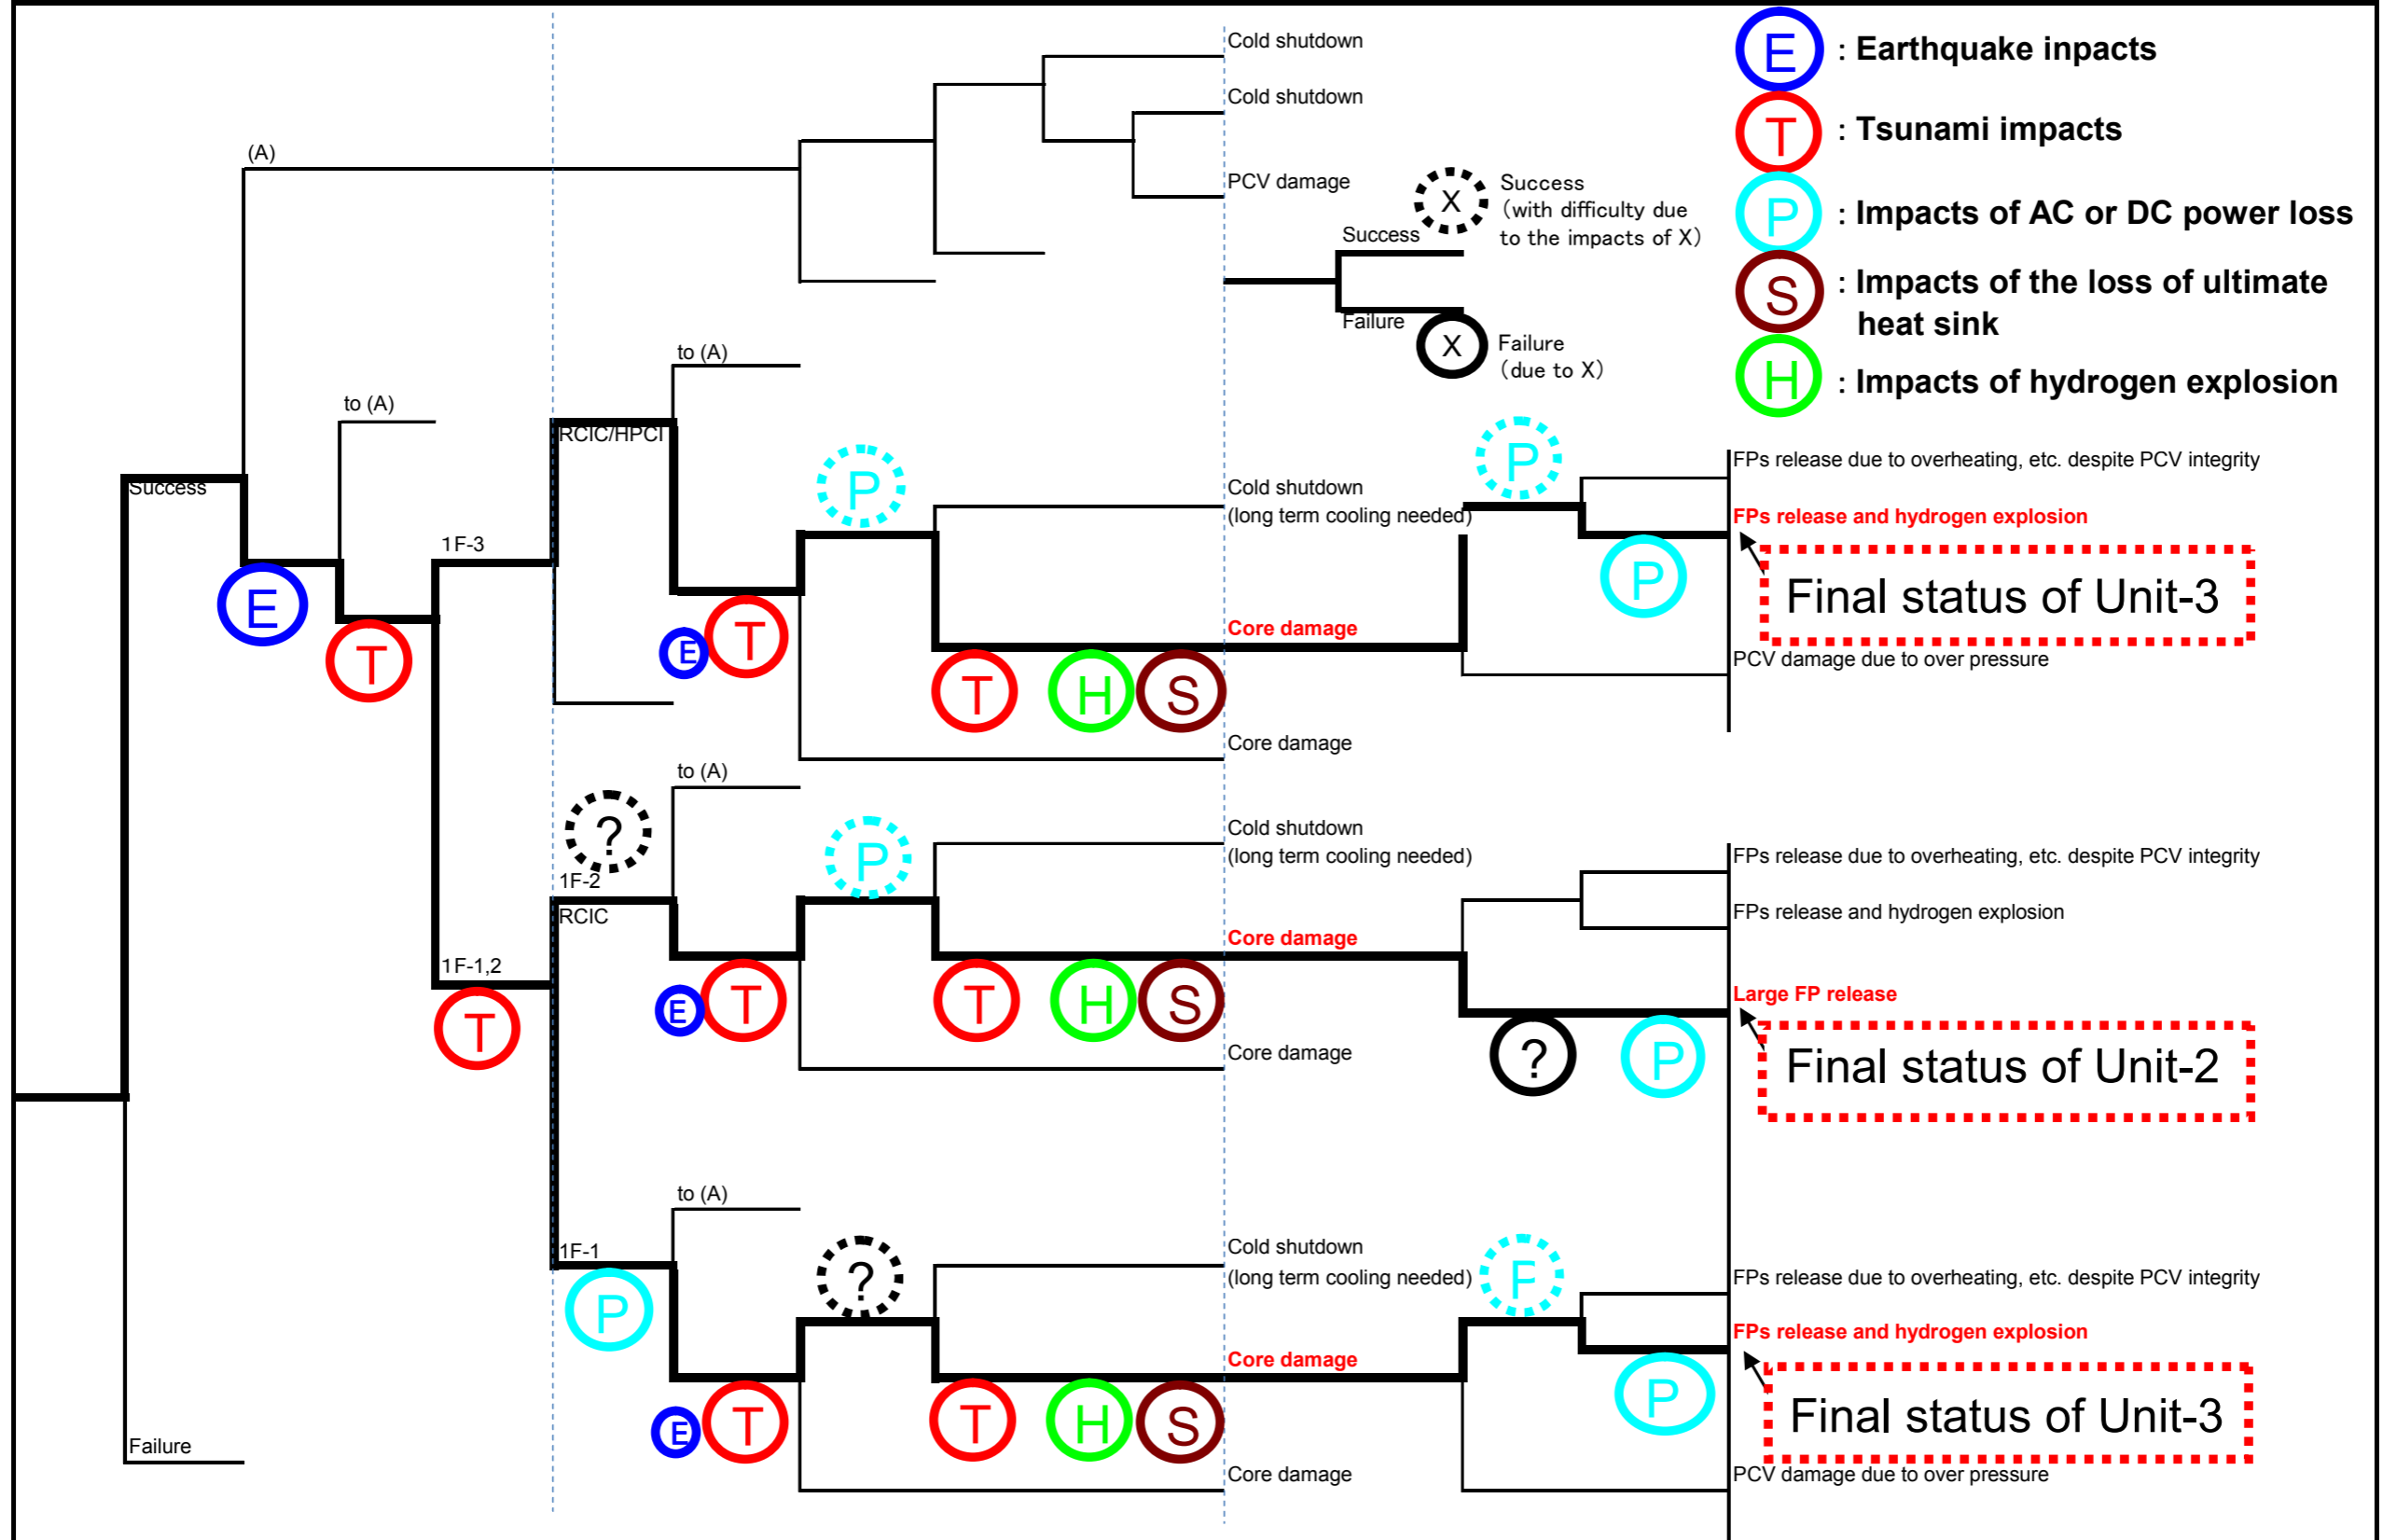
Fig. 1 Event-tree analysis results of Units-1 to 3 of Fukushima Daiichi Nuclear Power Station

The accident progression processes to the ultimate severe accidents have been interpreted in the response actions to the accident^{†1)} taken so far and the knowledge obtained therefrom has been integrated in safety enhancement measures of the Kashaiwazaki-Kariwa Nuclear Power Plant. (Refer to Fig. 1 Examinations of accident progression at Units-1 to 3 by event-tree analysis. ^{†2)} See 7.1 for further details.)

Below are detailed explanatory remarks about the event-tree analysis illustrated in Figure 1 of the first chapter. An event-tree analysis is a means to analyze what sequences a system follows starting at an initiating event to the ultimate status via junctions such as a loss of function of safety-related equipment. Generally at a junction, a branch above (success) leads an accident progression in the direction of cold shutdown, while a branch below (failure) leads in the direction to a severe accident. The more outcomes going to branches below, the more dangerous the ultimate plant conditions would be. Junctions are defined as a success or failure of functions of safety-related systems or equipment, etc. in an accident progression. Basically a junction follows a junction at its left, but the time difference between the two is not fixed, and varies according to the accident progression features at each unit.
