Status of investigation on estimating situation of cores and containment vessels

1. Introduction

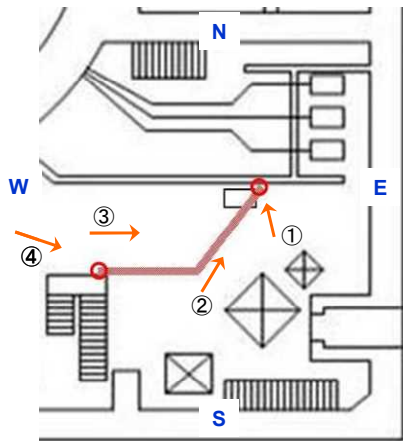
Figure 2. AC system piping route (about 2m elevation)

In December 2013, contamination was surveyed on the first floor of the Unit-1 reactor building by radiation dose measurements and gamma camera images taken using a robot. It was found that contamination was relatively high on the Atmospheric control system (AC) piping and Drywell humidity control system (DHC) piping (Figure 2-8) [8].

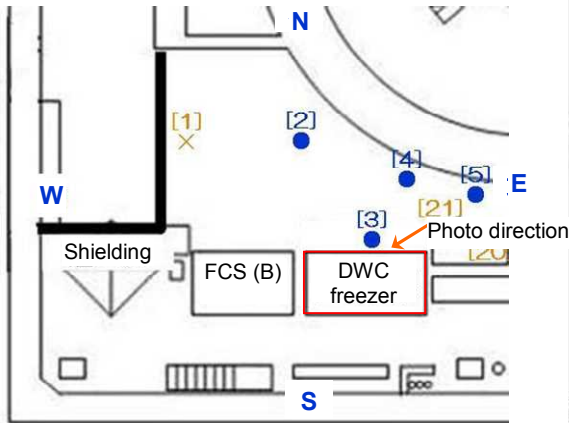
Figure 9. Layout

Hot spots confirmed along piping

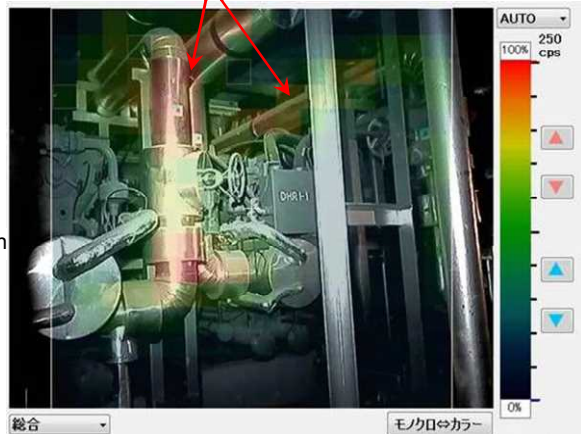
Figure 10. Gamma camera image taken near the DWC freezer

(Gamma camera image taken near the DWC system piping in the reactor building 1st floor)

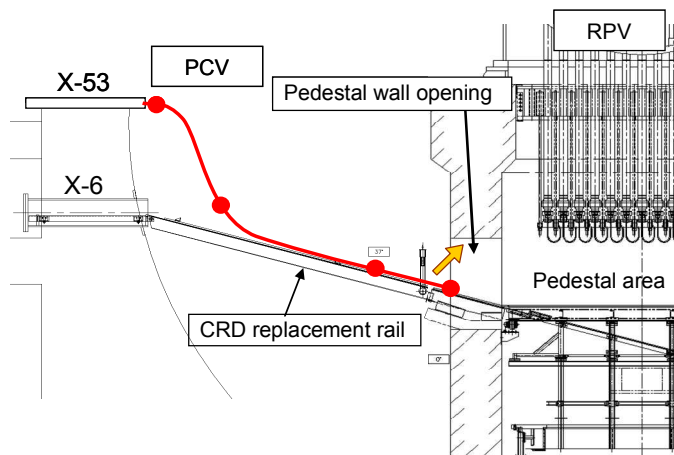
Figure 3-2 Survey areas inside Unit-2

In July and August 2013, a survey was conducted inside the PCV of Unit-2, when instrumentation was introduced through the PCV piping penetration X-53 (reactor building first floor) to take camera images and make dose and temperature measurements in the vicinity of the control rod drive mechanism (CRD) replacement rail and pedestal opening (Figure 3-2) [13].

Dosimeters measured the dose rates as far as the top of the CRD replacement rails. The values were about 45 – 80 Sv/h. As supplementary information, dose rates were estimated from the camera image noises; they were about 30 Sv/h near the landing point in replacement rail and

about 36 Sv/h near the pedestal opening. No clear indication was obtained about gaining access to fuel debris, even via the pedestal opening on the CRD replacement rail because access to fuel debris will result in rapid dose rate increase.

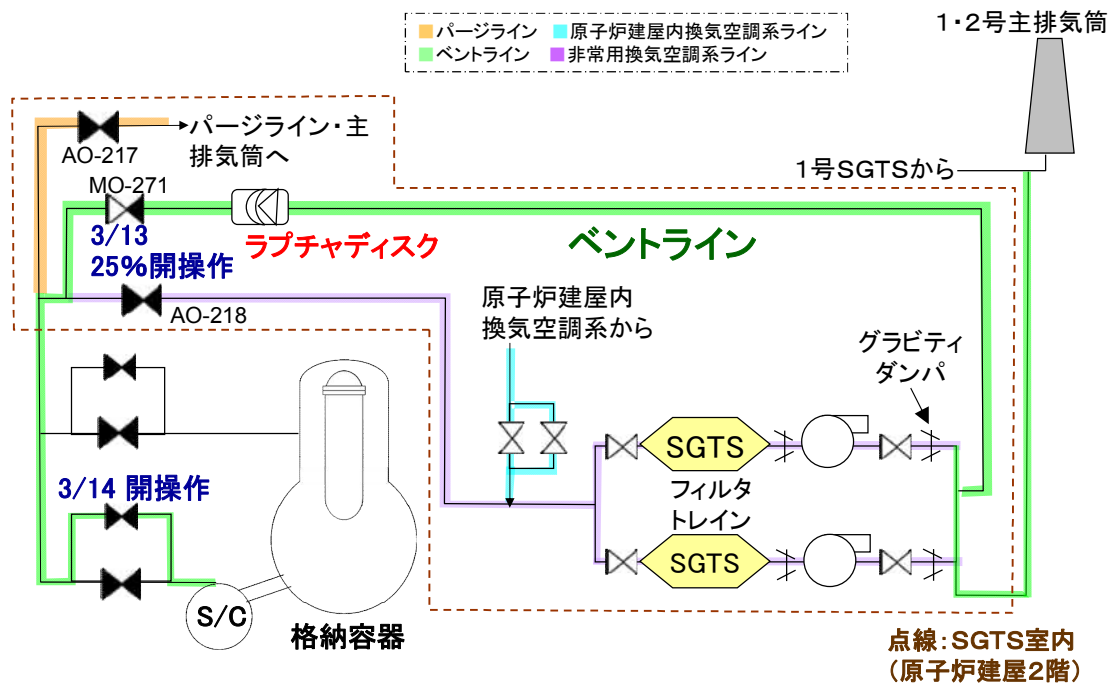
Figure 3-8 System configuration relevant to the rupture disk

Figure 3-8 illustrates the system configuration for venting from the primary containment vessel (PCV) to the Unit-1&2 stack. The green line is the venting line to release the PCV pressure when it exceeds its design pressure. This venting line bypasses the SGTS filters mounted, as early as the very beginning of the construction phase, on the emergency heating and ventilation air conditioning system. This venting line is also connected to the purge line as well as the reactor building heating and ventilation air conditioning (RB HVAC) system line. Valves in the figure are shown in black when fully closed, or when the opening aperture is unknown, and white when fully opened. The opening aperture of the valve (MO-271) located immediately upstream from the rupture disk was recorded as being operated to 25% mid-open position as of March 13<sup>th</sup>, 2011. The valve continues to hold the state even now. On the other hand, the valve immediately downstream on the S/C side of the PCV was operated to open its large and small vent valves until March 14<sup>th</sup>, 2011, but their real states when the venting line pressure reached the rupture disk working pressure remain unknown.

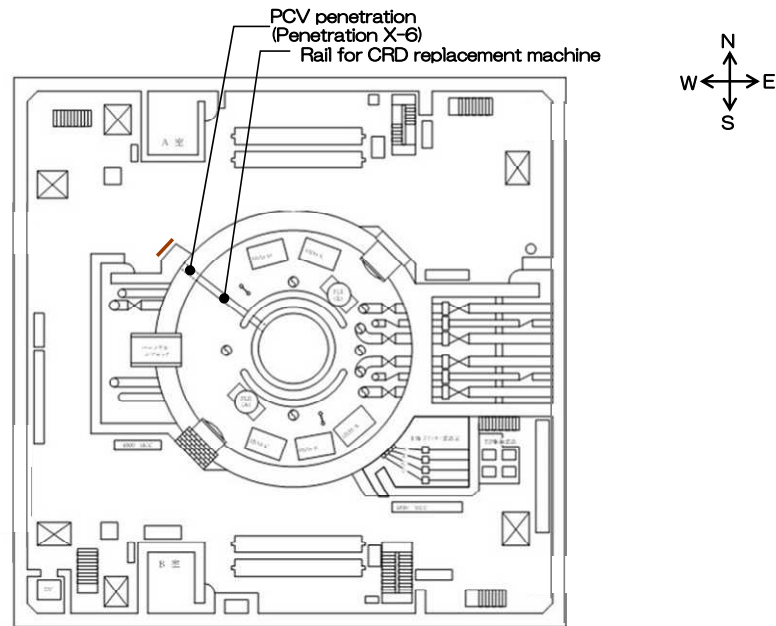
Figure 3-12 Layout on the ground floor of Unit-2 R/B [19]

In preparation for the internal investigation of the PCV and pedestal, shield blocks and iron plates were removed (between June 11<sup>th</sup> to October 1<sup>st</sup>, 2015) from the front of PCV penetration X-6 (see Figure 3-12 Building layout), which had been selected as the access route. When the area around the penetration was investigated, during the removal work, some melted material was found and a high radiation dose of more than 1,000mSv/h was noticed on the penetration flange and on the floor.
