Estimation of causes of high contamination of RCW piping at Unit-1

1. Background

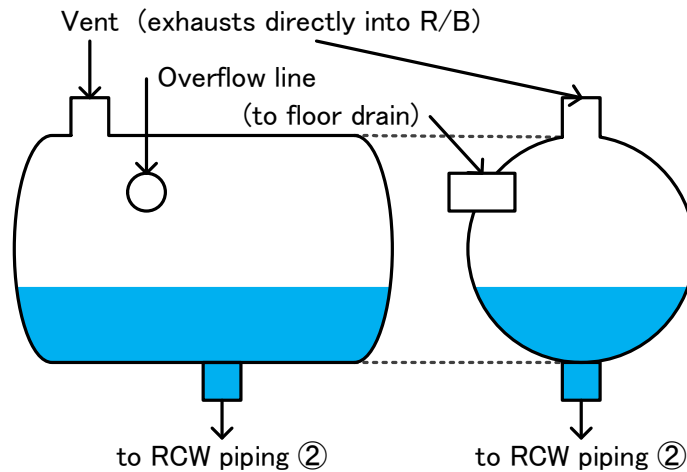
Figure 7 Structure of RCW surge tank (image)

The RCW system discharged its surge tank vent exhaust directly to the air in the R/B (Figure 7). Therefore, the pressure distribution in the RCW lines is considered to have been in a distribution with the pressure at the surge tank at 1 atmospheric pressure (about 0.1MPa[abs]). On the other hand, it has been confirmed that the PCV pressures of Unit-1 in the accident progression were kept high after the DW pressure of 0.6MPa[abs] had been measured at about 23:50 on March 11th until the PCV wet well venting (W/W venting) was successfully carried out, and then decreased over the period from 14:30 to 14:50 on March 12th when the W/W venting was implemented. Since it is probable that the migration behavior of radioactive materials in the RCW piping depended on the PCV pressures, investigation was made in Sections 4.1 and 4.2 concerning the destination of radioactive materials in the respective cases of high PCV pressures and low PCV pressures.

The RCW piping ② has four branch lines. The line to the surge tank is likely to be at about atmospheric pressure at its end and therefore the radioactive materials could have tended to migrate in the direction of the surge tank. This is consistent with the high dose rates observed

around the surge tank on the R/B Floor 4 (Figure 5). Migration to other lines depends on the distance and paths to the destination equipment or on the elevational relations with the surge tank, which is an easier destination for migration. But all downstream lines return to the heat exchanger outlet line in a closed circuit. Therefore, the line pressures are considered close to the RCW pressures and it can be considered to have been hard for radioactive materials to migrate to these lines. It should be noted that the relatively high dose rates observed in the vicinity of the MG set (A) could have been affected by the RCW heat exchanger, as mentioned in Section 2, and they could have been caused not only by the contamination in the piping.
