# “Development of a technology to investigate inside the Reactor Primary Containment Vessel (PCV)”

- Site test “Investigation B1” on grating around the pedestal inside Unit 1 PCV -

April 15, 2015

Tokyo Electric Power Company

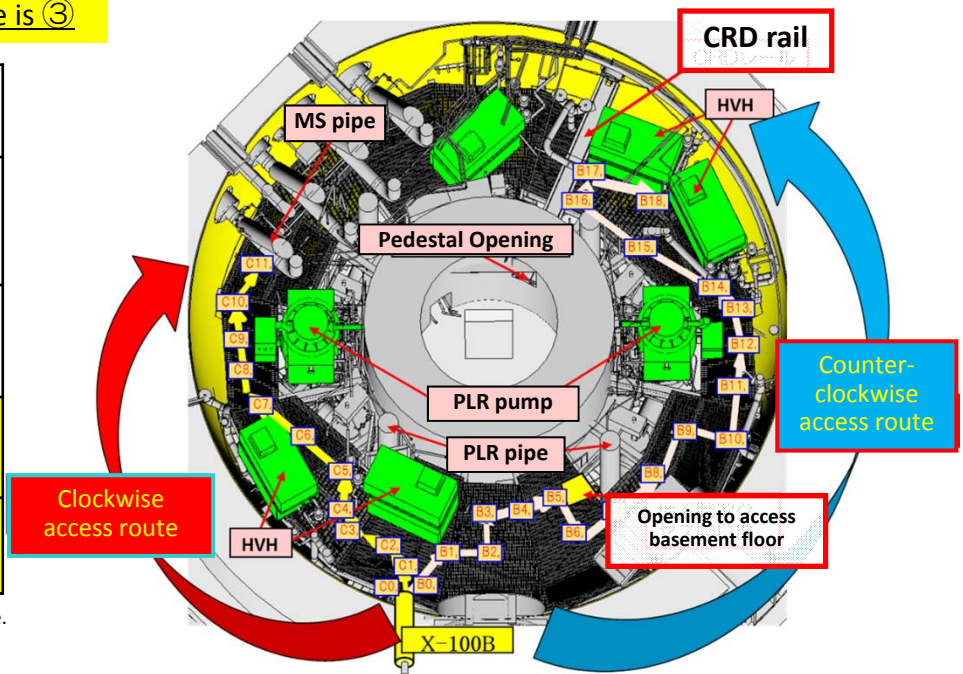
## Investigation items The items investigated on clockwise route this time is ③

No.	Purpose	Location	Item	Device
①	Check if there is a presence of any interfering object at the time of investigating the basement around the pedestal (B2)	Opening to access basement floor	Image	CCD camera
②	Check if there is a presence of any interfering object at the time of investigating inside the PCV pedestal.	CRD rail	Image	CCD camera
③	Check the environmental status.	On the access route*	Temperature Radiation dose	Thermometer Radiation dosimeter
	Check the conditions of existing facilities.		Image	CCD camera
