<Reference>
January 15, 2014
Tokyo Electric Power Company

Detailed Analysis Results in the Port of Fukushima Daiichi NPS, around Discharge Channel and Bank Protection (Sampling Locations of Underground Water Obtained at Bank Protection)

Detailed Analysis Results in the Port of Fukushima Daiichi NPS, around Discharge Channel and Bank Protection (1/4)

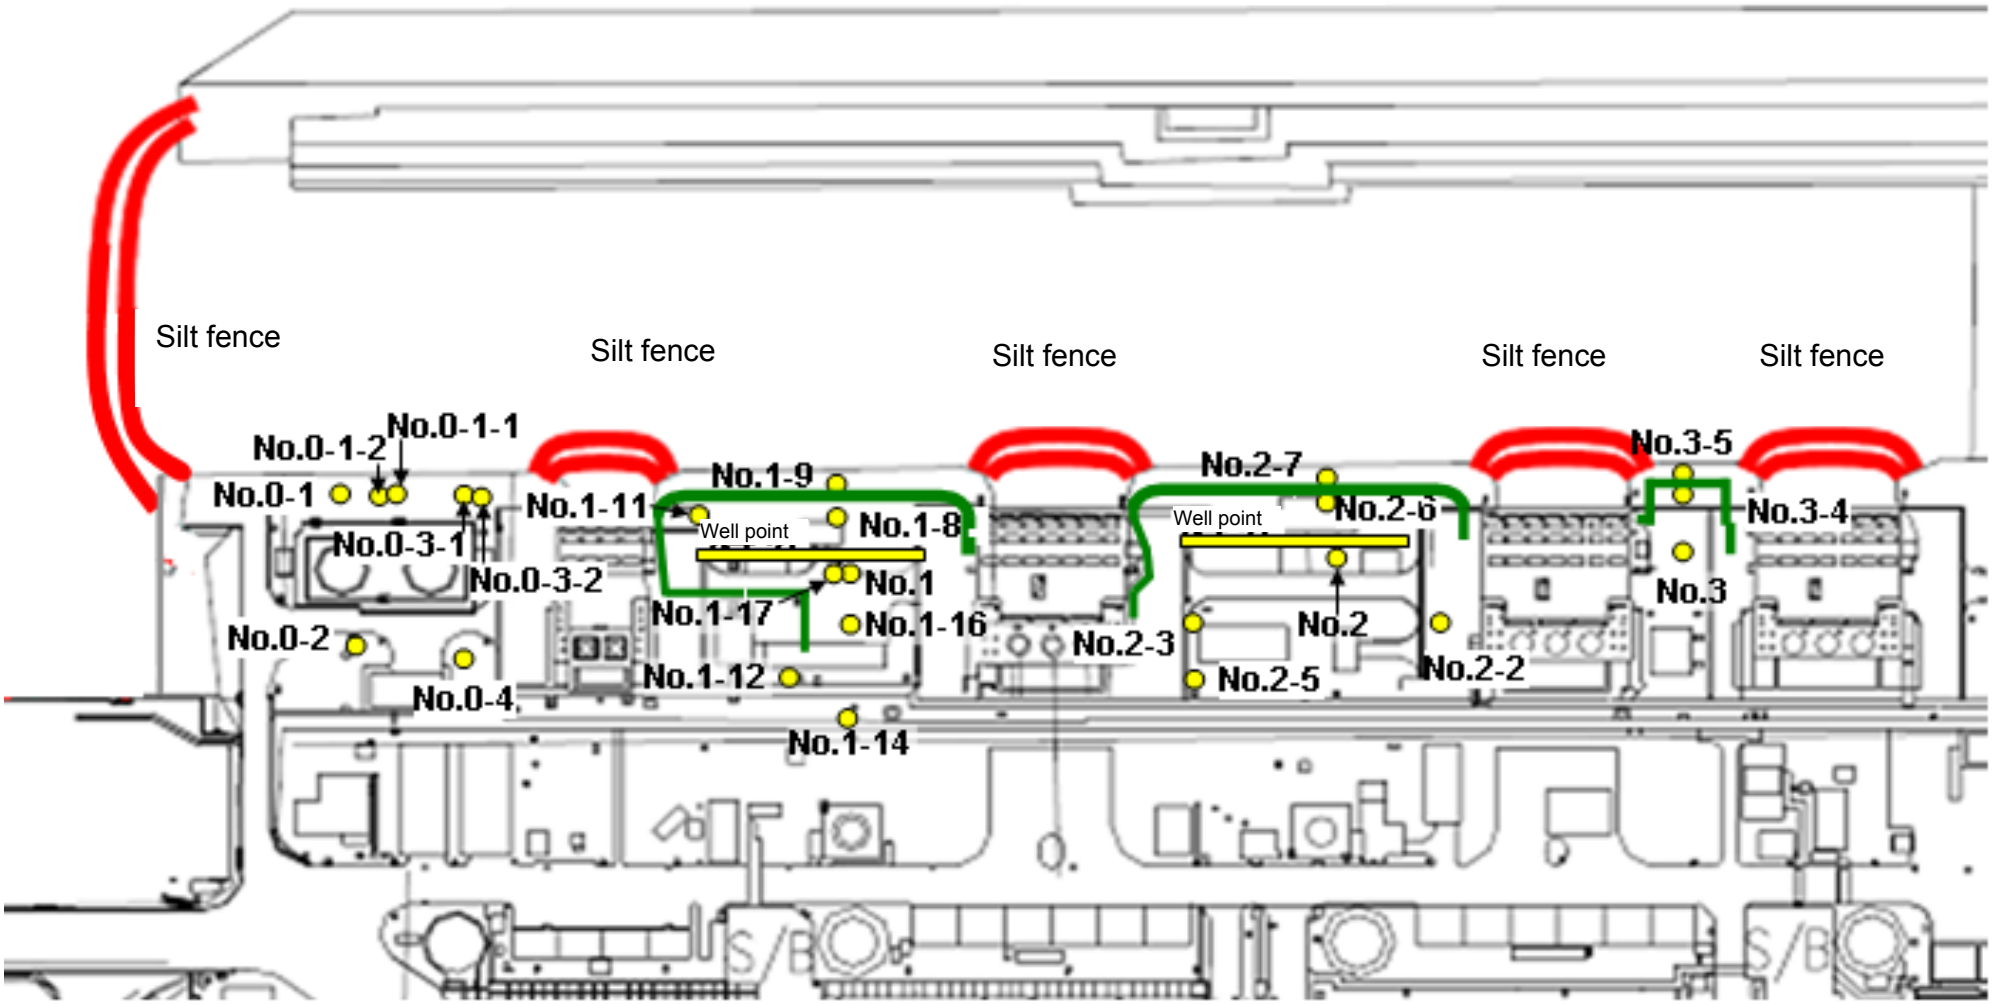
○ Sampling locations of underground water obtained at bank

—— : Location where ground improvement construction was completed, or being implemented (as of December 27)
