Main decommissioning work and steps

Fuel removal from the spent fuel pool was completed in December 2014 at Unit 4 and started from April 15, 2019 at Unit 3. Dust concentration in the surrounding environment is being monitored and work is being implemented with safety first. Work continues sequentially toward the start of fuel removal from Units 1 and 2 and debris (Note 1) retrieval from Units 1-3.

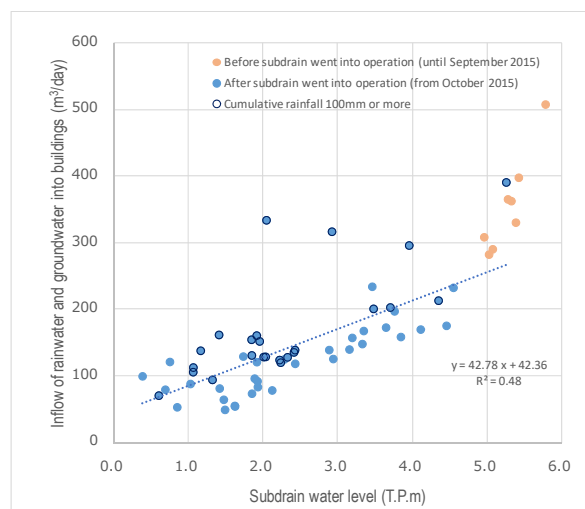
Figure 2: Correlation between inflow such as groundwater and rainwater into buildings and the water level of Units 1-4 subdrains

- Since the subdrains went into operation, the inflow to buildings tended to decline to under 150 m³/day when the subdrain water level declined below T.P. 3.0 m but increased during rainfall.
