Main decommissioning work and steps

Summary of TEPCO data as of June 30, 2020

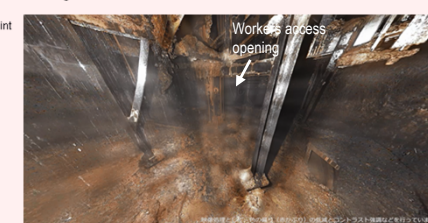
Capturing the location of fuel debris inside the reactor by measurement using muons

Period	Evaluation results
Mar – Jul 2016	Confirmed the existence of high-density materials, which was considered as fuel debris, at the bottom of RPV, and in the lower part and the outer periphery of the reactor core. It was assumed that a large part of fuel debris existed at the bottom of RPV.
