Main decommissioning work and steps

Fuel removal from the spent fuel pool was completed in December 2014 at Unit 4 and started from April 15, 2019 at Unit 3. Dust concentration in the surrounding environment is being monitored and work is being implemented with safety first. Work continues sequentially toward the start of fuel removal from Units 1 and 2 and debris (Note 1) retrieval from Units 1-3.

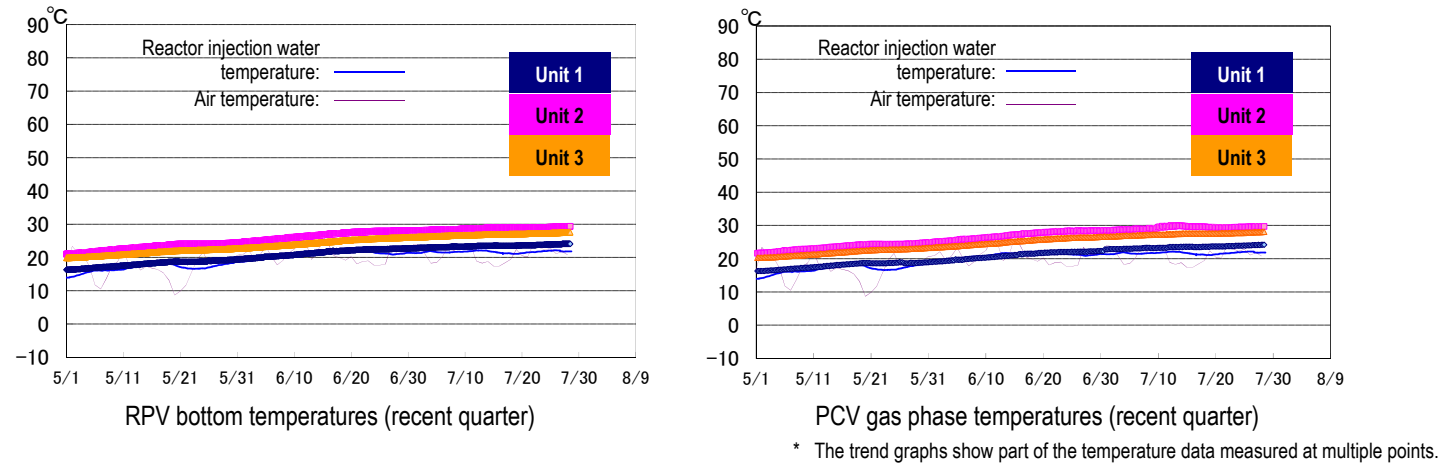
1. Temperatures inside the reactors

Through continuous reactor cooling by water injection, the temperatures of the Reactor Pressure Vessel (RPV) bottom and the Primary Containment Vessel (PCV) gas phase were maintained within the range of approx. 20 to 30°C for the past month, though it varied depending on the unit and location of the thermometer.

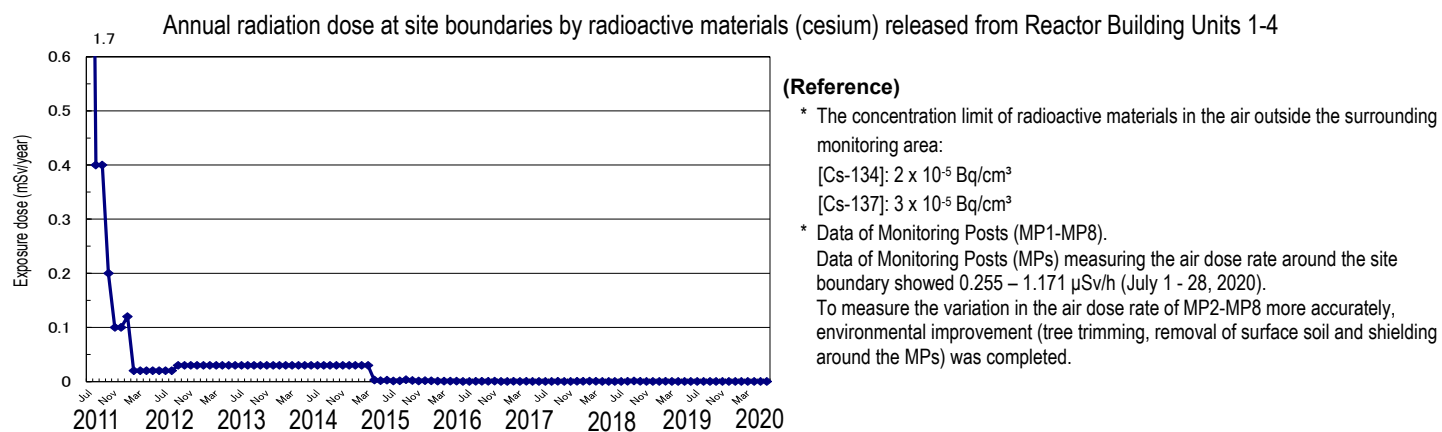
2. Release of radioactive materials from the Reactor Buildings

As of June 2020, the concentration of the radioactive materials newly released from Reactor Building Units 1-4 into the air and measured at the site boundary was evaluated at approx. 2.1×10^{-12} Bq/cm³ and 2.3×10^{-12} Bq/cm³ for Cs-134 and Cs-137 respectively, while the radiation exposure dose due to the release of radioactive materials there was less than 0.00005 mSv/year.

Note 1: Different formulas and coefficients were used to evaluate the radiation dose in the facility operation plan and monthly report. The evaluation methods were integrated in September 2012. As the fuel removal from the spent fuel pool (SFP) commenced for Unit 4, the radiation exposure dose from Unit 4 was added to the items subject to evaluation since November 2013. The evaluation has been changed to a method considering the values of continuous dust monitors since FY2015, with data to be evaluated monthly and announced the following month.

Note 2: Radiation dose was calculated using the evaluation values of release amount from Units 1-4 and Units 5 and 6. The radiation dose of Unit 5 and 6 was evaluated based on expected release amount during operation until September 2019 but the evaluation method was reviewed and changed to calculate based on the actual measurement results of Units 5 and 6 from October.

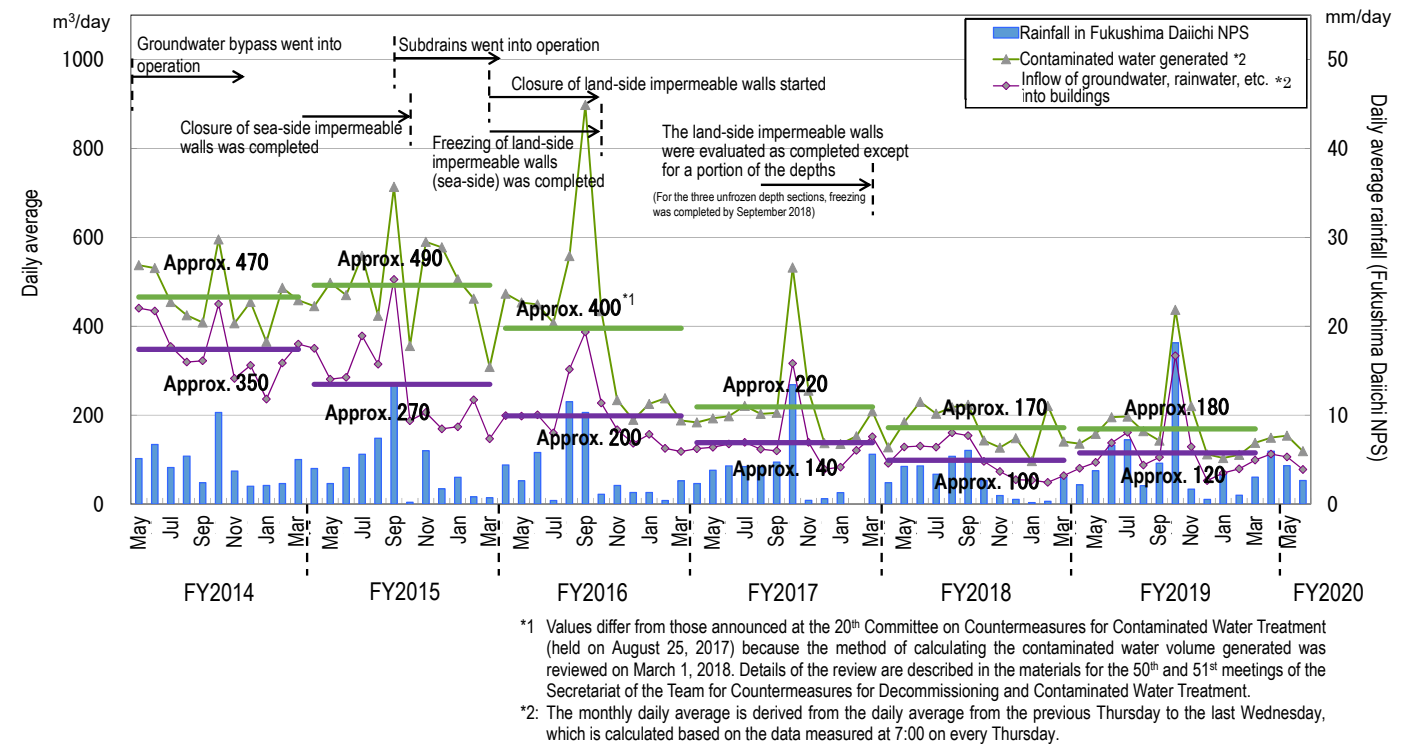
Figure 1: Changes in contaminated water generated and inflow of groundwater, rainwater, into buildings

- Multi-layered measures, including pumping up by subdrains and land-side impermeable walls, which were implemented to control the continued generation of contaminated water, suppressed the groundwater inflow into buildings.
- After "redirecting" measures (groundwater bypass, subdrains, land-side impermeable walls and others) were steadily implemented, the generation amount reduced from approx. 470 m³/day (the FY2014 average) when the measures were first launched to approx. 180 m³/day (the FY2019 average).
- Measures will continue to further reduce the volume of contaminated water generated.

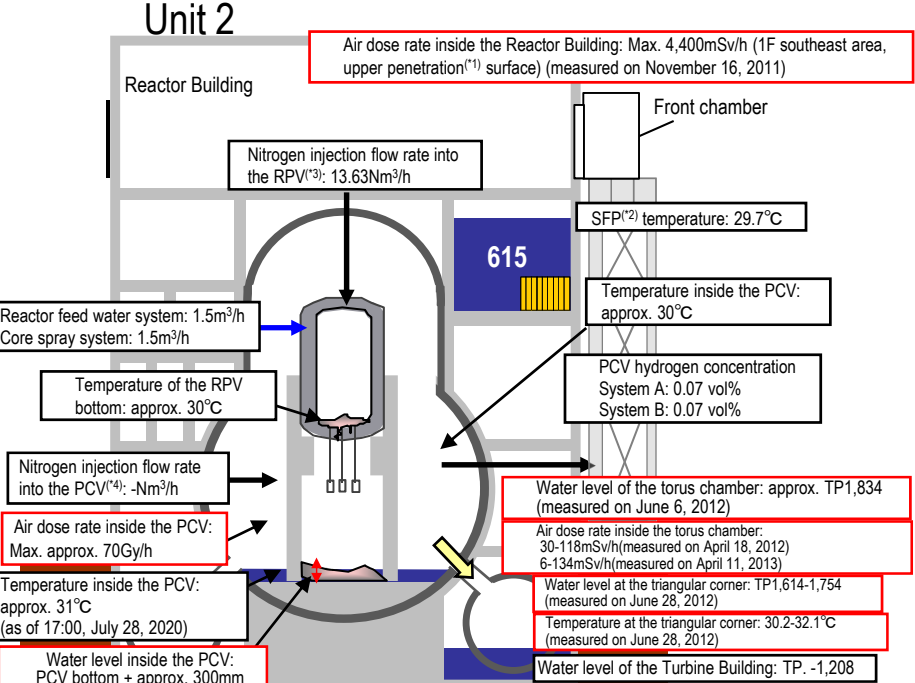
- ### Investigative results on torus chamber walls
- July 2014, the torus chamber walls were investigated (on the north and east-side walls) using equipment specially developed for that purpose (a swimming robot and a floor traveling robot).
 - At the east-side wall pipe penetrations (five points), "the status" and "existence of flow" were checked.
 - A demonstration using the above two types of underwater wall investigative equipment showed how the equipment could check the status of penetration.
 - Regarding Penetrations 1 - 5, the results of checking the sprayed tracer ⁽⁵⁾ by camera showed no flow around the penetrations. (investigation by the swimming robot)
 - Regarding Penetration 3, a sonar check showed no flow around the penetrations. (investigation by the floor traveling robot)
-

- Image of the torus chamber east-side cross-sectional investigation
