Main decommissioning work and steps

Fuel removal from the spent fuel pool was completed in December 2014 at Unit 4 and started from April 15, 2019 at Unit 3. Dust concentration in the surrounding environment is being monitored and work is being implemented with safety first. Work continues sequentially toward the start of fuel removal from Units 1 and 2 and debris (Note 1) retrieval from Units 1-3.

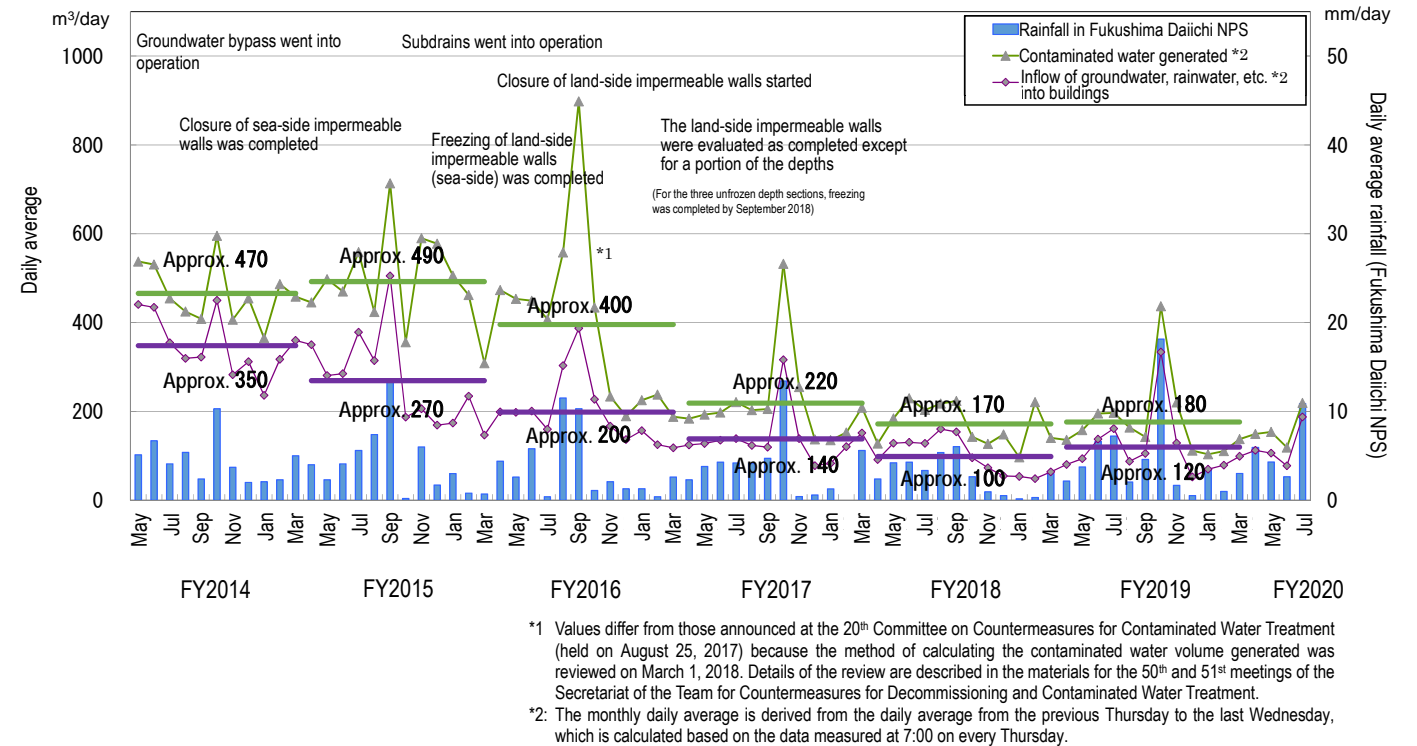
Figure 1: Changes in contaminated water generated and inflow of groundwater, rainwater, into buildings

- Multi-layered measures, including pumping up by subdrains and land-side impermeable walls, which were implemented to control the continued generation of contaminated water, suppressed the groundwater inflow into buildings.
- After "redirecting" measures (groundwater bypass, subdrains, land-side impermeable walls and others) were steadily implemented, the amount generated declined from approx. 470 m³/day (the FY2014 average) when the measures were first launched to approx. 180 m³/day (the FY2019 average).
- Measures will continue to further reduce the volume of contaminated water generated.

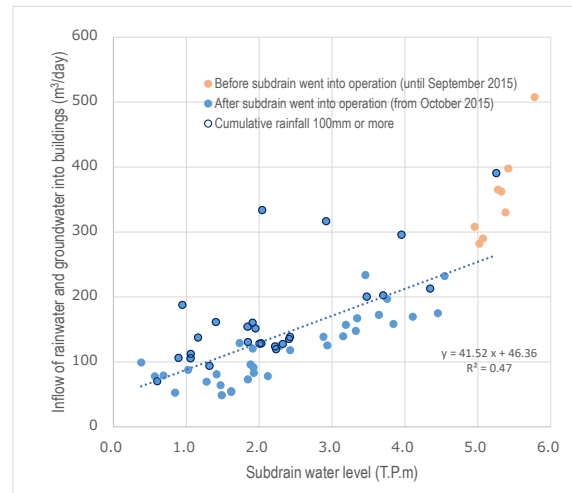
Figure 2: Correlation between inflow such as groundwater and rainwater into buildings and the water level of Units 1-4 subdrains

- To maintain the groundwater level, work to install additional subdrain pits and recover those existing is underway. The additional pits are scheduled to start operation sequentially, from pits for which work is completed (12 of 14 new subdrain pits went into operation). To recover existing pits, work for all three pits scheduled was completed and all went into operation from December 26, 2018. Work to recover another pit started from November 2019 (No. 49 pit).
- To eliminate the need to suspend water pumping while cleaning the subdrain transfer pipe, the pipe will be duplicated. Installation of the pipe and ancillary facilities was completed.
- Since the subdrains went into operation, the inflow to buildings tended to decline to under 150 m³/day when the subdrain water level declined below T.P. 3.0 m but increased during rainfall.

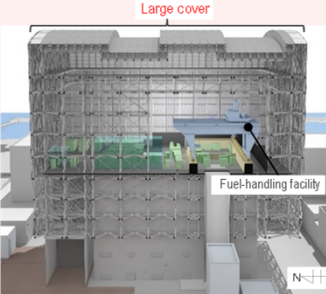
Rubble removal (image)

<Reference> Progress to date
Rubble removal on the north side of the operating floor started from January 2018 and has been implemented sequentially. In July and August 2019, the well plug, which was misaligned from its normal position, was investigated and in August and September, the conditions of the overhead crane were checked. Based on the results of these investigations, as the removal requires more careful work taking dust scattering into consideration, two methods were examined: installing a cover after rubble removal and initially installing a large cover over the Reactor Building and then removing rubble inside the cover.

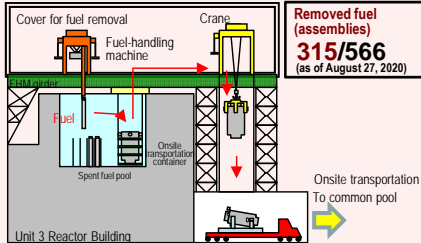
Installation of dome roof (February 21, 2019)

Overview of the fuel-handling facility inside the cover
