## Main decommissioning work and steps

Fuel removal from the spent fuel pool was completed in December 2014 at Unit 4 and started from April 15, 2019 at Unit 3. Dust concentration in the surrounding environment is being monitored and work is being implemented with safety first. Work continues sequentially toward the start of fuel removal from Units 1 and 2 and debris (Note 1) retrieval from Units 1-3.

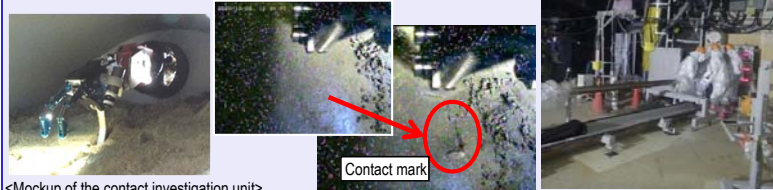
As a preparatory stage for the PCV inside investigation and the trial retrieval, a test to contact deposits in the penetration (X-6 penetration) was conducted on October 28.

It was confirmed that the shape of deposits had changed and no deposit was fixed in the penetration. Based on the information of deposit distribution to be obtained by the planned 3D scan investigation on October 30 and using the information collected in this investigation, procedures to remove deposits in the penetration will be examined.

<Mockup of the contact investigation unit>

<Deposit before and after contact>

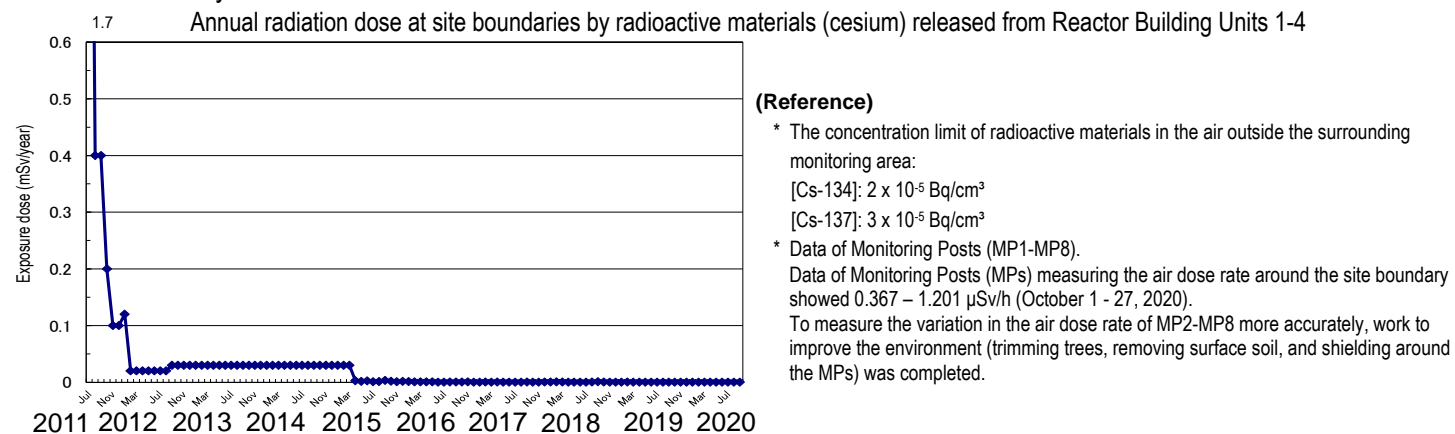
As of September 2020, the concentration of the radioactive materials newly released from Reactor Building Units 1-4 into the air and measured at the site boundary was evaluated at approx.  $2.8 \times 10^{-12}$  Bq/cm<sup>3</sup> and  $4.3 \times 10^{-12}$  Bq/cm<sup>3</sup> for Cs-134 and Cs-137 respectively, while the radiation exposure dose due to the release of radioactive materials there was less than 0.00007 mSv/year.

Note 1: Different formulas and coefficients were used to evaluate the radiation dose in the facility operation plan and monthly report. The evaluation methods were integrated in September 2012. As the fuel removal from the spent fuel pool (SFP) commenced for Unit 4, the radiation exposure dose from Unit 4 was added to the items subject to evaluation since November 2013. The evaluation has been changed to a method considering the values of continuous dust monitors since FY2015, with data to be evaluated monthly and announced the following month.

Note 2: Radiation dose was calculated using the evaluation values of release amount from Units 1-4 and Units 5 and 6. The radiation dose of Unit 5 and 6 was evaluated based on expected release amount during operation until September 2019 but the evaluation method was reviewed and changed to calculate based on the actual measurement results of Units 5 and 6 from October.

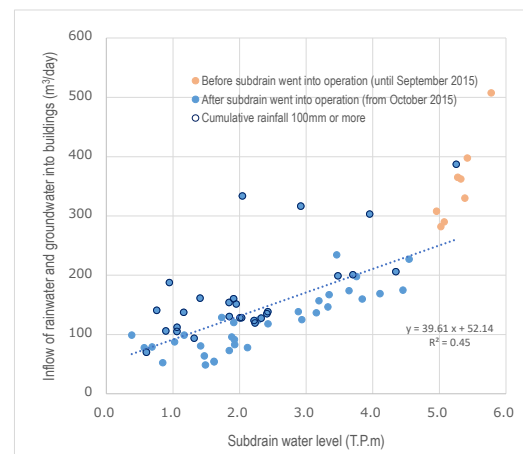
Figure 2: Correlation between inflow such as groundwater and rainwater into buildings and the water level of Units 1-4 subdrains

- To maintain the groundwater level, work to install additional subdrain pits and recover those existing is underway. The additional pits are scheduled to start operation sequentially, from pits for which work is completed (12 of 14 new subdrain pits went into operation). To recover existing pits, work for all three pits scheduled was completed and all went into operation from December 26, 2018. Work to recover another pit (No. 49) started from November 2019 and it went into operation from October 9, 2020.
- To eliminate the need to suspend water pumping while cleaning the subdrain transfer pipe, the pipe will be duplicated. Installation of the pipe and ancillary facilities was completed.
- Since the subdrains went into operation, the inflow to buildings tended to decline to under 150 m<sup>3</sup>/day when the subdrain water level declined below T.P. 3.0 m but increased during rainfall.

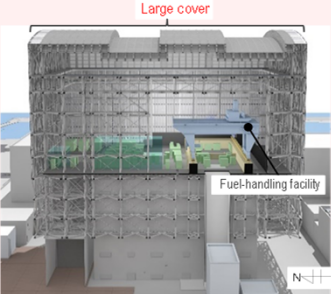
Rubble removal (image)

Toward fuel removal from the Unit 1 spent fuel pool, investigations have been implemented to ascertain the conditions of the fallen roof on the south side and the contamination of the well plug. Based on the results of these investigations, "the method to initially install a large cover over the Reactor Building and then remove rubble inside the cover" was selected to ensure a safer and more secure removal. Work continues to complete installation of a large cover by around FY2023 and start fuel removal from FY2027 to FY2028.

<Reference> Progress to date  
Rubble removal on the north side of the operating floor started from January 2018 and has been implemented sequentially. In July and August 2019, the well plug, which was misaligned from its normal position, was investigated and in August and September, the conditions of the overhead crane were checked. Based on the results of these investigations, as the removal requires more careful work taking dust scattering into consideration, two methods were examined: installing a cover after rubble removal and initially installing a large cover over the Reactor Building and then removing rubble inside the cover.

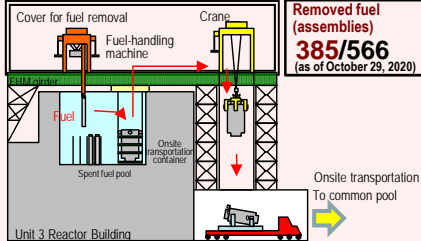
Installation of dome roof (February 21, 2019)

Overview of the fuel-handling facility inside the cover
