Main decommissioning work and steps

I. Confirmation of the reactor conditions

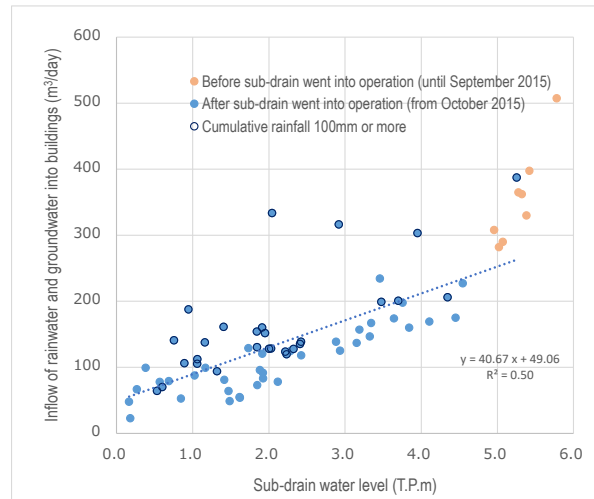
Figure 2: Correlation between inflow such as groundwater and rainwater into buildings and the water level of Units 1-4 sub-drains

- To maintain the groundwater level, work to install additional sub-drain pits and recover those existing is underway. The additional pits are scheduled to start operation sequentially, from pits for which work is completed (12 of 14 new sub-drain pits went into operation). To recover existing pits, work for all three pits scheduled was completed, all of which went into operation from December 26, 2018. Work to recover another pit (No. 49) started from November 2019 and it went into operation from October 9, 2020.
- To eliminate the need to suspend water pumping while cleaning the sub-drain transfer pipe, the pipe will be duplicated. Installation of the pipe and ancillary facilities was completed.
- Since the sub-drains went into operation, the inflow to buildings tended to decline to under 150 m³/day when the sub-drain water level declined below T.P. 3.0 m but increased during rainfall.

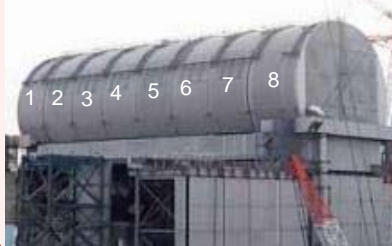
Installation of dome roof (February 21, 2019)

Prior to the installation of a cover for fuel removal, removal of large rubble from the spent fuel pool was completed in November 2015. To ensure safe and steady fuel removal, training of remote control was conducted at the factory using the actual fuel-handling machine which will be installed on site (February – December 2015). Measures to reduce dose on the Reactor Building top floor (decontamination, shields) were completed in December 2016. Installation of a cover for fuel removal and a fuel-handling machine is underway from January 2017. Installation of the fuel removal cover was completed on February 23, 2018.
