Main decommissioning work and steps

Fuel removal from the spent fuel pool was completed in December 2014 at Unit 4 and started from April 15, 2019 at Unit 3. Dust concentration in the surrounding environment is being monitored and work is being implemented with safety first. Work continues sequentially toward the start of fuel removal from Units 1 and 2 and debris (Note 1) retrieval from Units 1-3.

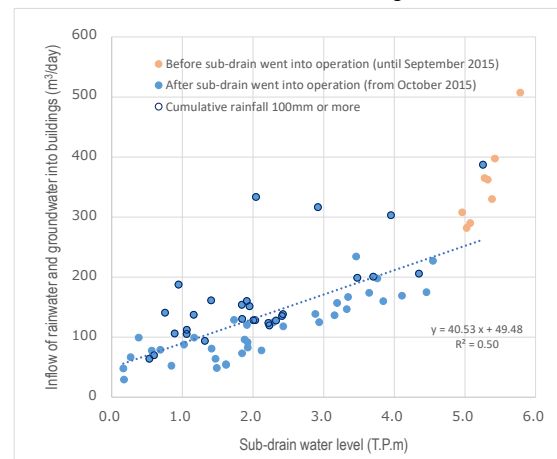
Figure 2: Correlation between inflow such as groundwater and rainwater into buildings and the water level of Units 1-4 sub-drains

- To maintain the groundwater level, work to install additional sub-drain pits and recover those existing is underway. The additional pits are scheduled to start operation sequentially, from pits for which work is completed (12 of 14 new sub-drain pits went into operation). To recover existing pits, work for all three pits scheduled was completed, all of which went into operation from December 26, 2018. Work to recover another pit (No. 49) started from November 2019 and it went into operation from October 9, 2020.
- To eliminate the need to suspend water pumping while cleaning the sub-drain transfer pipe, the pipe will be duplicated. Installation of the pipe and ancillary facilities was completed.
- Since the sub-drains went into operation, the inflow to buildings tended to decline to under 150 m³/day when the sub-drain water level declined below T.P. 3.0 m but increased during rainfall.
