Main decommissioning work and steps

Fuel removal from the spent fuel pool was completed in December 2014 at Unit 4 and on February 28, 2021 at Unit 3.
 Work continues sequentially toward the start of fuel removal from Units 1 and 2 and debris (Note 1) retrieval from Units 1-3.

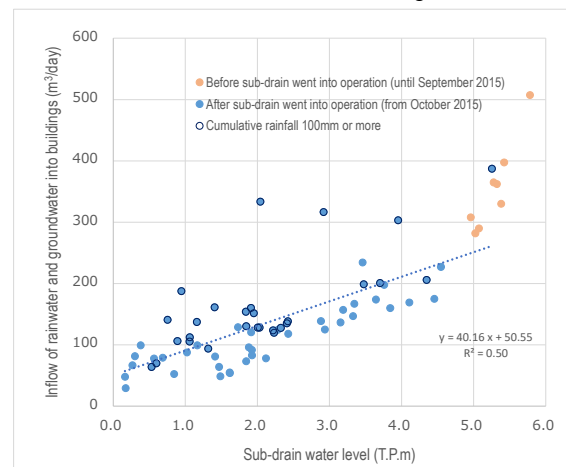
Figure 2: Correlation between inflow such as groundwater and rainwater into buildings and the water level of Units 1-4 sub-drains

- To maintain the groundwater level, work to install additional sub-drain pits and recover those existing is underway. The additional pits are scheduled to start operation sequentially, from pits for which work is completed (12 of 14 new sub-drain pits went into operation). To recover existing pits, work for all three pits scheduled was completed, all of which went into operation from December 26, 2018. Work to recover another pit (No. 49) started from November 2019 and it went into operation from October 9, 2020.
- To eliminate the need to suspend water pumping while cleaning the sub-drain transfer pipe, the pipe will be duplicated. Installation of the pipe and ancillary facilities was completed.
- Since the sub-drains went into operation, the inflow to buildings tended to decline to under 150 m³/day when the sub-drain water level declined below T.P. 3.0 m but increased during rainfall.
