Main decommissioning work and steps

Progress status

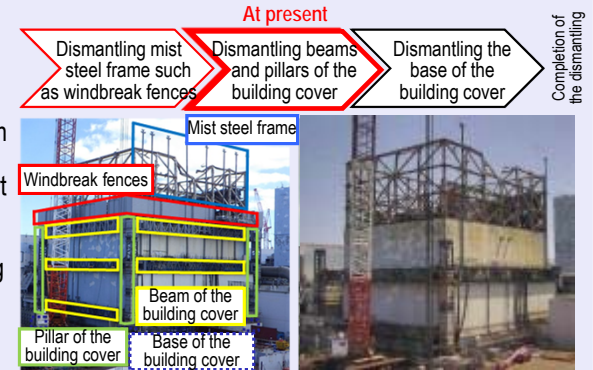
<Full view of the Unit 1 Reactor Building>
 (Left: as of March 2020, Right: as of April 22, 2021)

Dismantling of the Unit 1 Reactor Building cover steadily continues

Before installing a large cover over the Reactor Building, dismantling of the interfering building cover (remaining part) started from December 19, 2020 and will be completed in the first part of FY2021.

At present, beams and pillars (upper part) are being dismantled.

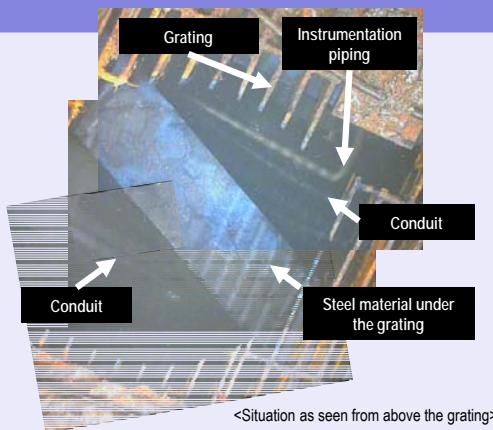
By suspending water injection into the Unit 3 reactor, the leaking condition from PCV was inspected

A test suspending water injection into the Unit 3 reactor was conducted from April 9 and confirmed the tendency for the water-level drop in the Primary Containment Vessel (PCV) to decline near the lower end of the main steam piping bellows.

Based on these investigations, the main leakage from the PCV is considered to be near the lower end of those bellows.

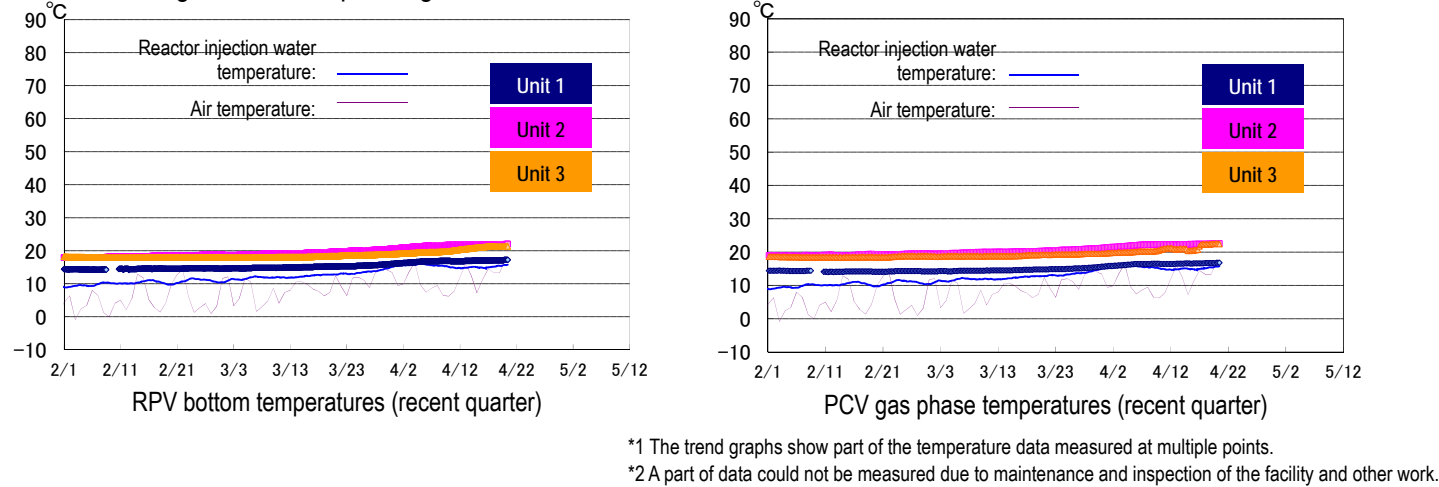
Through continuous reactor cooling by water injection, the temperatures of the Reactor Pressure Vessel (RPV) bottom and the Primary Containment Vessel (PCV) gas phase were maintained within the range of approx. 15 to 25°C for the past month, though it varied depending on the unit and location of the thermometer.

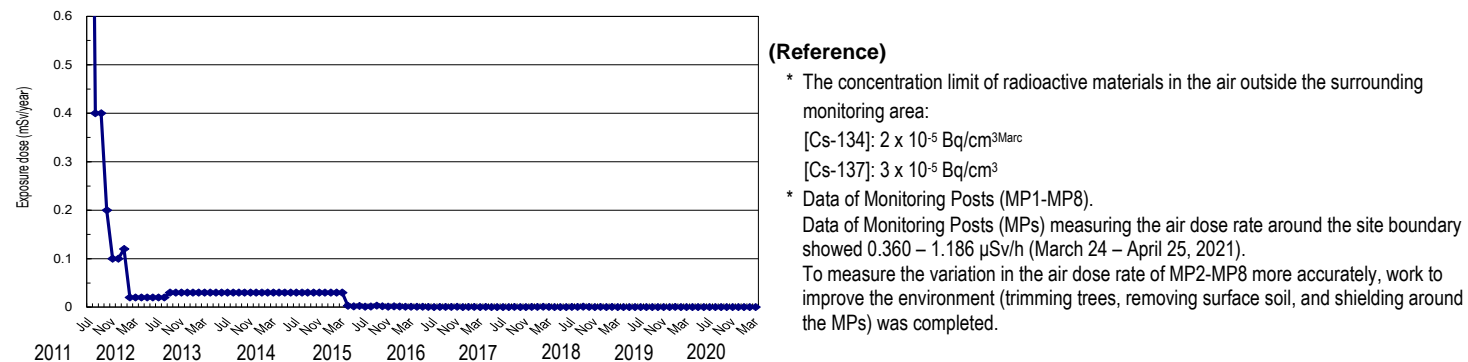
Annual radiation dose at site boundaries by radioactive materials (cesium) released from Reactor Building Units 1-4

As of March 2021, the concentration of radioactive materials newly released from Reactor Building Units 1-4 into the air and measured at the site boundary was evaluated at approx. 2.3×10^{-12} Bq/cm³ and 3.2×10^{-12} Bq/cm³ for Cs-134 and -137 respectively, while the radiation exposure dose due to the release of radioactive materials there was less than 0.00005 mSv/year.

Note 1: Different formulas and coefficients were used to evaluate the radiation dose in the facility operation plan and monthly report. The evaluation methods were integrated in September 2012. As the fuel removal from the spent fuel pool (SFP) commenced for Unit 4, the radiation exposure dose from Unit 4 was added to the items subject to evaluation since November 2013. The evaluation has been changed to a method considering the values of continuous dust monitors since FY2015, with data to be evaluated monthly and announced the following month.

Note 2: Radiation dose was calculated using the evaluation values of release amount from Units 1-4 and Units 5 and 6. The radiation dose of Unit 5 and 6 was evaluated based on expected release amount during operation until September 2019 but the evaluation method was reviewed and changed to calculate based on the actual measurement results of Units 5 and 6 from October.

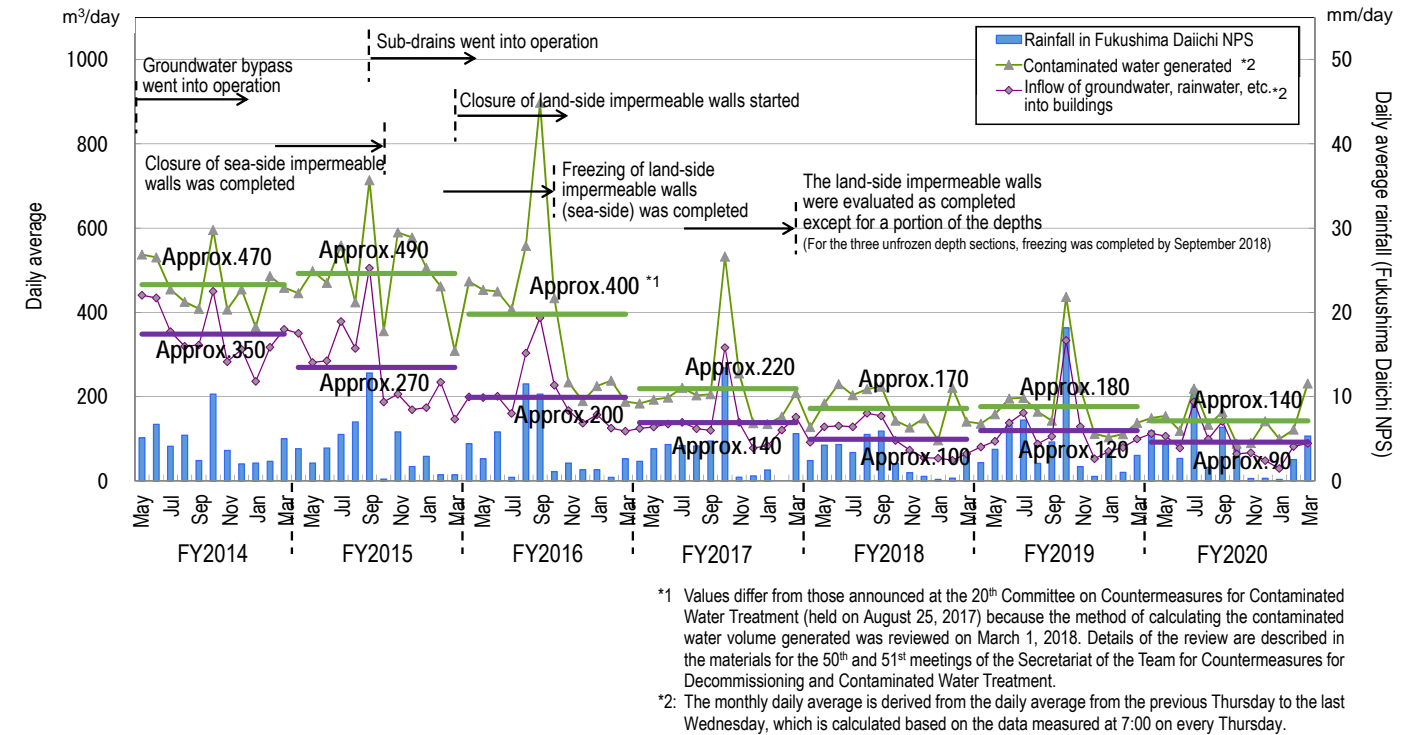
Figure 1: Changes in contaminated water generated and inflow of groundwater and rainwater into buildings

- Multi-layered measures, including pumping up by sub-drains and land-side impermeable walls, which were implemented to control the continued generation of contaminated water, suppressed the groundwater inflow into buildings.
- After implementing "redirecting" measures (groundwater bypass, sub-drains, land-side impermeable walls and others) and rainwater prevention measures, including repairing damaged parts of building roofs, the amount of contaminated water generated within 2020 declined to approx. 140 m³/day.
- Measures will continue to further reduce the amount of contaminated water generated.

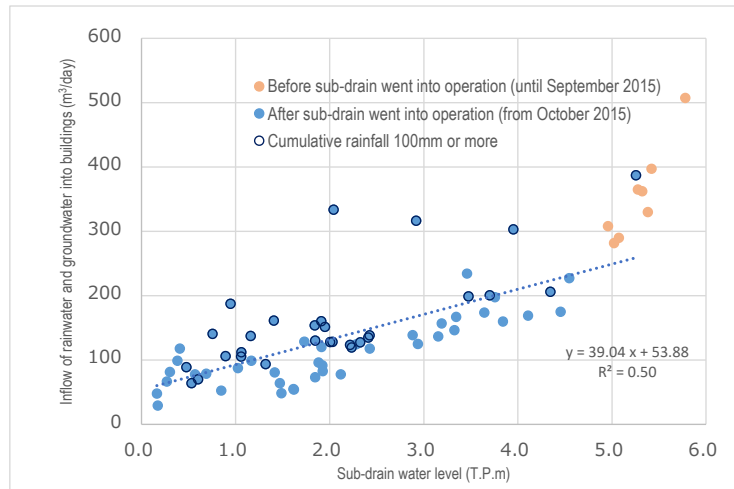
Figure 2: Correlation between inflow such as groundwater and rainwater into buildings and the water level of Units 1-4 sub-drains

- To maintain the groundwater level, work to install additional sub-drain pits and recover those existing is underway. The additional pits are scheduled to start operation sequentially, from pits for which work is completed (12 of 14 new sub-drain pits went into operation). To recover existing pits, work for all three pits scheduled was completed, all of which went into operation from December 26, 2018. Work to recover another pit (No. 49) started from November 2019 and it went into operation from October 9, 2020.
- To eliminate the need to suspend water pumping while cleaning the sub-drain transfer pipe, the pipe will be duplicated. Installation of the pipe and ancillary facilities was completed.
- Since the sub-drains went into operation, the inflow to buildings tended to decline to under 150 m³/day when the sub-drain water level declined below T.P. 3.0 m but increased during rainfall.

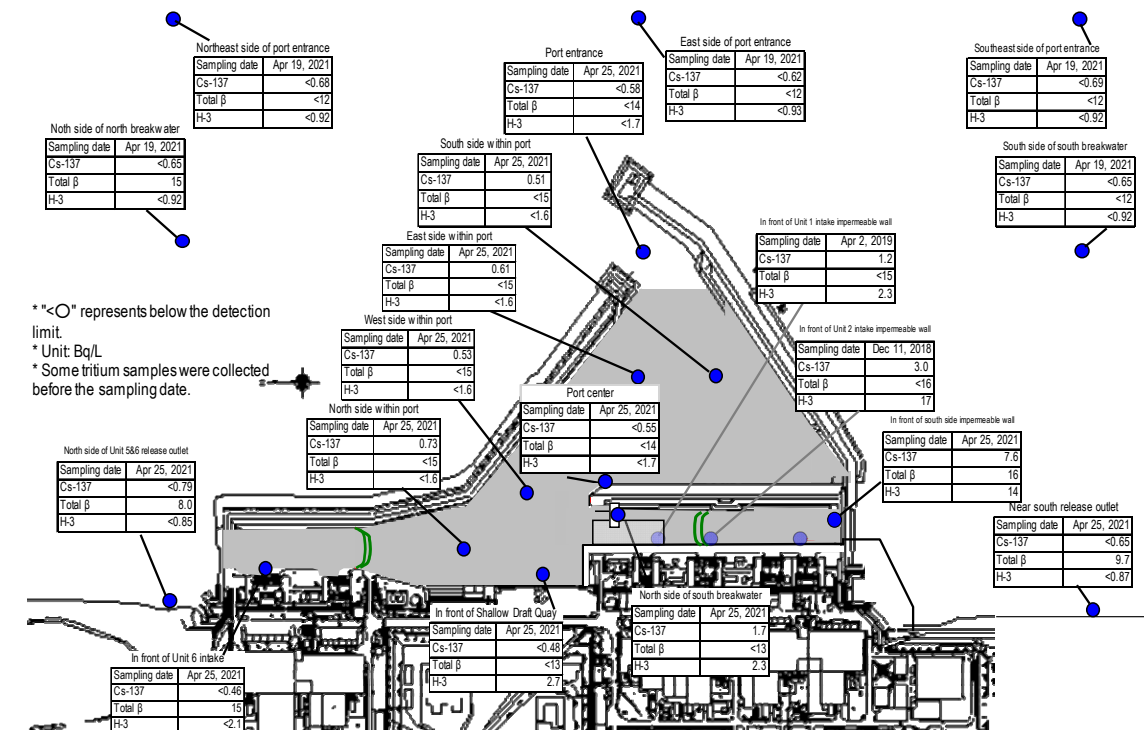
Figure 6: Seawater concentration around the port

- The concentration of radioactive materials in drainage channels has remained constant, despite increasing during rainfall.
 - In the open channel area of seawater intake for Units 1 to 4, the concentration of radionuclides in seawater has remained below the legal discharge limit, despite increases in Cs-137 and Sr-90 noted during rainfall. They have also been declining following the completed installation and the connection of steel pipe sheet piles for the sea-side impermeable walls. The concentration of Cs-137 has remained slightly higher in front of the south side impermeable walls and slightly lower on the north side of the east breakwater since March 20, 2019, when the silt fence was transferred to the center of the open channel due to mega float-related construction.

- In the port area, the concentration of radionuclides in seawater has remained below the legal discharge limit, despite increases in Cs-137 and Sr-90 observed during rainfall. They have remained below the level of those in the Units 1-4 intake open channel area and been declining following the completed installation and connection of steel pipe sheet piles for the sea-side impermeable walls.

- In the area outside the port, regarding the concentration of radioactive materials in seawater, those of Cs-137 and Sr-90 declined and remained low after steel pipe sheet piles for the sea-side impermeable walls were installed and connected.

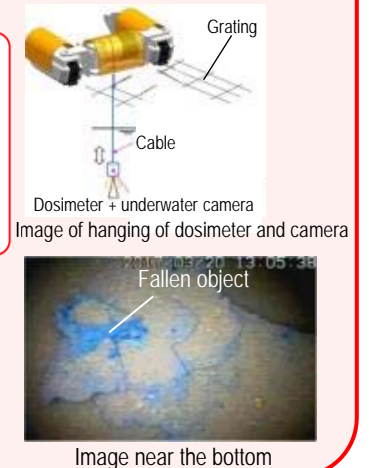
[Investigative outline]

- In April 2015, a device, which entered the inside of the PCV through a narrow access opening (bore: ϕ 100 mm), collected information such as images and airborne dose inside the PCV 1st floor.
- In March 2017, the investigation using a self-propelled investigation device, conducted to inspect the spreading of debris to the basement floor outside the pedestal, took images of the PCV bottom status for the first time. The status inside the PCV will continue to be examined based on the collected image and dose data.

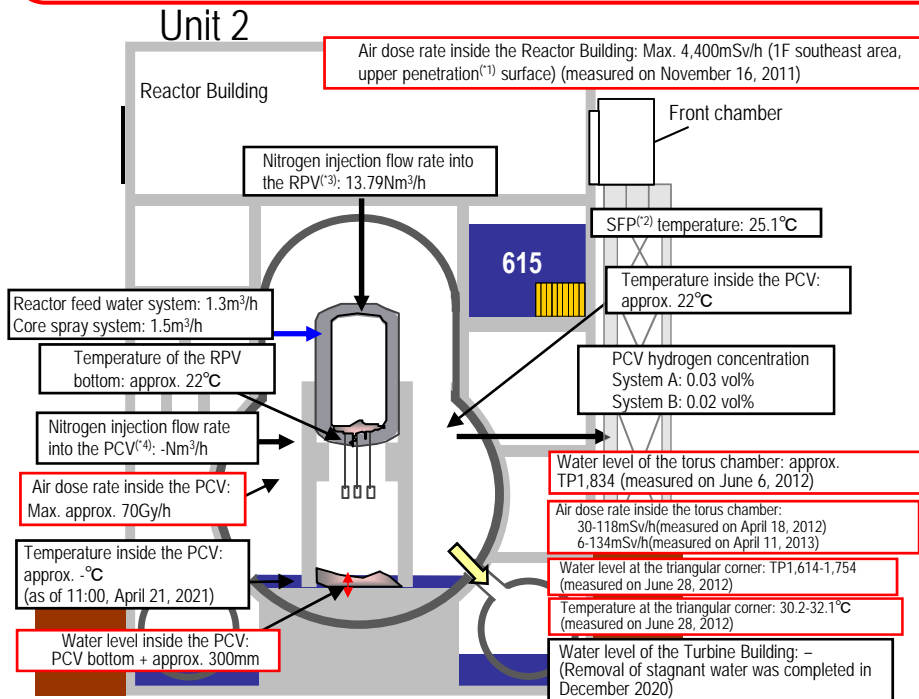
Investigative results on torus chamber walls

- July 2014, the torus chamber walls were investigated (on the north and east-side walls) using equipment specially developed for that purpose (a swimming robot and a floor traveling robot).
- At the east-side wall pipe penetrations (five points), "the status" and "existence of flow" were checked.
- A demonstration using the above two types of underwater wall investigative equipment showed how the equipment could check the status of penetration.
- Regarding Penetrations [1]-[5], the results of checking the sprayed tracer ⁽⁵⁾ by camera showed no flow around the penetrations. (investigation by the swimming robot)
- Regarding Penetration 3, a sonar check showed no flow around the penetrations. (investigation by the floor traveling robot)

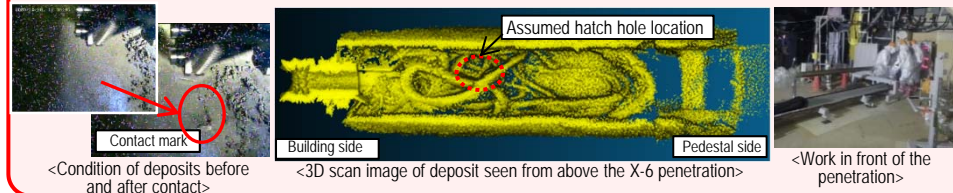
- On October 28, 2020, as a preparatory stage of the PCV internal investigation and the trial retrieval, a contact investigation into deposits inside the penetration (X-6 penetration) was conducted. In this investigation, a guide pipe incorporating an investigative unit inserted into the penetration. By the contact, it was confirmed that deposits inside the penetration did not deform and unstuck.

- On October 30, 2020, a 3D scan investigation was conducted, measuring deposits by the 3D scan sensor mounted on the top of the investigative unit. Information obtained in the investigation will be utilized in the mockup test of the equipment to remove deposits inside the X-6 penetration.

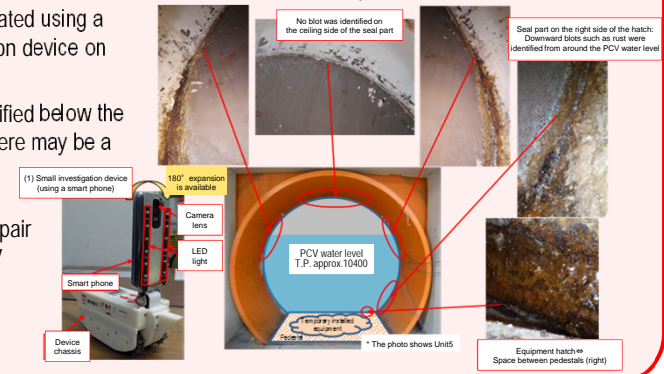
- As part of the investigation into the PCV to facilitate fuel debris retrieval, the status around the Unit 3 PCV equipment hatch was investigated using a small self-traveling investigation device on November 26, 2015.

- Given blots such as rust identified below the water level inside the PCV, there may be a leakage from the seal to the extent of bleeding. Methods to investigate and repair the parts, including other PCV penetrations with a similar structure, will be considered.

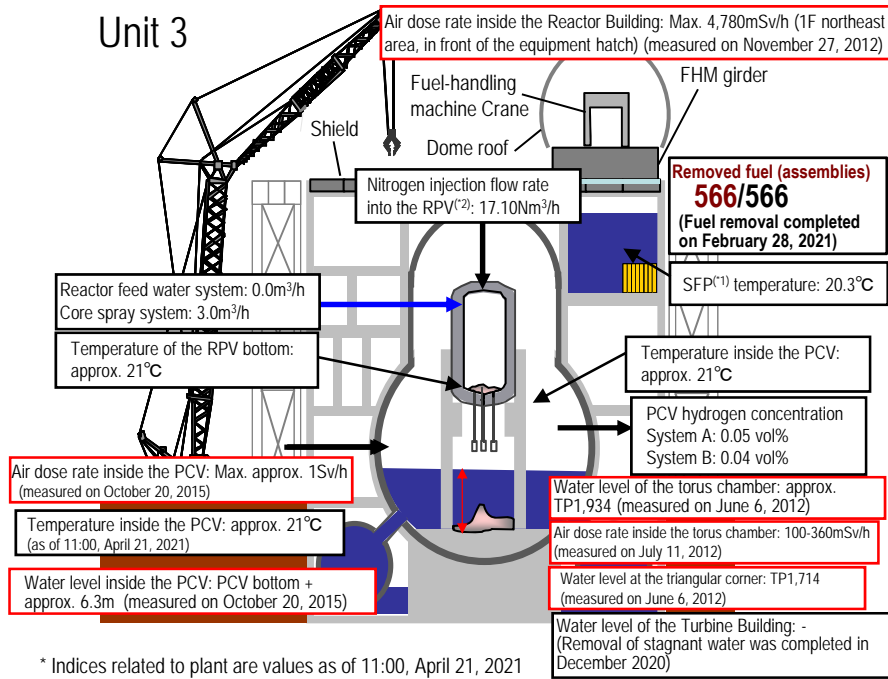
Unit 3

Investigations inside PCV	1st (Oct – Dec 2015)	- Acquiring images - Measuring air temperature and dose rate - Measuring water level and temperature - Sampling stagnant water - Installing permanent monitoring instrumentation (December 2015)
	2nd (Jul 2017)	- Acquiring images - Installing permanent monitoring instrumentation (August 2017)
Leakage points from PCV	- Main steam pipe bellows (identified in May 2014)

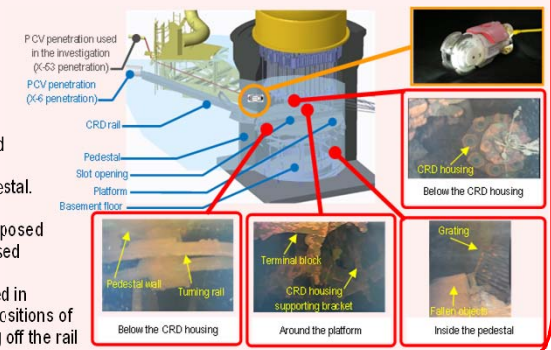
- Analysis of image data obtained in the investigation identified damage to multiple structures and the supposed core internals. Consideration about fuel removal based on the obtained information will continue.

- Videos obtained in the investigation were reproduced in 3D. Based on the reproduced images, the relative positions of the structures, such as the rotating platform slipping off the rail with a portion buried in deposits, were visually understood.

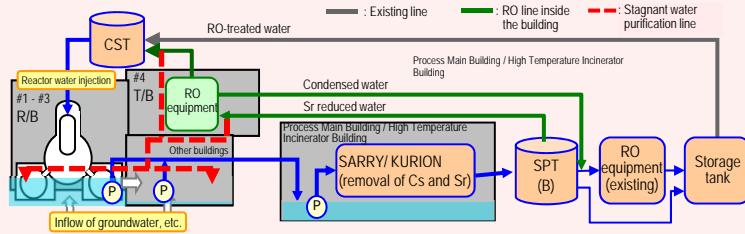
- To reduce the risk of contaminated-water leakage, the circulation loop was shortened by installing a reverse osmosis (RO) device in the Unit 4 Turbine Building within the circulation loop, comprising the transfer of contaminated water, water treatment and injection into the reactors. Operation of the installed RO device started from October 7 and 24-hour operation started from October 20. Installation of the new RO device inside the building shortened the circulation loop from approx. 3 to 0.8 km.

- For circulating purification, a new pipe (stagnant water purification line) divided from the water treatment equipment outlet line was installed to transfer water purified at the water treatment equipment to the Unit 1 Reactor Building and the Unit 2-4 Turbine Buildings.

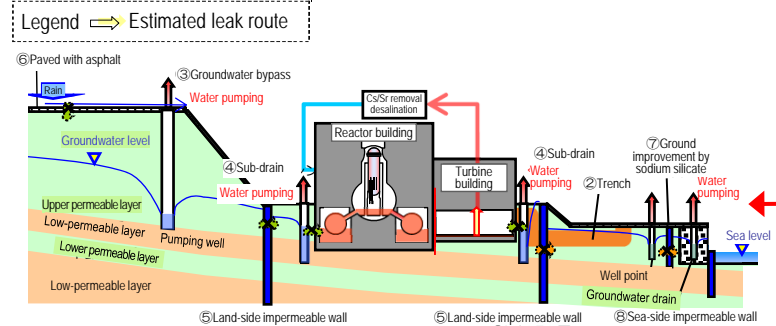
In March 2018, construction of the land-side impermeable walls was completed, except for a portion of the depth, based on a monitoring result showing that the underground temperature had declined below 0°C in almost all areas, while on the mountain side, the difference between the inside and outside increased to approx. 4-5 m. The 21st Committee on Countermeasures for Contaminated Water Treatment, held on March 7, 2018, evaluated that together with the function of sub-drains, etc., a water-level management system to stably control groundwater and isolate the buildings from it had been established and had allowed a significant reduction in the amount of contaminated water generated.

For the unfrozen depth, a supplementary method was implemented and it was confirmed that temperature of the part declined below 0°C by September 2018. From February 2019, maintenance operation started at all sections.
