# Outline of Decommissioning and Contaminated Water Management

## Main decommissioning work and steps

# Progress status

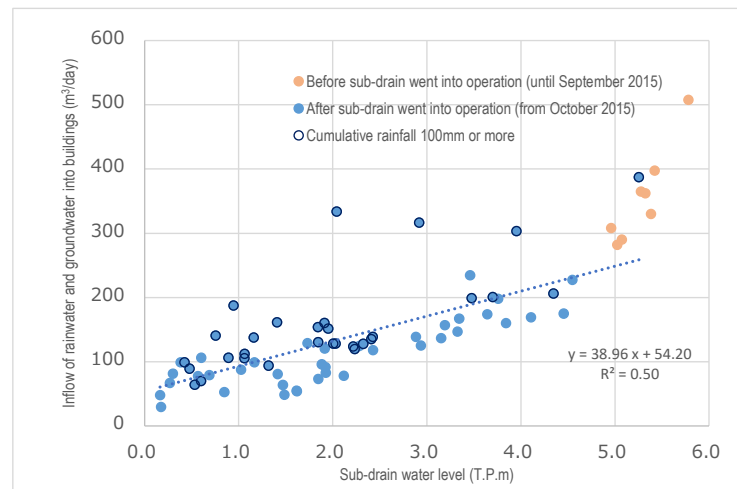
Figure 2: Correlation between inflow such as groundwater and rainwater into buildings and the water level of Units 1-4 sub-drains

- Since the sub-drains went into operation, the inflow to buildings tended to decline to under 150 m<sup>3</sup>/day when the sub-drain water level declined below T.P. 3.0 m but increased during rainfall.

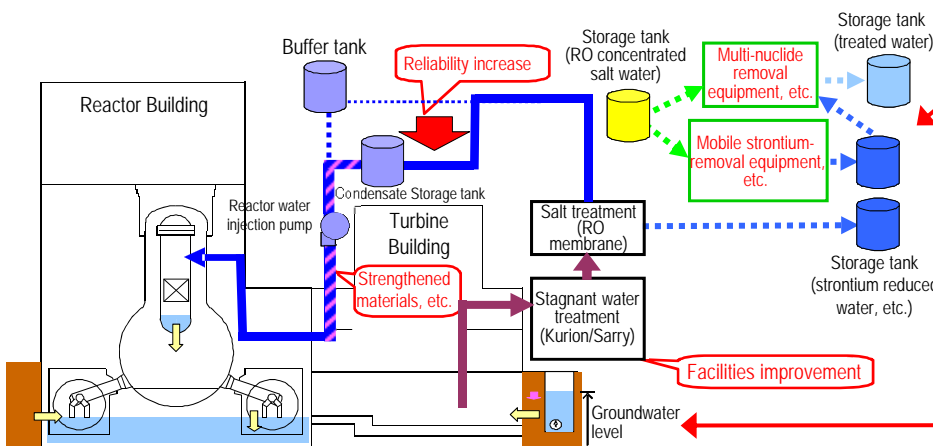
Contaminated water (RO concentrated salt water) is being treated using seven types of equipment including the multi-nuclide removal equipment (ALPS). Treatment of the RO concentrated salt water was completed on May 27, 2015, with the exception of the remaining water at the tank bottom. The remaining water will be treated sequentially toward dismantling the tanks.

The strontium reduced water from other facilities than the multi-nuclide removal equipment will be re-purified in the multi-nuclide removal equipment to further reduce risks.
