Outline of Decommissioning and Contaminated Water Management

Main decommissioning work and steps

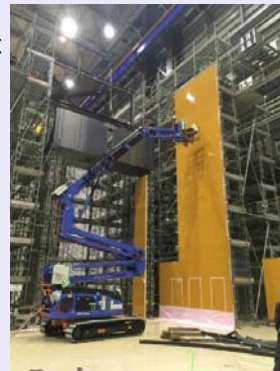
<Decontamination of mockup high-place wall>

Mockup for decontamination completed toward Unit 2 fuel removal

Based on the effect of dose reduction by decontamination and shielding, efforts to reduce the dose will continue to approach the target level of 1 mSv/h.

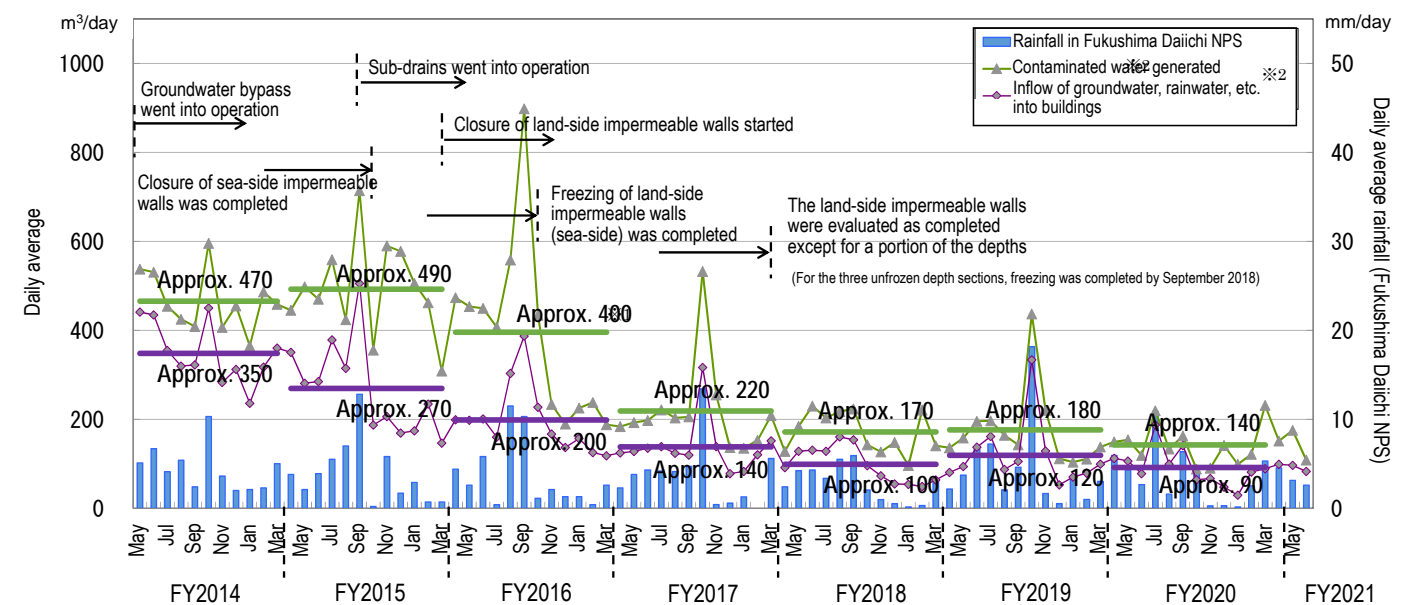
- Multi-layered measures, including pumping up by sub-drains and land-side impermeable walls, which were implemented to control the continued generation of contaminated water, suppressed the groundwater inflow into buildings.
- After implementing “redirecting” measures (groundwater bypass, sub-drains, land-side impermeable walls and others) and rainwater prevention measures, including repairing damaged portions of building roofs, the amount of contaminated water generated within FY2020 declined to approx. 140 m³/day.
- Measures will continue to further reduce the amount of contaminated water generated.

*1 Values differ from those announced at the 20th Committee on Countermeasures for Contaminated Water Treatment (held on August 25, 2017) because the method of calculating the contaminated water volume generated was reviewed on March 1, 2018. Details of the review are described in the materials for the 50th and 51st meetings of the Secretariat of the Team for Countermeasures for Decommissioning and Contaminated Water Treatment.

*2: The monthly daily average is derived from the daily average from the previous Thursday to the last Wednesday, which is calculated based on the data measured at 7:00 on every Thursday.

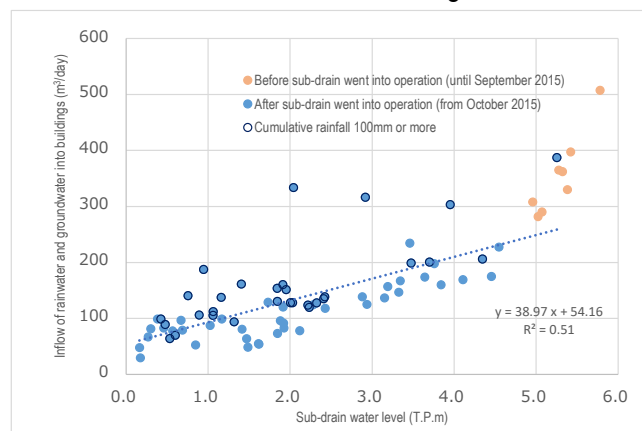
Figure 2: Correlation between inflow such as groundwater and rainwater into buildings and the water level of Units 1-4 sub-drains

- Since the sub-drains went into operation, the inflow to buildings tended to decline to under 150 m³/day when the sub-drain water level declined below T.P. 3.0 m but increased during rainfall.
