Main decommissioning work and steps

TEPCO Holdings Fukushima Daiichi Nuclear Power Station Site Layout

Appendix 2
August 26, 2021

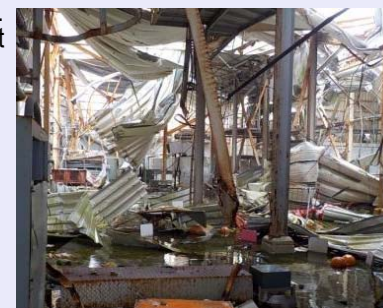
Work on rainwater prevention measures for the Unit 1/2 Radioactive Waste Treatment Building to be resumed

Rainwater prevention measures will be resumed for the Unit 1 Reactor Building and a portion of the Unit 1/2 Rw/B, for which these measures were incomplete.

Preparatory work will start from September. After completing the removal of the SGTS pipe hindrance, rubble will be removed and the drainage route will be switched.

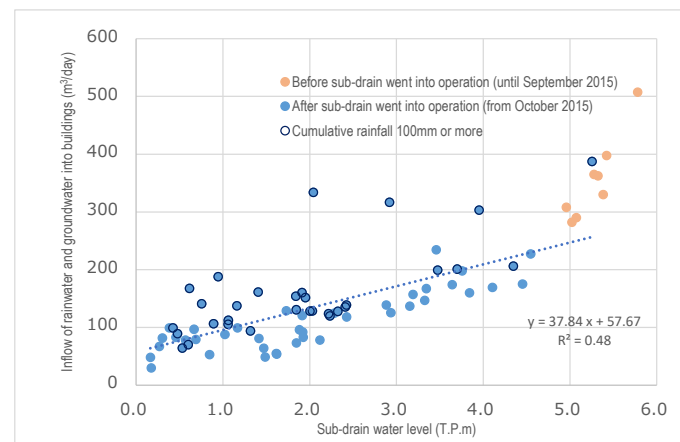
Figure 2: Correlation between inflow such as groundwater and rainwater into buildings and the water level of Units 1-4 sub-drains

- To maintain the groundwater level, work to install additional sub-drain pits and recover existing pits is underway. The additional pits are scheduled to start operation sequentially, from pits for which work is completed (12 of 14 new sub-drain pits went into operation). To recover existing pits, work for all three pits scheduled was completed, all of which went into operation from December 26, 2018. Work to recover another pit (No. 49) started from November 2019 and it went into operation from October 9, 2020.
- To eliminate the need to suspend water pumping while cleaning the sub-drain transfer pipe, the pipe will be duplicated. Installation of the pipe and ancillary facilities was completed.
- Since the sub-drains went into operation, the inflow to buildings tended to decline to under 150 m³/day when the sub-drain water level declined below T.P. 3.0 m but increased during rainfall.
