# Outline of Decommissioning and Contaminated Water Management

# Progress status

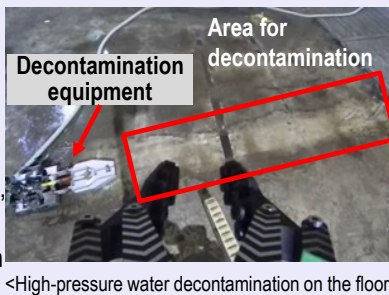
## Construction steadily progressing toward starting Unit 2 fuel removal

Toward starting Unit 2 spent fuel removal in FY2024-2026, work is underway inside and outside the building. Outside the building, with the installation of the gantry for fuel removal in the 1st half of FY2022 in mind, pre-work such as removing interferences is underway. Subsequently, ground improvement will start from late October. Inside the building, toward installing the shielding in FY2021, decontamination work is underway on the top floor of the Reactor Building. At present, rough decontamination on the floor surface was completed and decontamination of the high area is being prepared.

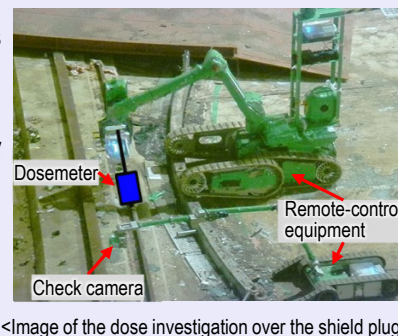
## Investigation utilizing the existing drilled hole of the shield plug inside the Unit 2 Reactor Building top floor

A dose investigation from the existing drilled hole of the Unit 2 shield plug was conducted from August to September. Based on the results, assumptions were made, including that radioactive materials, including cesium, were highly likely to adhere to and accumulate in upper and middle sections of the shield plug. Subsequently, to understand the contamination conditions more accurately, dose investigations will be conducted over the shield plug from October and the new drilled hole from December.

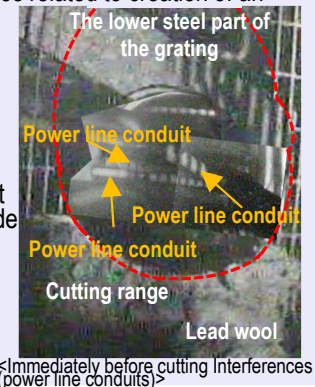
## Toward the Unit 1 PCV internal investigation, work to eliminate interferences was completed

Toward the internal investigation of the Unit 1 Primary Containment Vessel (PCV), all work to eliminate interferences related to creation of an access route was completed on September 17. After this, pre-work will be implemented, including pulling out the AWJ (Abrasive Water Jet) equipment and inserting the guide pipe. Pre-work continues toward starting the PCV internal investigation within FY2021.

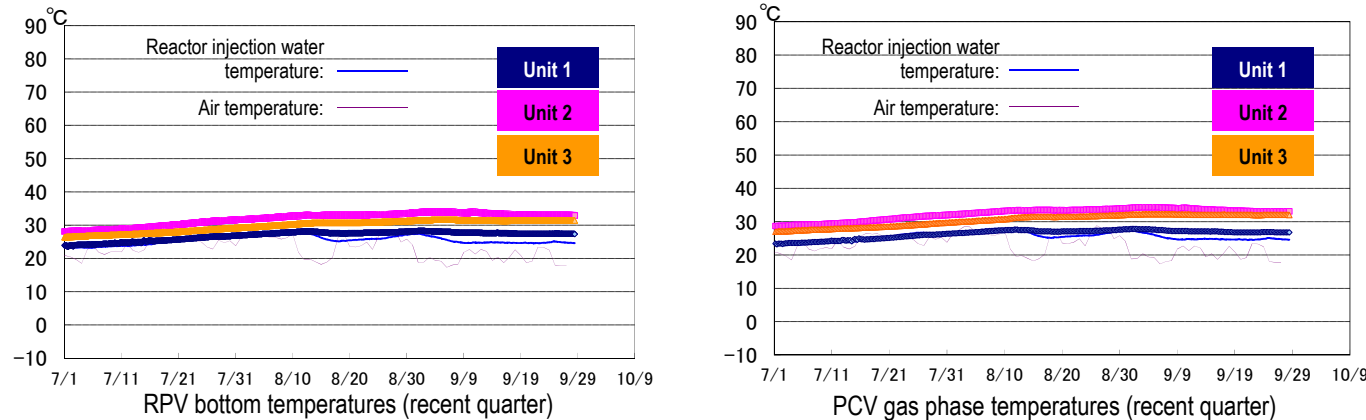
Through continuous reactor cooling by water injection, the temperatures of the Reactor Pressure Vessel (RPV) bottom and the Primary Containment Vessel (PCV) gas phase were maintained within the range of approx. 25 to 35°C for the past month, though it varied depending on the unit and location of the thermometer.

\*1 The trend graphs show part of the temperature data measured at multiple points.  
\*2 A part of data could not be measured due to maintenance and inspection of the facility and other work.

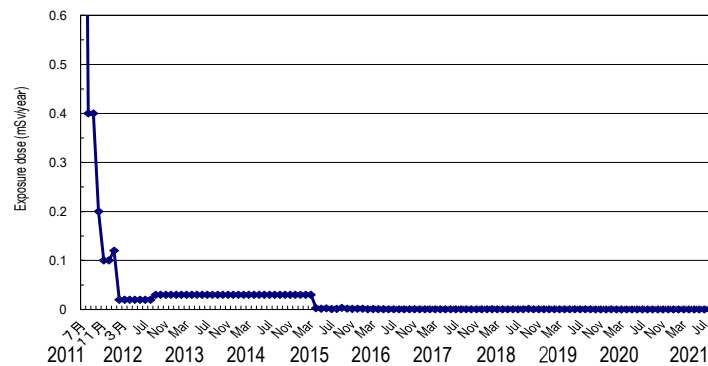
Annual radiation dose at site boundaries by radioactive materials (cesium) released from Reactor Building Units 1-4

As of August 2021, the concentration of radioactive materials newly released from Reactor Building Units 1-4 into the air and measured at the site boundary was evaluated at approx.  $2.5 \times 10^{-12}$  Bq/cm<sup>3</sup> and  $2.4 \times 10^{-12}$  Bq/cm<sup>3</sup> for Cs-134 and -137 respectively, while the radiation exposure dose due to the release of radioactive materials there was less than 0.00005 mSv/year.

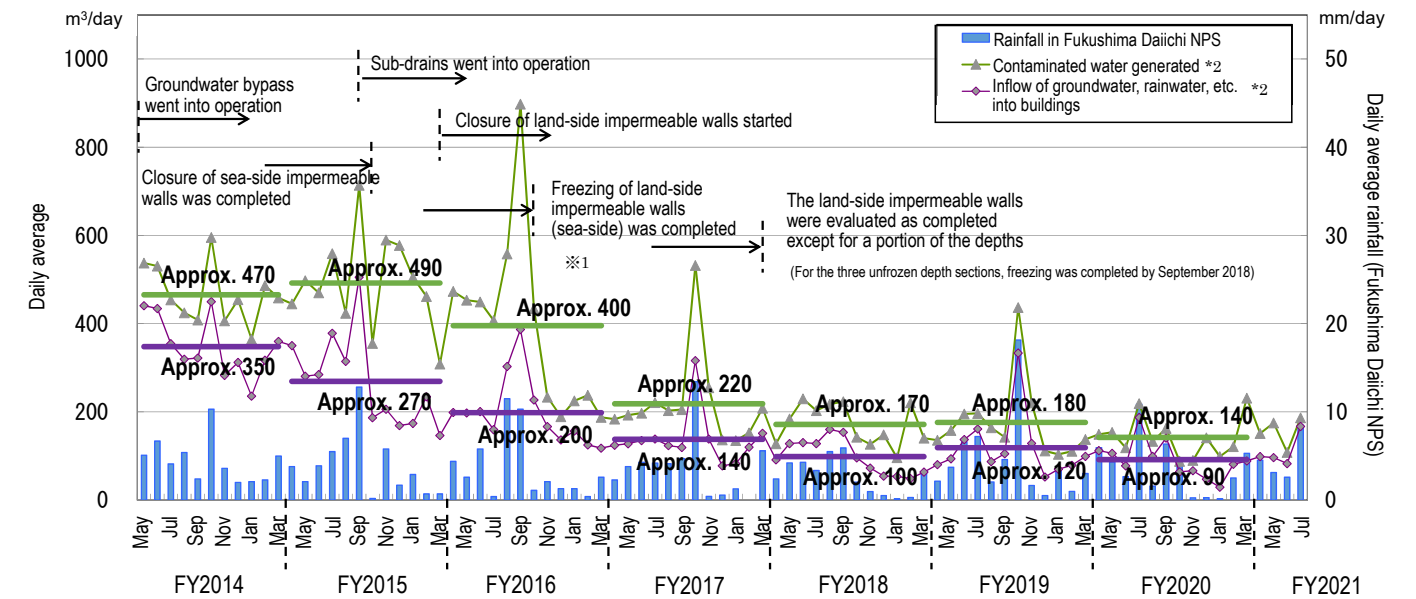
- Multi-layered measures, including pumping up by sub-drains and land-side impermeable walls, which were implemented to control the continued generation of contaminated water, suppressed the groundwater inflow into buildings.
- After implementing "redirecting" measures (groundwater bypass, sub-drains, land-side impermeable walls and others) and rainwater prevention measures, including repairing damaged portions of building roofs, the amount of contaminated water generated within FY2020 declined to approx. 140 m<sup>3</sup>/day.
- Measures will continue to further reduce the amount of contaminated water generated.

\*1 Values differ from those announced at the 20<sup>th</sup> Committee on Countermeasures for Contaminated Water Treatment (held on August 25, 2017) because the method of calculating the contaminated water volume generated was reviewed on March 1, 2018. Details of the review are described in the materials for the 50<sup>th</sup> and 51<sup>st</sup> meetings of the Secretariat of the Team for Countermeasures for Decommissioning and Contaminated Water Treatment.

\*2: The monthly daily average is derived from the daily average from the previous Thursday to the last Wednesday, which is calculated based on the data measured at 7:00 on every Thursday.

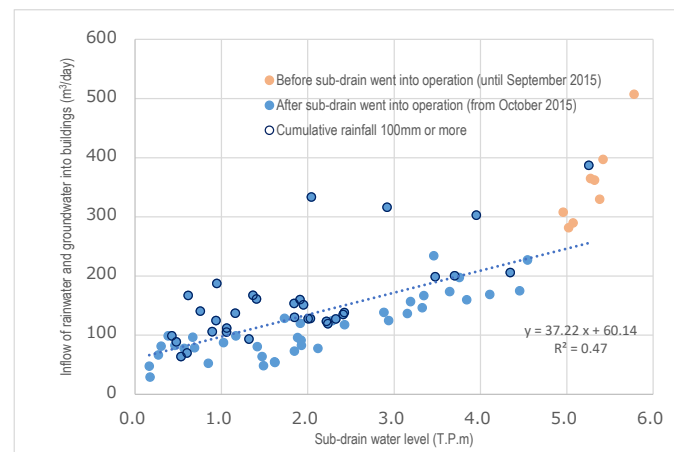
Figure 2: Correlation between inflow such as groundwater and rainwater into buildings and the water level of Units 1-4 sub-drains

- Since the sub-drains went into operation, the inflow to buildings tended to decline to under 150 m<sup>3</sup>/day when the sub-drain water level declined below T.P. 3.0 m but increased during rainfall.

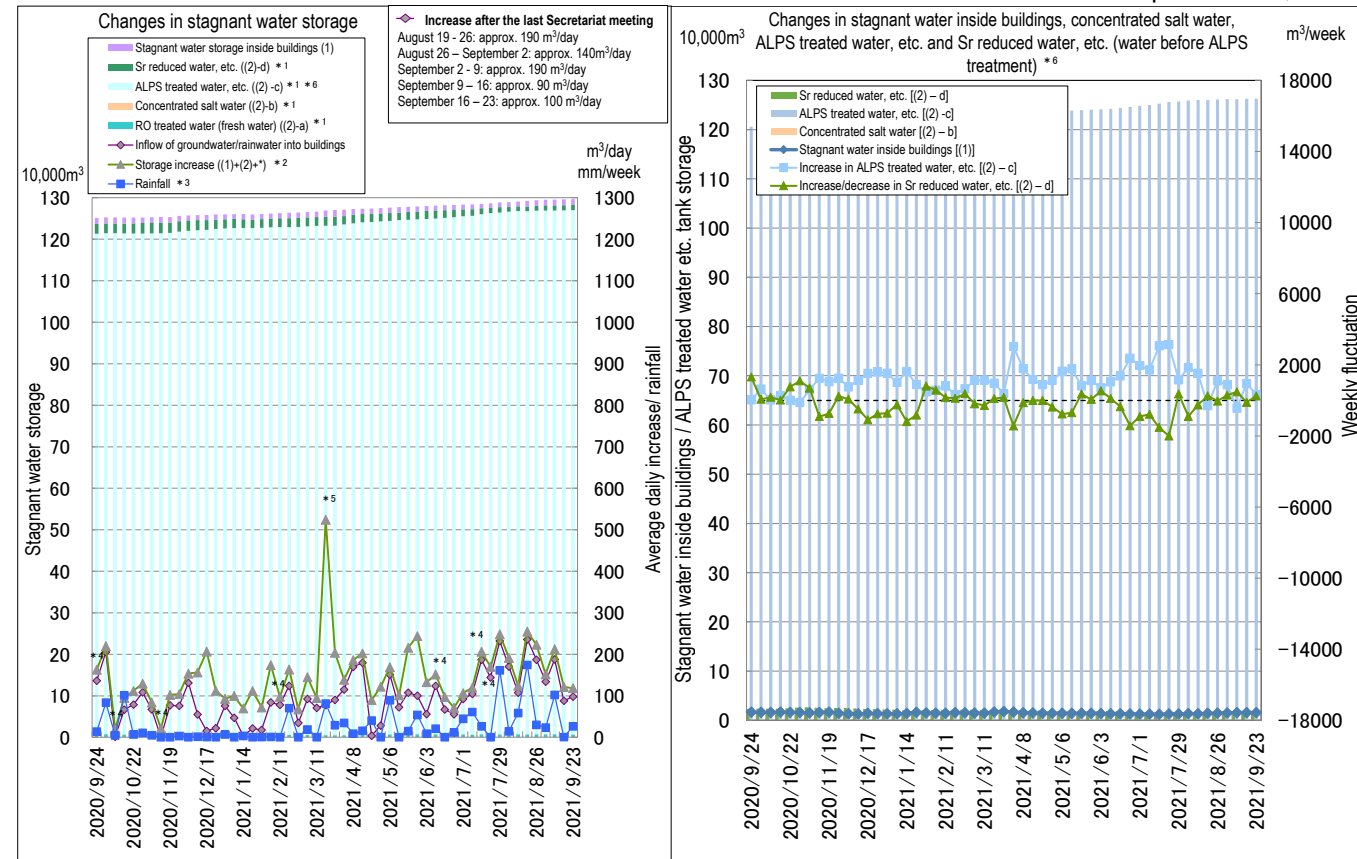
As of September 23, 2021

\*1: Water amount for which the water-level gauge indicates 0% or more  
 \*2: To detect storage increases more accurately, the calculation method was reviewed as follows from February 9, 2017: (The revised method was applied from March 1, 2018)  
 [(Inflow of groundwater/rainwater into buildings) + (other transfer) + (chemical injection into ALPS)]  
 \*3: Changed from December 13, 2018 from rainfall in Namie to that within the site.  
 \*4: Considered attributable to the fluctuation inflow of groundwater, rainwater, and others to buildings due to the decline in the level of stagnant water in buildings.  
 (September 17-24, October 1-8, November 12-19, 2020, February 4-11, June 3-10 and July 8-22, 2021)  
 \*5: Stored amount increased due to transfer to buildings in association with decommissioning work on March 18, 2021.  
 (Major breakdown of the transferred amount: (1) Stagnant water inside the tank fences (water transferred from the Shallow Draft Quay drainage channel) was transferred to the Process Main Building: approx. 390 m³/day, (2) Stagnant water inside the tank fences (water transferred from the Shallow Draft Quay drainage channel) was transferred to the High Temperature Incinerator Building: approx. 10 m³/day, (3) Transfer from the Unit 3 additional FSTR to the Unit 3 Radioactive Waste Treatment Building: approx. 10 m³/day and others)

\*6: The notation of treated water by the multi-nuclide removal equipment and others was reviewed in accordance with the definition change of ALPS treated water by the Government (April 27, 2021)

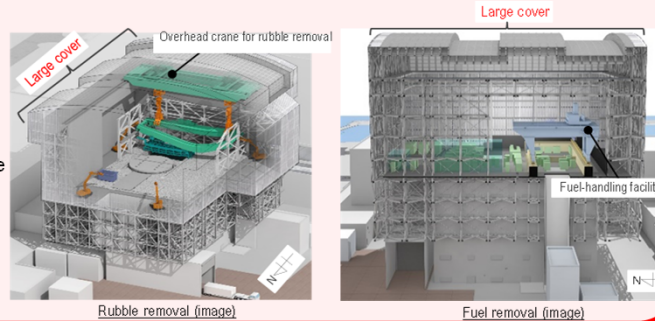
Toward fuel removal from the Unit 1 spent fuel pool, investigations have been implemented to ascertain the conditions of the fallen roof on the south side and the contamination of the well plug. Based on the results of these investigations, "the method to initially install a large cover over the Reactor Building and then remove rubble inside the cover" was selected to ensure a safer and more secure removal. Work to install a large cover will start from the first half of FY2021. Work continues to complete installation of a large cover by around FY2023 and start fuel removal from FY2027 to FY2028.

Rubble removal on the north side of the operating floor started from January 2018 and has been implemented sequentially. In July and August 2019, the well plug, which was misaligned from its normal position, was investigated and in August and September, the conditions of the overhead crane were checked. Based on the results of these investigations, as the removal requires more careful work taking dust scattering into consideration, two methods were examined: installing a cover after rubble removal and initially installing a large cover over the Reactor Building and then removing rubble inside the cover.

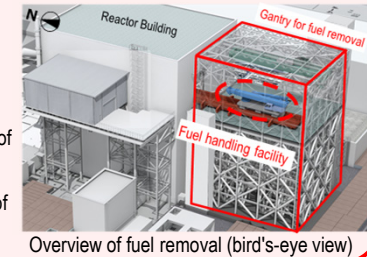
Toward fuel removal from the Unit 2 spent fuel pool, based on findings from internal operating floor investigations from November 2018 to February 2019, instead of fully dismantling the upper part of the building, the decision was made to install a small opening on the south side and use a boom crane. Examination continues to start fuel removal from FY2024 to FY2026.

Previously, potential to recover the existing overhead crane and the fuel handling machine was examined. However, the high radiation dose inside the operating floor meant the decision was taken to dismantle the upper part of the building in November 2015. Findings from internal investigations of the operating floor from November 2018 to February 2019 underlined the potential to conduct limited work there and the means of accessing from the south side had been examined.

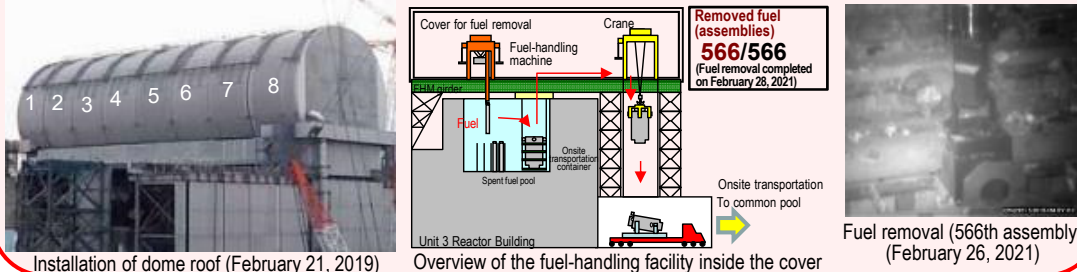
Prior to the installation of a cover for fuel removal, removal of large rubble from the spent fuel pool was completed in November 2015. To ensure safe and steady fuel removal, training of remote control was conducted at the factory using the actual fuel-handling machine which will be installed on site (February – December 2015). Measures to reduce dose on the Reactor Building top floor (decontamination, shields) were completed in December 2016. Installation of a cover for fuel removal and a fuel-handling machine is underway from January 2017. Installation of the fuel removal cover was completed on February 23, 2018.

Toward fuel removal, the rubble retrieval training inside the pool, which was scheduled in conjunction with fuel removal training, started from March 15, 2019, and started fuel removal from April 15, 2019. Fuel removal was completed on February 28, 2021.

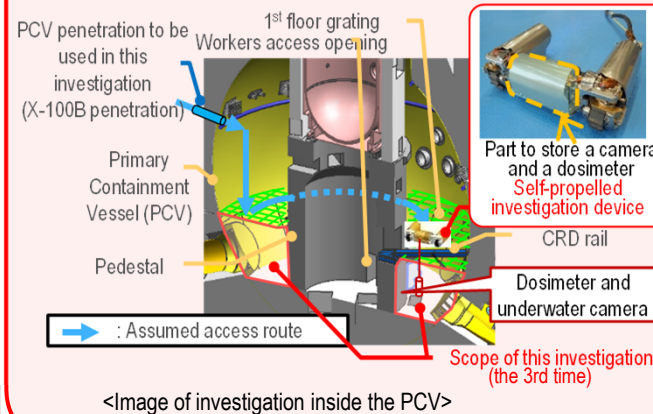
### Status of investigation inside the PCV

Prior to fuel debris retrieval, an investigation inside the PCV will be conducted to inspect the status there including the location of fuel debris.

- In April 2015, a device, which entered the inside of the PCV through a narrow access opening (bore:  $\phi$  100 mm), collected information such as images and airborne dose inside the PCV 1st floor.
- In March 2017, the investigation using a self-propelled investigation device, conducted to inspect the spreading of debris to the basement floor outside the pedestal, took images of the PCV bottom status for the first time. The status inside the PCV will continue to be examined based on the collected image and dose data.

Image of hanging of dosimeter and camera

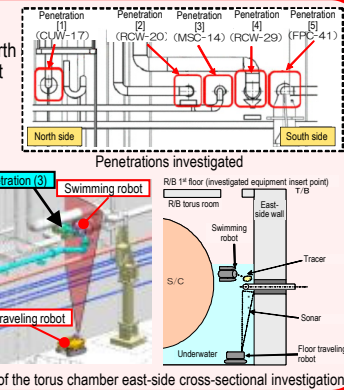
## Investigative results on torus chamber walls

- July 2014, the torus chamber walls were investigated (on the north and east-side walls) using equipment specially developed for that purpose (a swimming robot and a floor traveling robot).
- At the east-side wall pipe penetrations (five points), "the status" and "existence of flow" were checked.
- A demonstration using the above two types of underwater wall investigative equipment showed how the equipment could check the status of penetration.
- Regarding Penetrations [1]-[5], the results of checking the sprayed tracer<sup>(5)</sup> by camera showed no flow around the penetrations. (investigation by the swimming robot)
- Regarding Penetration 3, a sonar check showed no flow around the penetrations. (investigation by the floor traveling robot)

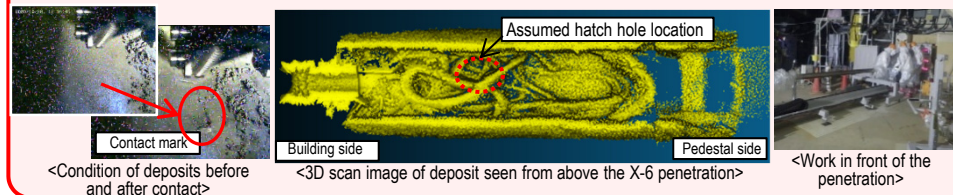
- On October 28, 2020, as a preparatory stage of the PCV internal investigation and the trial retrieval, a contact investigation into deposits inside the penetration (X-6 penetration) was conducted. In this investigation, a guide pipe incorporating an investigative unit inserted into the penetration. By the contact, it was confirmed that deposits inside the penetration did not deform and unstuck.

- On October 30, 2020, a 3D scan investigation was conducted, measuring deposits by the 3D scan sensor mounted on the top of the investigative unit. Information obtained in the investigation will be utilized in the mockup test of the equipment to remove deposits inside the X-6 penetration.

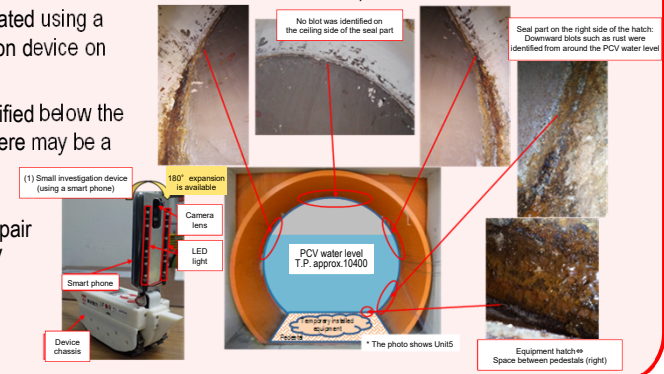
### Investigative results into the Unit 3 PCV equipment hatch using a small investigation device

- As part of the investigation into the PCV to facilitate fuel debris retrieval, the status around the Unit 3 PCV equipment hatch was investigated using a small self-traveling investigation device on November 26, 2015.
- Given blots such as rust identified below the water level inside the PCV, there may be a leakage from the seal to the extent of bleeding. Methods to investigate and repair the parts, including other PCV penetrations with a similar structure, will be considered.

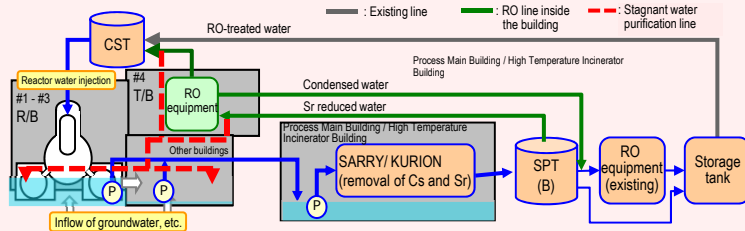
- To reduce the risk of contaminated-water leakage, the circulation loop was shortened by installing a reverse osmosis (RO) device in the Unit 4 Turbine Building within the circulation loop, comprising the transfer of contaminated water, water treatment and injection into the reactors. Operation of the installed RO device started from October 7 and 24-hour operation started from October 20. Installation of the new RO device inside the building shortened the circulation loop from approx. 3 to 0.8 km.

\* The entire length of contaminated water transfer pipes is approx. 2.1km, including the transfer line of surplus water to the upper heights (approx. 1.3km).
