Main decommissioning work and steps

Reference
October 28, 2021
Secretariat of the Team for Countermeasures for
commissioning and Contaminated Water Treatment
3/6

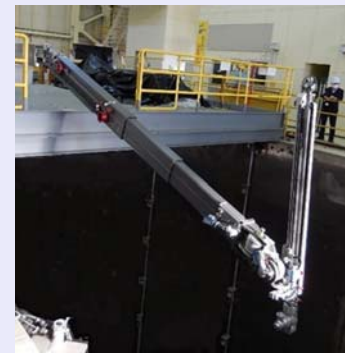
<Performance verification test of the robot arm>

The ongoing performance verification test in a domestic factory (Kobe), which started from August, continues.

Moreover, training sessions are conducted under a VR environment to operate the robot arm or using the actual dual-arm manipulator.

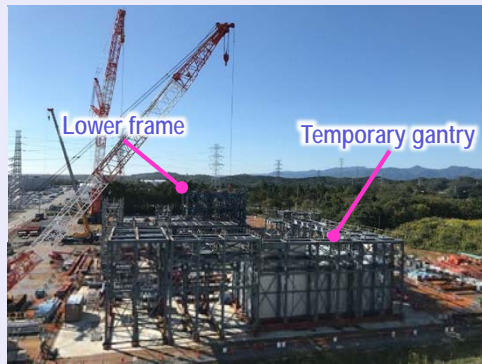
<Whole view of the yard outside the site (October 11, 2021)>

Toward installation of a large cover, the semi-assembly of steel frames and others is underway in a yard outside the site and that of the temporary gantry is almost completed.

Around the building, before installing an anchor in the Reactor Building and subsequently a large cover, work started from October 20 to investigate cracks on external walls of the Reactor Building and verify their strength by sampling the concrete core.

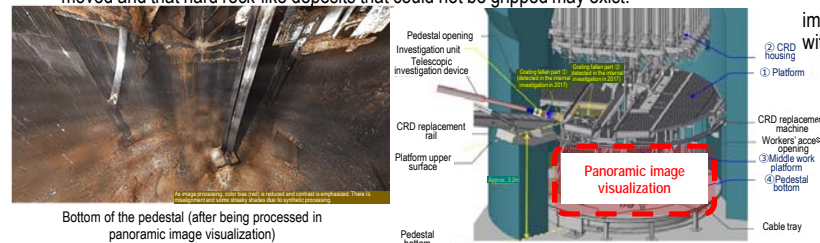
- In February 2019, an investigation touching the deposits at the bottom of the pedestal and on the platform was conducted and confirmed that the pebble-shaped deposits, etc. could be moved and that hard rock-like deposits that could not be gripped may exist.

- In January 2018, the conditions below the platform inside the pedestal were investigated. Based on the analytical results of images obtained in the investigation, deposits, probably including fuel debris, were found at the bottom of the pedestal. Moreover, multiple parts exceeding the surrounding deposits were also detected. We presumed that there were multiple instances of fuel debris falling.

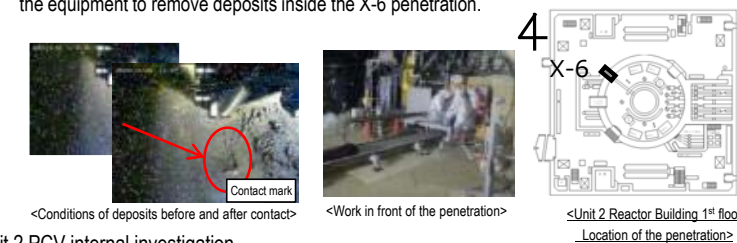
- In October 2020, as part of work to prepare for the PCV internal investigation and trial retrieval, a contact investigation to study deposits inside the penetration (X-6 penetration) was conducted, which involved inserting a guide pipe incorporating an investigative unit into the penetration. This confirmed that deposits inside the penetration had not deformed and come unstuck. The investigative information obtained will be utilized in the mockup test of the equipment to remove deposits inside the X-6 penetration.

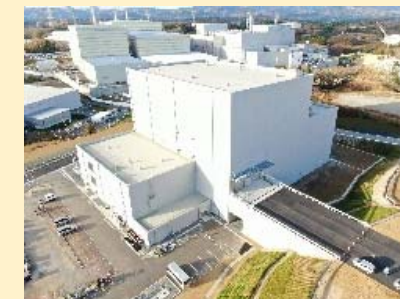
Whole view of the Additional Solid Waste Incinerator Building

To incinerate trimmed trees and combustible rubble (woods, packing materials, paper and others), work to install the Additional Solid Waste Facility is underway.

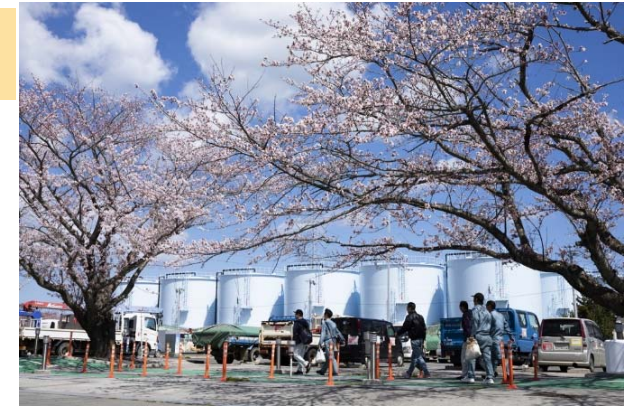
Regarding the site-wide reduction in the radiation dose and prevention of contamination spreading, the radiation dose on site was reduced by removal of rubble, topsoil and facing. Moreover, the operation was improved to use environmentally-improved areas as a Green Zone, within which workers are allowed to wear general work clothes and disposable dust-protective masks which are less of a physical burden.

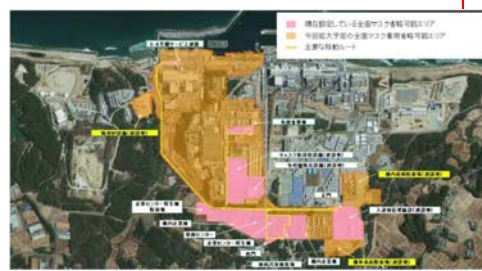
In August 2021, operation started while eliminating the need for the DS2 mask during light work in G-zone outside the protection area around Unit 1-4 (except for inside Units 5 and 6).

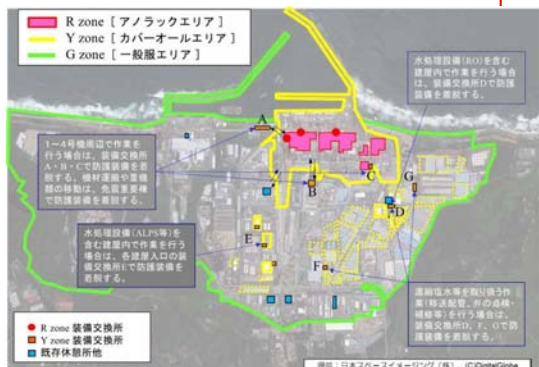
In May 2013, areas excluding those around Unit 1-4, tank areas and rubble storage areas were set to full-face mask unnecessary areas.

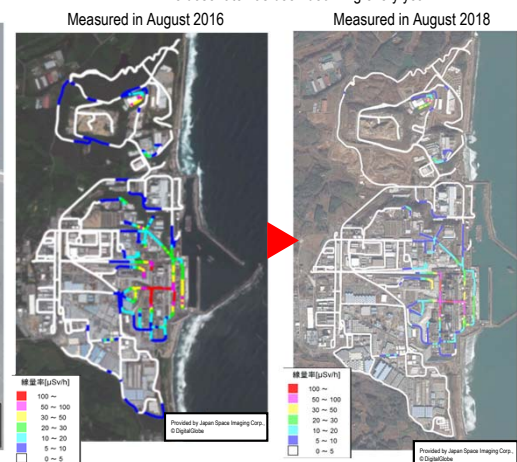
<Travel survey results of major roads within the site>
The dose rate has been declining every year.
