Main decommissioning work and steps

Radiological impact assessment regarding the discharge of ALPS treated water into the sea (design stage)

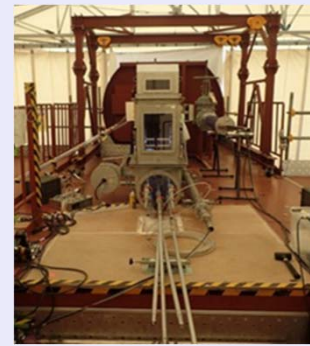
<Image of installation of equipment to insert and remove an underwater ROV (mockup)>

From November 5, pre-work is underway, such as covering the work area and installing equipment and materials in the on-site headquarters and the remote-control room, toward the internal investigation of the Unit 1 Primary Containment Vessel (PCV).

After installing equipment to insert and remove an underwater ROV inside the PCV and verifying its operation, work toward starting the investigation in mid-January 2022 will proceed.

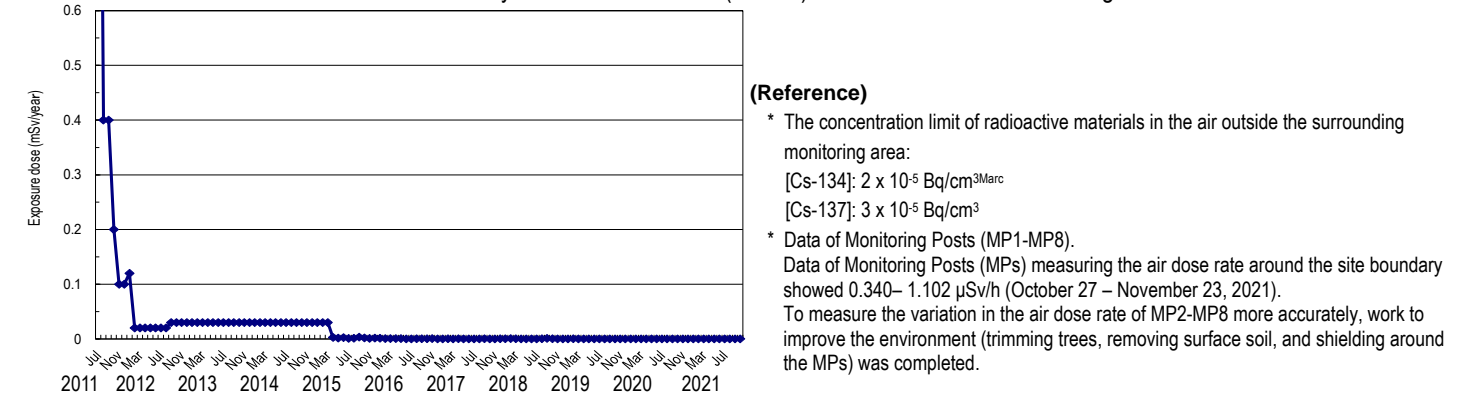
Annual radiation dose at site boundaries by radioactive materials (cesium) released from Reactor Building Units 1-4

- Note 1: Different formulas and coefficients were used to evaluate the radiation dose in the facility operation plan and monthly report. The evaluation methods were integrated in September 2012. As the fuel removal from the spent fuel pool (SFP) commenced for Unit 4, the radiation exposure dose from Unit 4 was added to the items subject to evaluation since November 2013. The evaluation has been changed to a method considering the values of continuous dust monitors since FY2015, with data to be evaluated monthly and announced the following month.

- Note 2: Radiation dose was calculated using the evaluation values of release amount from Units 1-4 and Units 5 and 6. The radiation dose of Unit 5 and 6 was evaluated based on expected release amount during operation until September 2019 but the evaluation method was reviewed and changed to calculate based on the actual measurement results of Units 5 and 6 from October.

As of October 2021, the concentration of radioactive materials newly released from Reactor Building Units 1-4 into the air and measured at the site boundary was evaluated at approx. 3.0×10^{-12} Bq/cm³ and 2.8×10^{-12} Bq/cm³ for Cs-134 and -137 respectively, while the radiation exposure dose due to the release of radioactive materials there was less than 0.00006 mSv/year.

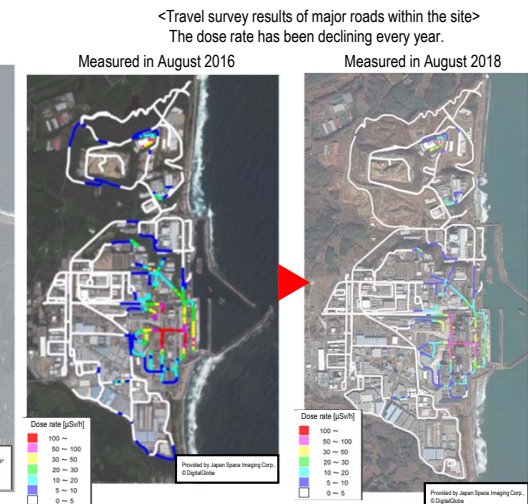
In May 2018, within about 96% of the site, workers are allowed to wear light equipment such as general workwear and disposable dust-protective masks.

Regarding the site-wide reduction in the radiation dose and prevention of contamination spreading, the radiation dose on site was reduced by removal of rubble, topsoil and facing. Moreover, the operation was improved to use environmentally-improved areas as a Green Zone, within which workers are allowed to wear general work clothes and disposable dust-protective masks which are less of a physical burden.
