## Main decommissioning work and steps

# Progress status

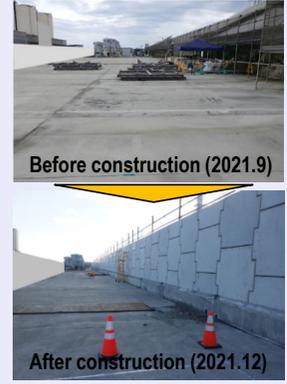
In association with the construction of the Japan Trench Tsunami Seawall, a T.P.+2.5m slope on the east side of Units 1-4 is being reinforced, the seawall is being installed and the road to use with it is being constructed.  
Construction is progressing steadily and the seawall will be completed in the 2nd half of FY2023.  
To minimize the outflow of contaminated water from buildings due to a backrush to the Unit 1-4 buildings and suppress the increase of contaminated water in buildings, openings were closed and other measures were implemented and they were completed on January 26.  
Efforts to maintain closed parts and reduce tsunami risks continue while prioritizing safety and according to the plan.  
<Progress of slope reinforcement>

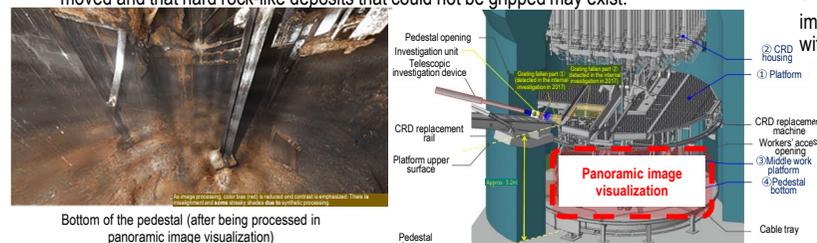
- In January 2017, a camera was inserted from the PCV penetration to inspect the conditions of the rail on which the robot traveled. The results of a series of investigations confirmed some gratings had fallen and deformed as well as a quantity of deposit inside the pedestal.

- In January 2018, the conditions below the platform inside the pedestal were investigated. Based on the analytical results of images obtained in the investigation, deposits, probably including fuel debris, were found at the bottom of the pedestal. Moreover, multiple parts exceeding the surrounding deposits were also detected. We presumed that there were multiple instances of fuel debris falling.

- In February 2019, an investigation touching the deposits at the bottom of the pedestal and on the platform was conducted and confirmed that the pebble-shaped deposits, etc. could be moved and that hard rock-like deposits that could not be gripped may exist.

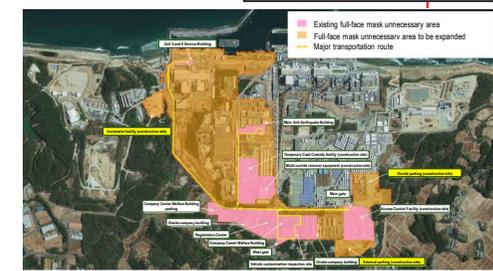
Changes in operation of controlled area

In March 2016, based on the progress of measures to reduce the environmental dosage on site, the site was categorized into two zones: Highly contaminated area around Unit 1-4 buildings, etc. and other areas where limited operation started to optimize protective equipment according to each category.

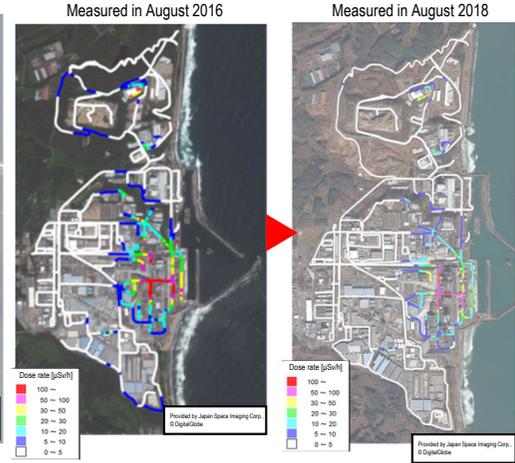
<Travel survey results of major roads within the site>  
The dose rate has been declining every year.
