Main decommissioning work and steps

Progress status

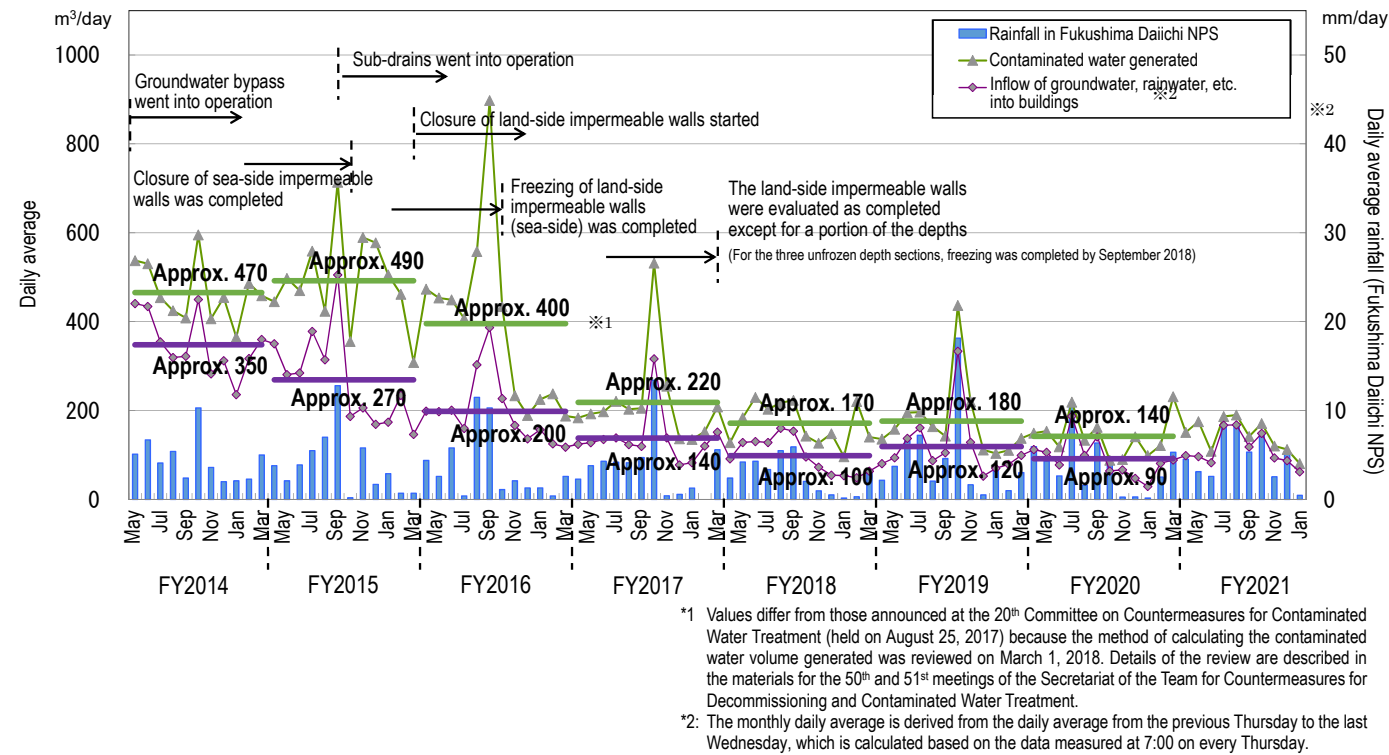
Figure 1: Changes in contaminated water generated and inflow of groundwater and rainwater into buildings

➤ Status of contaminated water generated

- Multi-layered measures, including pumping up by sub-drains and land-side impermeable walls, which were implemented to control the continued generation of contaminated water, suppressed the groundwater inflow into buildings.
- After implementing “redirecting” measures (groundwater bypass, sub-drains, land-side impermeable walls and others) and rainwater prevention measures, including repairing damaged portions of building roofs, the amount of contaminated water generated within FY2020 declined to approx. 140 m³/day.
- Measures will continue to further reduce the amount of contaminated water generated.

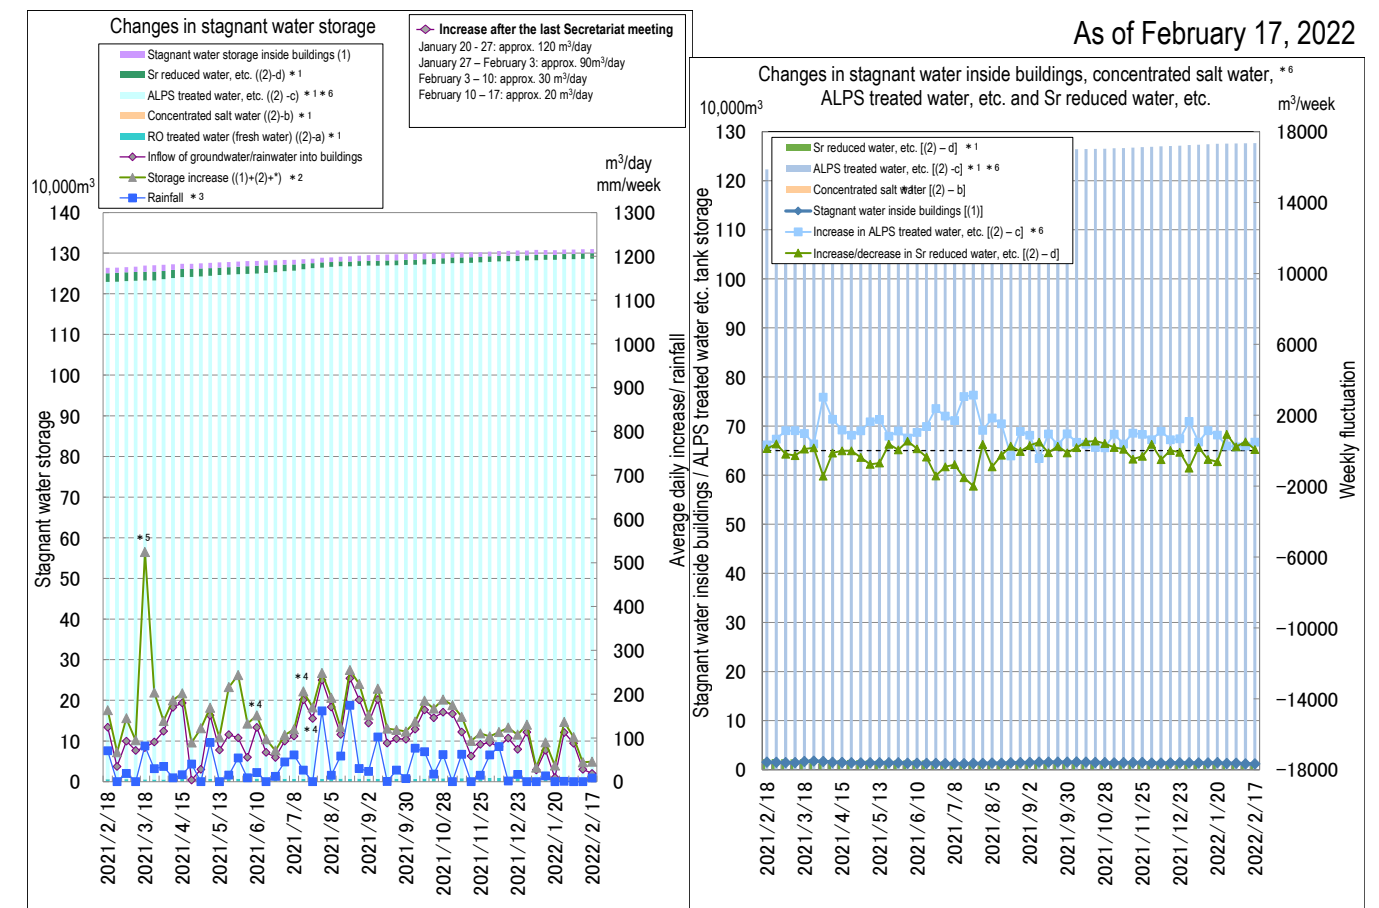
- To reduce the risks of strontium-reduced water, treatment using existing, additional and high-performance multi-nuclide removal equipment is underway. Up until February 17, 2022, approx. 832,000 m³ had been treated.

*1: Water amount for which the water-level gauge indicates 0% or more
 *2: To detect storage increases more accurately, the calculation method was reviewed as follows from February 9, 2017: (The revised method was applied from March 1, 2018) [(Inflow of groundwater/rainwater into buildings) + (other transfer) + (chemical injection into ALPS)]
 *3: Changed from December 13, 2018 from rainfall in Namie to that within the site.
 *4: Considered attributable to the fluctuation inflow of groundwater, rainwater, and others to buildings due to the decline in the level of contaminated water in buildings. (February 4-11, June 3-10 and July 8-22, 2021)
 *5: Stored amount increased due to transfer to buildings in association with decommissioning work on March 18, 2021. (Major breakdown of the transferred amount: (1) Contaminated water inside the tank fences (water transferred from the Shallow Draft Quay drainage channel) was transferred to the Process Main Building: approx. 390 m³/day, (2) Contaminated water inside the tank fences (water transferred from the Shallow Draft Quay drainage channel) was transferred to the High Temperature Incinerator Building: approx. 10 m³/day, (3) Transfer from the Unit 3 additional FSTR to the Unit 3 Radioactive Waste Treatment Building: approx. 10 m³/day and others)

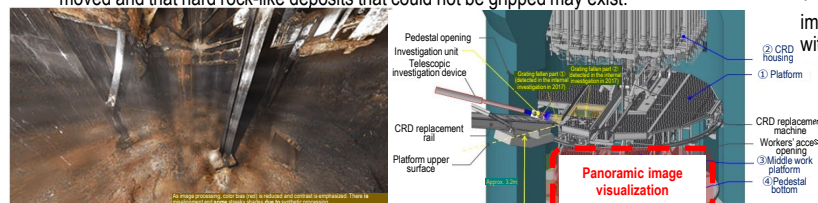
- In January 2017, a camera was inserted from the PCV penetration to inspect the conditions of the rail on which the robot traveled. The results of a series of investigations confirmed some gratings had fallen and deformed as well as a quantity of deposit inside the pedestal.

- In January 2018, the conditions below the platform inside the pedestal were investigated. Based on the analytical results of images obtained in the investigation, deposits, probably including fuel debris, were found at the bottom of the pedestal. Moreover, multiple parts exceeding the surrounding deposits were also detected. We presumed that there were multiple instances of fuel debris falling.

- In February 2019, an investigation touching the deposits at the bottom of the pedestal and on the platform was conducted and confirmed that the pebble-shaped deposits, etc. could be moved and that hard rock-like deposits that could not be gripped may exist.

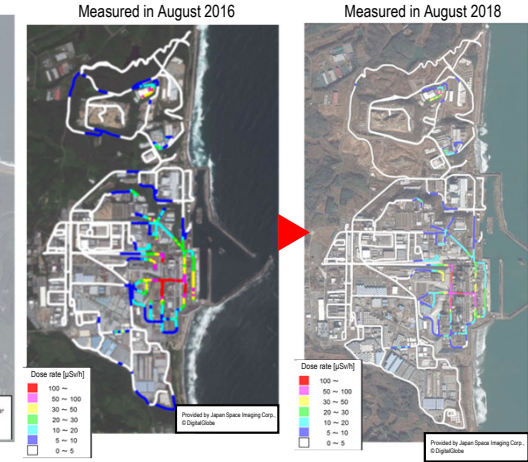
<Travel survey results of major roads within the site>
The dose rate has been declining every year.
