## Main decommissioning work and steps

## Measures of treated water

# Major initiatives – Locations on site

# TEPCO Holdings Fukushima Daiichi Nuclear Power Station Site Layout

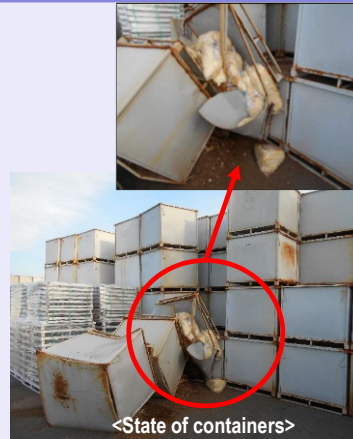
<State of containers>

The earthquake had influence on facilities (water-level decline in the Unit 1 Primary Containment Vessel (PCV), cooling of the spent fuel pool stopped, topped-over containers, tanks moved out of position and others), but there was no leakage of radioactive materials into the environment, fatal accidents, or events possibly affecting future plant operation.

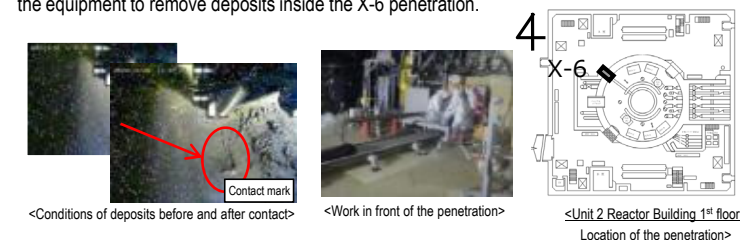
- In October 2020, as part of work to prepare for the PCV internal investigation and trial retrieval, a contact investigation to study deposits inside the penetration (X-6 penetration) was conducted. This involved inserting a guide pipe incorporating an investigative unit into the penetration. This confirmed that deposits inside the penetration had not deformed and come unstuck. The investigative information obtained will be utilized in the mockup test of the equipment to remove deposits inside the X-6 penetration.

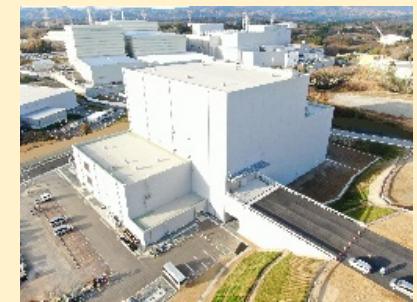
Whole view of the Additional Solid Waste Incinerator Building

To incinerate trimmed trees and combustible rubble (woods, packing materials, paper and others), work to install the Additional Solid Waste Facility is underway.
