Main decommissioning work and steps

I. Confirmation of the reactor conditions

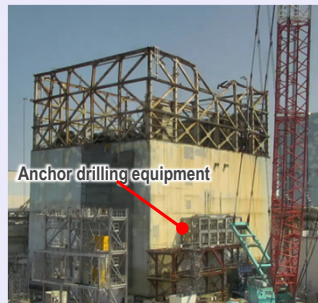
<On-site status (from northwest)>
(photo: April 12, 2022)

Unit 1 Progress of work to help fuel removal

Before installing a large cover, the investigation of external walls on the western, northern and eastern sides of the Reactor Building was completed. Subsequently, from April 13, drilling to install an anchor in the building started.

To reduce the exposure risk of workers, work proceeds carefully using a remotely-operated anchor drilling equipment and suctioning dust.

- A work yard was prepared around the Reactor Building and work to install a large cover started from August 2021.
 - Before installing the anchor of the large cover, the exterior walls of the Reactor Building were investigated. An investigation of representative parts on the west side of the building revealed that both cracking and concrete strength were within the assumed range and that the anchor would be installable as planned.

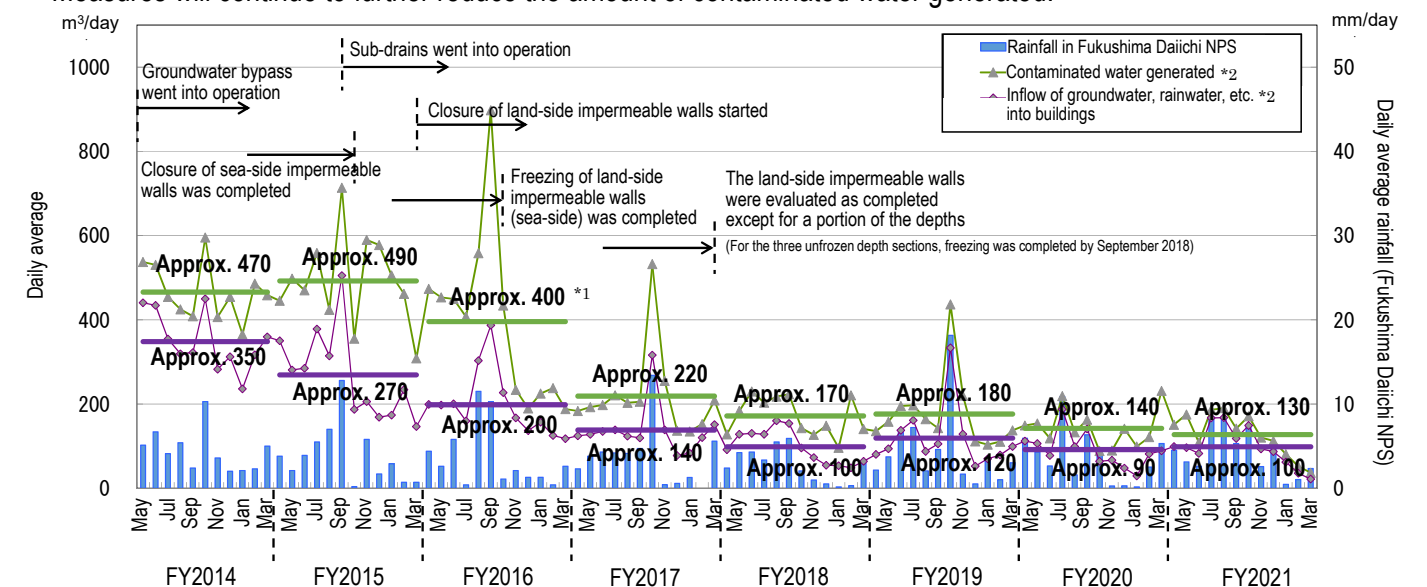
- Multi-layered measures, including pumping up by sub-drains and land-side impermeable walls, which were implemented to control the continued generation of contaminated water, suppressed the groundwater inflow into buildings.
- After implementing “redirecting” measures (groundwater bypass, sub-drains, land-side impermeable walls and others) and rainwater prevention measures, including repairing damaged portions of building roofs, the amount of contaminated water generated within FY2021 declined to approx. 130 m³/day.
- Measures will continue to further reduce the amount of contaminated water generated.

*1 Values differ from those announced at the 20th Committee on Countermeasures for Contaminated Water Treatment (held on August 25, 2017) because the method of calculating the contaminated water volume generated was reviewed on March 1, 2018. Details of the review are described in the materials for the 50th and 51st meetings of the Secretariat of the Team for Countermeasures for Decommissioning and Contaminated Water Treatment.

*2: The monthly daily average is derived from the daily average from the previous Thursday to the last Wednesday, which is calculated based on the data measured at 7:00 on every Thursday.

After implementing multi-layered contaminated water management measures, including repairing building roofs and facing around the buildings, the amount of contaminated water generated within FY2021 declined to approx. 130 m³/day and the groundwater inflow into the buildings is considered suppressed.

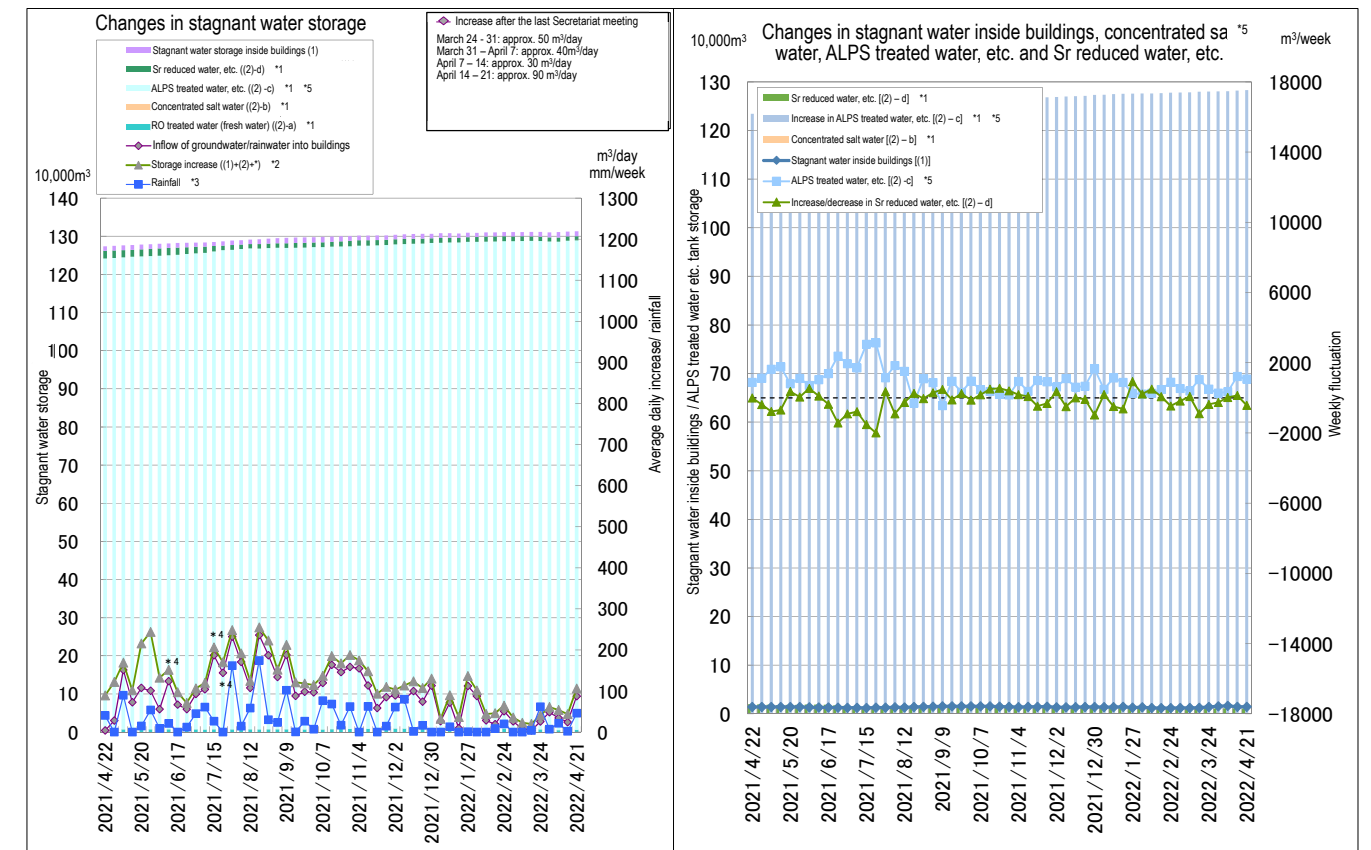
Figure 3: Status of stagnant water storage

*1: Water amount for which the water-level gauge indicates 0% or more
 *2: To detect storage increases more accurately, the calculation method was reviewed as follows from February 9, 2017: ((Inflow of groundwater/rainwater into buildings) + (other transfer) + (chemical injection into ALPS))
 *3: Changed from December 13, 2018 from rainfall in Namie to that within the site.
 *4: Considered attributable to the fluctuation inflow of groundwater, rainwater, and others to buildings due to the decline in the level of contaminated water in buildings. (June 3-10 and July 8-22, 2021)
 *5: The notation of treated water by the multi-nuclide removal equipment and others was reviewed in accordance with redefining of ALPS treated water by the Government (April 27, 2021)

- To reduce the risks of strontium-reduced water, treatment using existing, additional and high-performance multi-nuclide removal equipment is underway. Up until April 21, 2022, approx. 838,000 m³ had been treated.

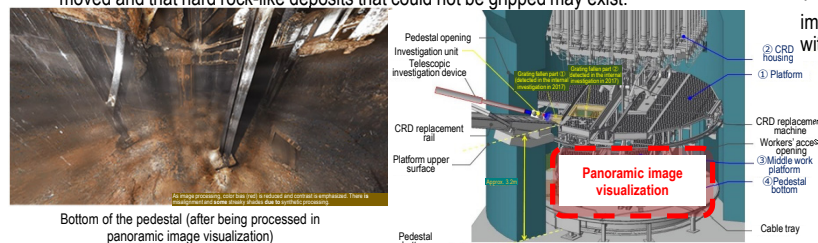
Unit 2 Investigation overview

- In January 2017, a camera was inserted from the PCV penetration to inspect the conditions of the rail on which the robot traveled. The results of a series of investigations confirmed some gratings had fallen and deformed as well as a quantity of deposit inside the pedestal.

- In January 2018, the conditions below the platform inside the pedestal were investigated. Based on the analytical results of images obtained in the investigation, deposits, probably including fuel debris, were found at the bottom of the pedestal. Moreover, multiple parts exceeding the surrounding deposits were also detected. We presumed that there were multiple instances of fuel debris falling.

- In February 2019, an investigation touching the deposits at the bottom of the pedestal and on the platform was conducted and confirmed that the pebble-shaped deposits, etc. could be moved and that hard rock-like deposits that could not be gripped may exist.

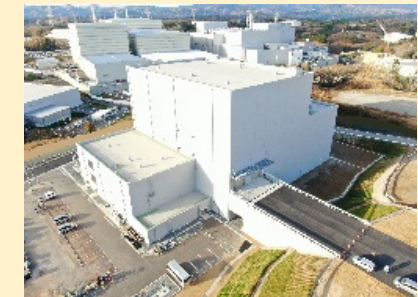
Whole view of the Additional Solid Waste Incinerator Building

To incinerate trimmed trees and combustible rubble (woods, packing materials, paper and others), work to install the Additional Solid Waste Facility is underway.

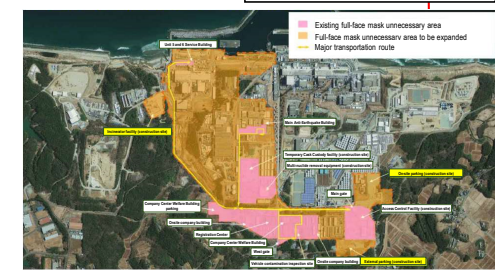
In May 2013, areas excluding those around Unit 1-4, tank areas and rubble storage areas were set to full-face mask unnecessary areas.

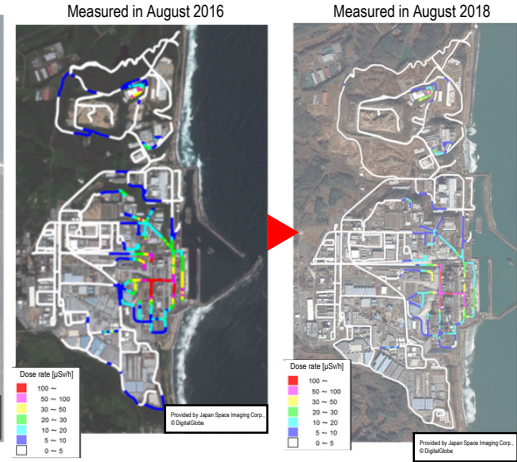
<Travel survey results of major roads within the site>
The dose rate has been declining every year.
