## Main decommissioning work and steps

# Major initiatives – Locations on site

# TEPCO Holdings Fukushima Daiichi Nuclear Power Station Site Layout

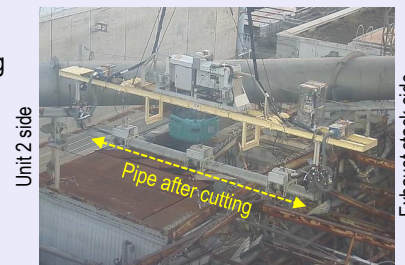
<Pipe cutting work>

The cutting work proceeds carefully after implementing measures to prevent dust scattering and it was confirmed that the values indicated on the dust monitors were less than the control standard values.

Work continues carefully while monitoring the dust concentration and prioritizing safety above all.

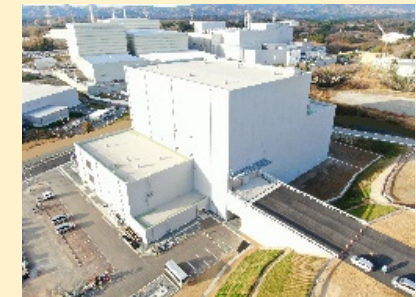
Whole view of the Additional Solid Waste Incinerator Building

To incinerate trimmed trees and combustible rubble (woods, packing materials, paper and others), work to install the Additional Solid Waste Facility is underway.

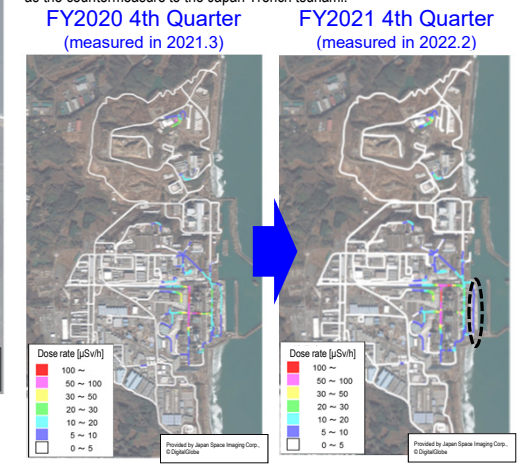
<Travel survey results of major roads within the site>  
The dose rate has been declining every year. In particular, in the area on the east side of the Turbine Building shown a black dotted line, the dose rate declined by facing related to installation of the seawall as the countermeasure to the Japan Trench tsunami.
