Main decommissioning work and steps

Progress status

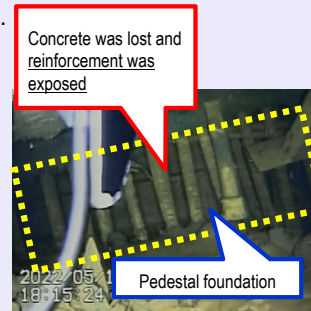
<Status near the pedestal foundation>

Unit 1 Consideration concerning the exposure of pedestal reinforcement

The status of the pedestal peripheral inside the Primary Containment Vessel (PCV) was investigated. The results showed that on the wall of the pedestal opening, a table-shaped deposit was detected and on the wall under the deposit, concrete was lost and reinforcement and others were exposed.

Based on the present information and others, The impact of pedestal damage on the plant was considered. The results showed that the potential of an earthquake to cause significant damage was low. Also considered was the fact that even if the support capability of the pedestal decreased, the risk of significant radiation exposure would not be presented to those in surrounding areas. We will continue the PCV internal investigation and accumulate more knowledge.

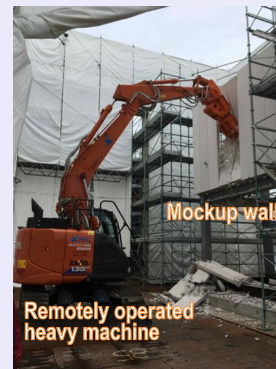
<Mockup to remove the fuel handling machine room>

Inside the building, the existing fuel-handling machine having been installed over the spent fuel pool was transferred to the north side of the Reactor Building by June 13. Moreover, a mockup toward removing the fuel-handling machine, which is scheduled from July, started from June 7. The feasibility of the dismantling method, rubble treatment, dust scattering prevention and others is being verified and proficiency training is underway.

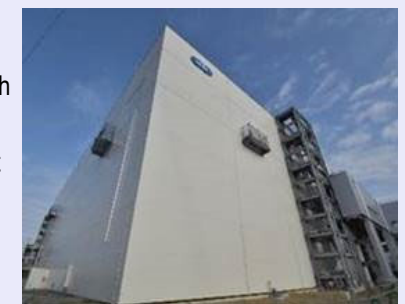
<Radioactive Material Analysis and Research Facility Laboratory-1 >

Construction completion of the Radioactive Material Analysis and Research Facility Laboratory-1

The Japan Atomic Energy Agency (JAEA) had been constructing the Radioactive Material Analysis and Research Facility Laboratory-1 within the site of the Fukushima Daiichi Nuclear Power Station, as part of research and development into waste treatment and handling. After finishing the comprehensive functional test and others, construction was completed on June 24.

Following the operation test and others, analytical work will commence.

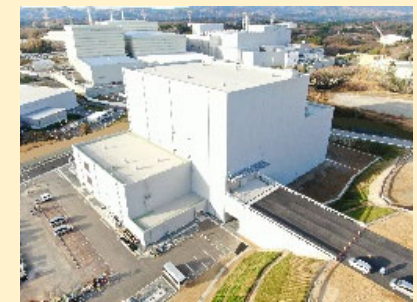
Whole view of the Additional Solid Waste Incinerator Building

To incinerate trimmed trees and combustible rubble (woods, packing materials, paper and others), work to install the Additional Solid Waste Facility is underway.

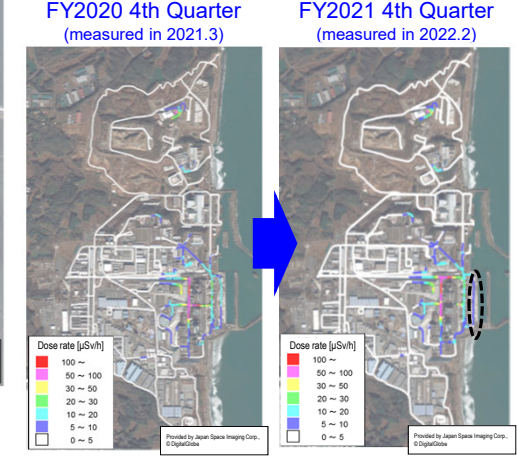
<Travel survey results of major roads within the site>
The dose rate has been declining every year. In particular, in the area on the east side of the Turbine Building shown a black dotted line, the dose rate declined by facing related to installation of the seawall as the countermeasure to the Japan Trench tsunami.
