## Main decommissioning work and steps

# TEPCO Holdings Fukushima Daiichi Nuclear Power Station Site Layout

Appendix 2  
August 25, 2022

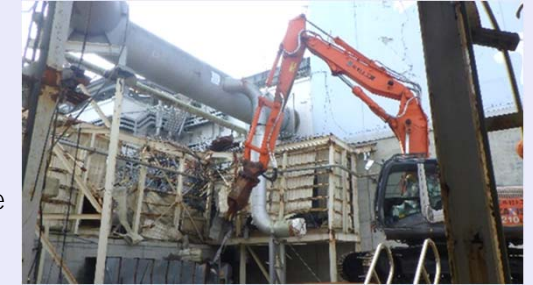
<Rubble removal work>

Rubble removal work around the Unit 1/2 Rw/B resumed from August 23, as the construction of the course for the rubble-removing heavy machine was completed in the range for preceding work.

Work to date to remove the SGTS pipes was reviewed and measures to improve reliability by modifying the cutter and others are being examined.

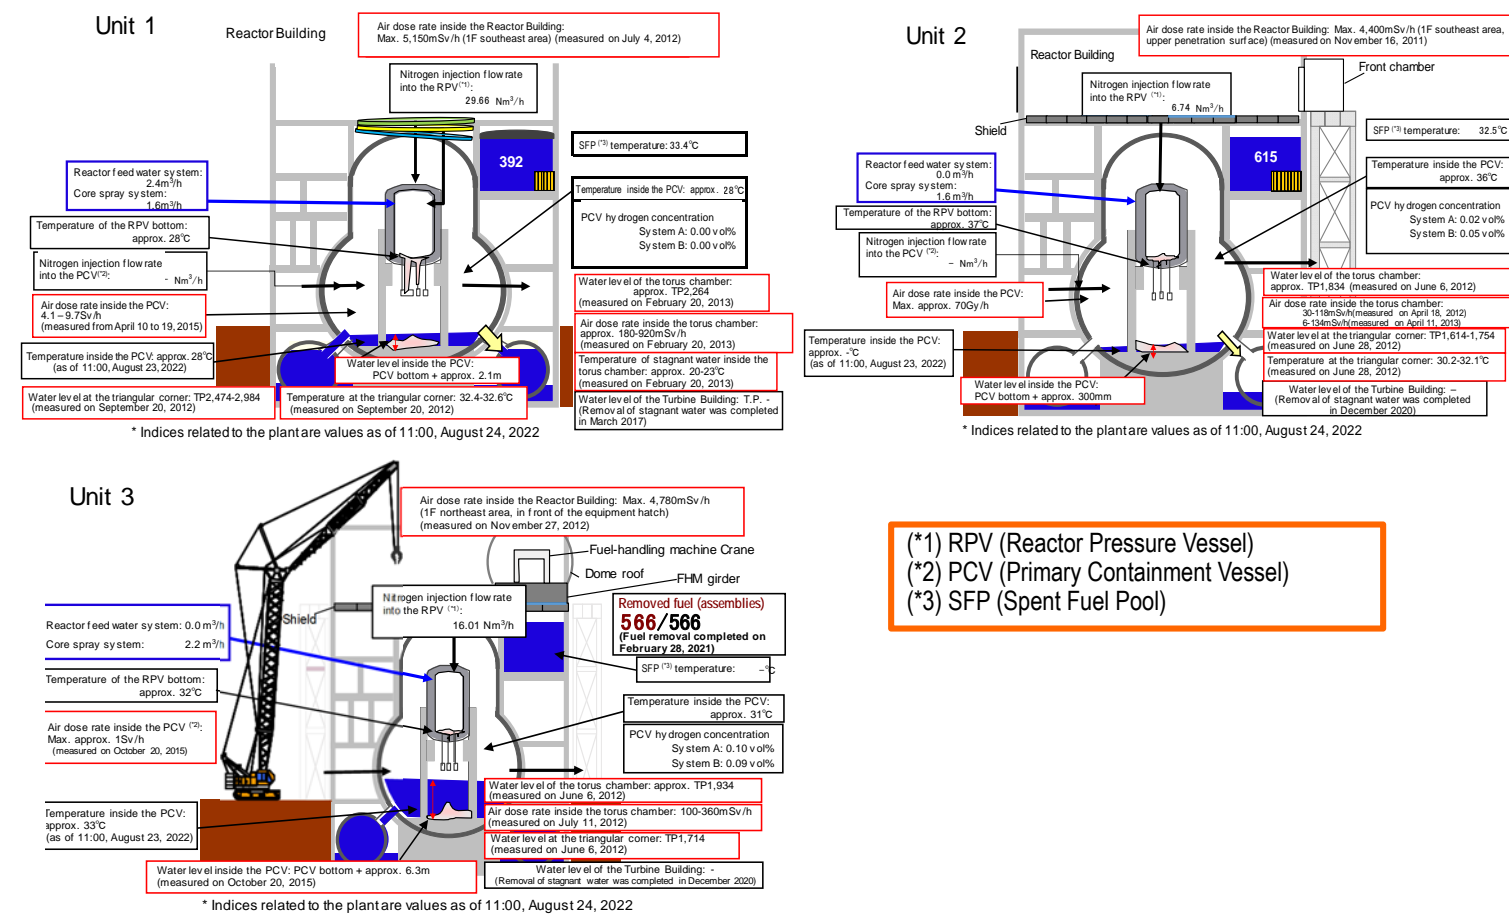
Through continuous reactor cooling by water injection, the temperatures of the Reactor Pressure Vessel (RPV) bottom and the Primary Containment Vessel (PCV) gas phase were maintained within the range of approx. 25 to 40°C for the past month, though it varied depending on the unit and location of the thermometer.

\*1 The trend graphs show part of the temperature data measured at multiple points.  
\*2 A part of data could not be measured due to maintenance and inspection of the facility and other work.

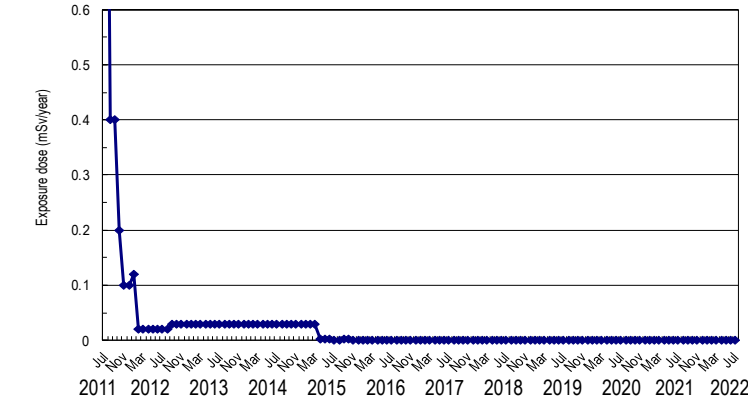
## Annual radiation dose at site boundaries by radioactive materials (cesium) released from Reactor Building Units 1-4

As of July 2022, the concentration of radioactive materials newly released from Reactor Building Units 1-4 into the air and measured at the site boundary was evaluated at approx.  $2.1 \times 10^{-12}$  Bq/cm<sup>3</sup> and  $1.8 \times 10^{-12}$  Bq/cm<sup>3</sup> for Cs-134 and -137 respectively, while the radiation exposure dose due to the release of radioactive materials there was less than 0.00004 mSv/year.

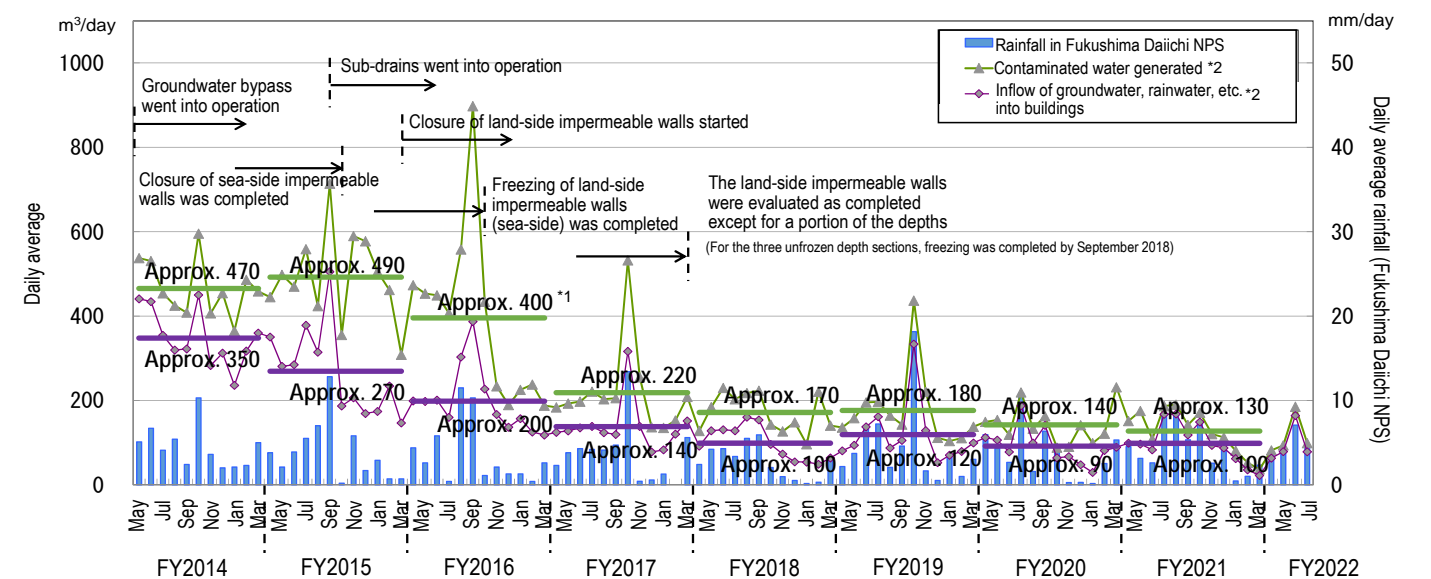
Figure 1: Changes in contaminated water generated and inflow of groundwater and rainwater into buildings

- Multi-layered measures, including pumping up by sub-drains and land-side impermeable walls, which were implemented to control the continued generation of contaminated water, suppressed the groundwater inflow into buildings.
- After implementing “redirecting” measures (groundwater bypass, sub-drains, land-side impermeable walls and others) and rainwater prevention measures, including repairing damaged portions of building roofs, the amount of contaminated water generated within FY2021 declined to approx. 130 m<sup>3</sup>/day.
- Measures will continue to further reduce the amount of contaminated water generated.

\*1 Values differ from those announced at the 20<sup>th</sup> Committee on Countermeasures for Contaminated Water Treatment (held on August 25, 2017) because the method of calculating the contaminated water volume generated was reviewed on March 1, 2018. Details of the review are described in the materials for the 50<sup>th</sup> and 51<sup>st</sup> meetings of the Secretariat of the Team for Countermeasures for Decommissioning and Contaminated Water Treatment.  
\*2: The monthly daily average is derived from the daily average from the previous Thursday to the last Wednesday, which is calculated based on the data measured at 7:00 on every Thursday.

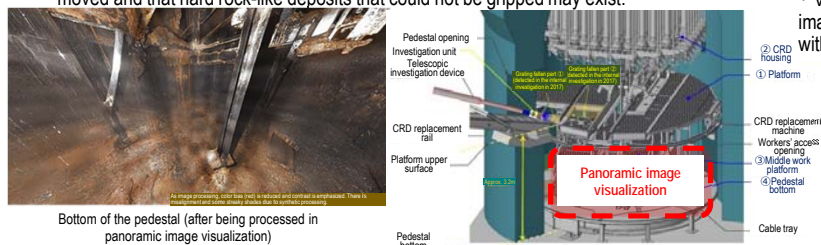
- In January 2017, a camera was inserted from the PCV penetration to inspect the conditions of the rail on which the robot traveled. The results of a series of investigations confirmed some gratings had fallen and deformed as well as a quantity of deposit inside the pedestal.

- In January 2018, the conditions below the platform inside the pedestal were investigated. Based on the analytical results of images obtained in the investigation, deposits, probably including fuel debris, were found at the bottom of the pedestal. Moreover, multiple parts exceeding the surrounding deposits were also detected. We presumed that there were multiple instances of fuel debris falling.

- In February 2019, an investigation touching the deposits at the bottom of the pedestal and on the platform was conducted and confirmed that the pebble-shaped deposits, etc. could be moved and that hard rock-like deposits that could not be gripped may exist.

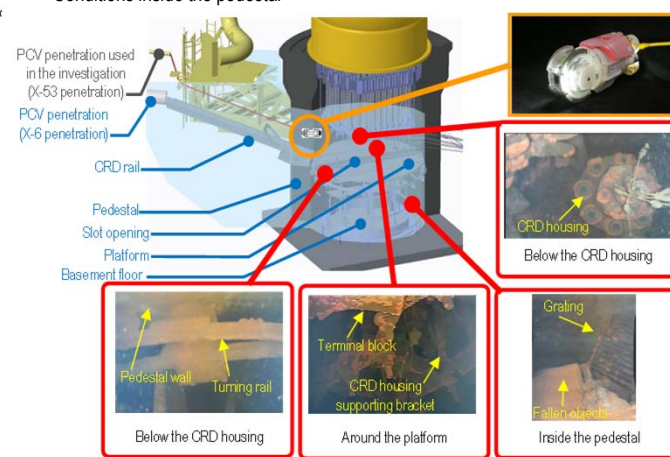
### <Conditions inside the pedestal>

- In July 2017, the inside of the PCV was investigated using the underwater ROV (remotely operated underwater vehicle) to inspect the inside of the pedestal. Analysis of the imagery obtained in the investigation identified damage to multiple structures and the supposed core internals.

- Videos obtained in the investigation were reproduced in 3D. Based on the reproduced images, the relative positions of the structures, such as the rotating platform slipping off the rail with a portion buried in deposits, were visually understood.

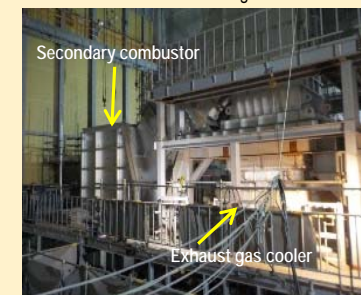
Secondary combustor

Exhaust gas cooler

- **Status of the additional Radioactive Waste Incinerator**
  - On May 23, the operation of the additional Radioactive Waste Incinerator resumed.
  - On June 10, water was detected inside the fly removal system, the incineration operation was suspended for inspection. No external leakage of radioactive materials was identified.

- Before resuming operation, the temperature control value will be changed and the properties of the ash will be verified.
  - On June 18, during a patrol, cracking and others were detected in the seal plate over the joint of the secondary burner and stoker and in the welded part of the rotary kiln joint cylinder.

- After observing the crack surface, the cracking was deemed attributable to ductile fracture by excessive stress, caused by the impact of the Fukushima Offshore Earthquake on March 16. Moreover, cracking of the welded parts due to insufficient strength was also detected.

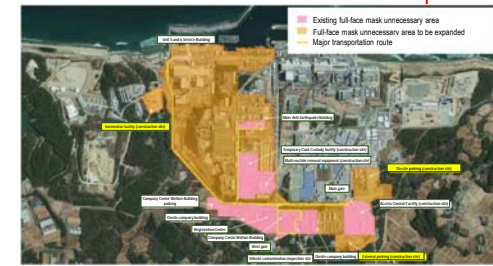
In May 2013, areas excluding those around Unit 1-4, tank areas and rubble storage areas were set to full-face mask unnecessary areas.

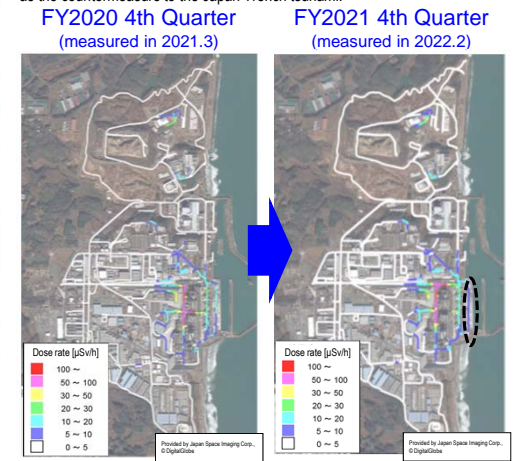
<Travel survey results of major roads within the site>  
The dose rate has been declining every year. In particular, in the area on the east side of the Turbine Building shown a black dotted line, the dose rate declined by facing related to installation of the seawall as the countermeasure to the Japan Trench tsunami.
