Main decommissioning work and steps

Fuel removal from the spent fuel pool was completed in December 2014 at Unit 4 and on February 28, 2021 at Unit 3.
 Work continues sequentially toward the start of fuel removal from Units 1 and 2 and debris (Note 1) retrieval from Units 1-3.
 (Note 1) Fuel assemblies having melted through in the accident.

I. Confirmation of the reactor conditions

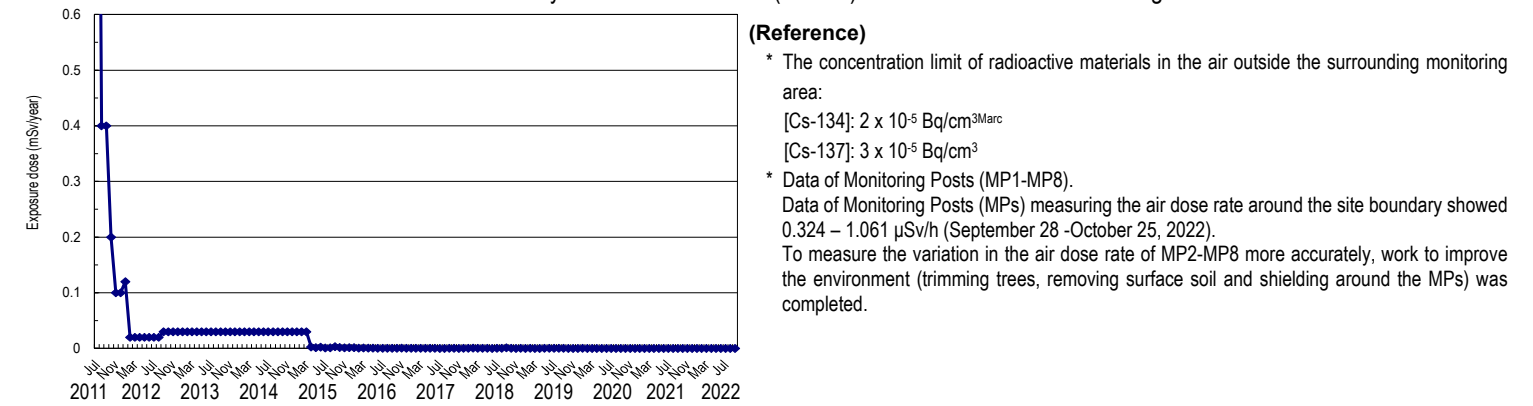
Annual radiation dose at site boundaries by radioactive materials (cesium) released from Reactor Building Units 1-4

As of September 2022, the concentration of radioactive materials newly released from Reactor Building Units 1-4 into the air and measured at the site boundary was evaluated at approx. 2.1×10^{-12} Bq/cm³ and 2.1×10^{-12} Bq/cm³ for Cs-134 and -137 respectively, while the radiation exposure dose due to the release of radioactive materials there was less than 0.00004 mSv/year.

(Reference)
* The concentration limit of radioactive materials in the air outside the surrounding monitoring area:
[Cs-134]: 2×10^{-5} Bq/cm³
[Cs-137]: 3×10^{-5} Bq/cm³
* Data of Monitoring Posts (MP1-MP8).
Data of Monitoring Posts (MPs) measuring the air dose rate around the site boundary showed 0.324 – 1.061 μSv/h (September 28 -October 25, 2022).
To measure the variation in the air dose rate of MP2-MP8 more accurately, work to improve the environment (trimming trees, removing surface soil and shielding around the MPs) was completed.

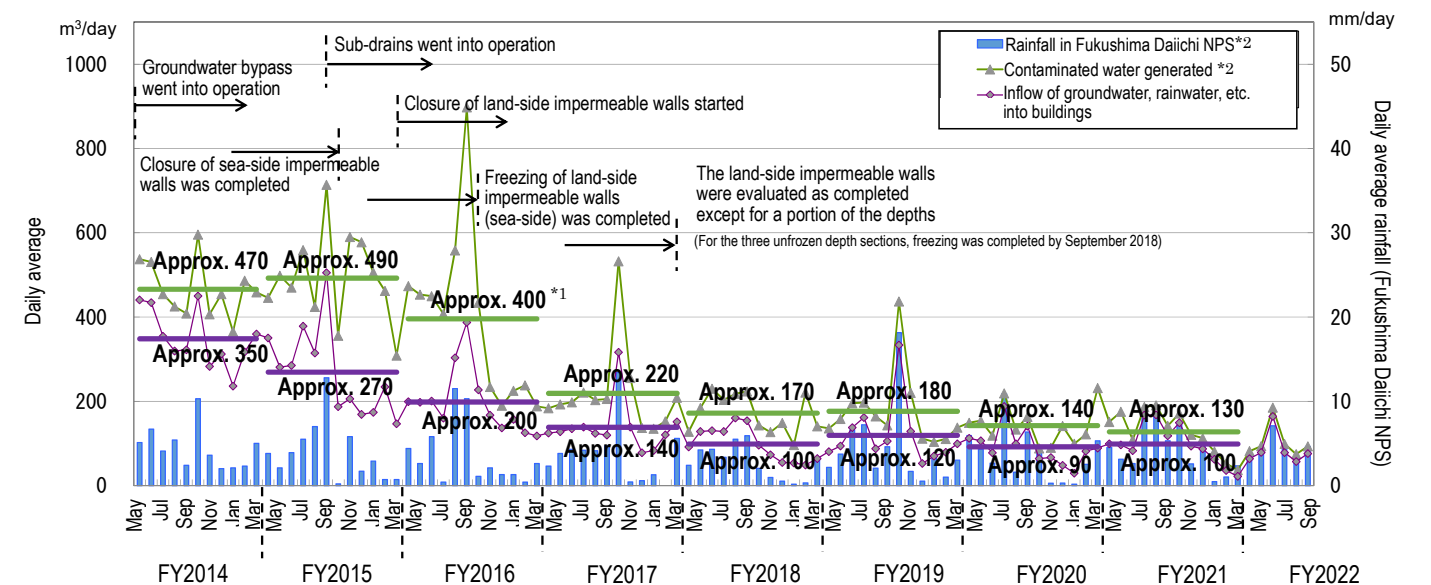
Figure 1: Changes in contaminated water generated and inflow of groundwater and rainwater into buildings

➤ Status of contaminated water generated

- Multi-layered measures, including pumping up by sub-drains and land-side impermeable walls, which were implemented to control the continued generation of contaminated water, suppressed the groundwater inflow into buildings.
- After implementing “redirecting” measures (groundwater bypass, sub-drains, land-side impermeable walls and others) and rainwater prevention measures, including repairing damaged portions of building roofs, the amount of contaminated water generated within FY2021 declined to approx. 130 m³/day.
- Measures will continue to further reduce the amount of contaminated water generated.

*1 Values differ from those announced at the 20th Committee on Countermeasures for Contaminated Water Treatment (held on August 25, 2017) because the method of calculating the contaminated water volume generated was reviewed on March 1, 2018. Details of the review are described in the materials for the 50th and 51st meetings of the Secretariat of the Team for Countermeasures for Decommissioning and Contaminated Water Treatment.
*2: The monthly daily average is derived from the daily average from the previous Thursday to the last Wednesday, which is calculated based on the data measured at 7:00 on every Thursday.

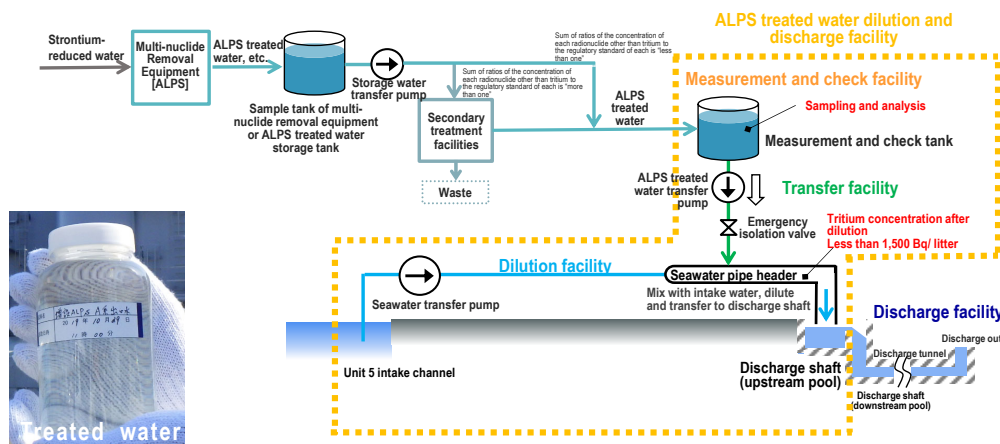
[Overview of ALPS treated water dilution and discharge facility]

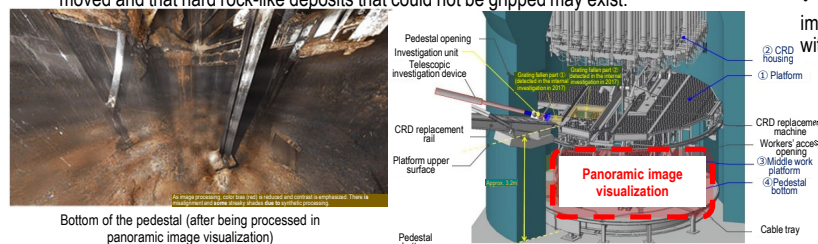
Unit 2 Investigation overview

- In January 2017, a camera was inserted from the PCV penetration to inspect the conditions of the rail on which the robot traveled. The results of a series of investigations confirmed some gratings had fallen and deformed as well as a quantity of deposit inside the pedestal.

- In January 2018, the conditions below the platform inside the pedestal were investigated. Based on the analytical results of images obtained in the investigation, deposits, probably including fuel debris, were found at the bottom of the pedestal. Moreover, multiple parts exceeding the surrounding deposits were also detected. We presumed that there were multiple instances of fuel debris falling.

- In February 2019, an investigation touching the deposits at the bottom of the pedestal and on the platform was conducted and confirmed that the pebble-shaped deposits, etc. could be moved and that hard rock-like deposits that could not be gripped may exist.

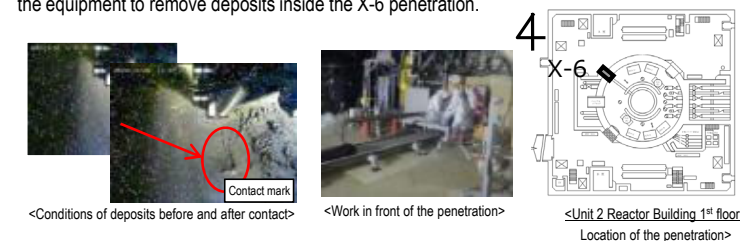
- In October 2020, as part of work to prepare for the PCV internal investigation and trial retrieval, a contact investigation to study deposits inside the penetration (X-6 penetration) was conducted, which involved inserting a guide pipe incorporating an investigative unit into the penetration. This confirmed that deposits inside the penetration had not deformed and come unstuck. The investigative information obtained will be utilized in the mockup test of the equipment to remove deposits inside the X-6 penetration.

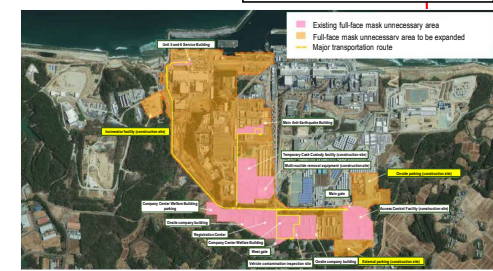
In May 2013, areas excluding those around Unit 1-4, tank areas and rubble storage areas were set to full-face mask unnecessary areas.

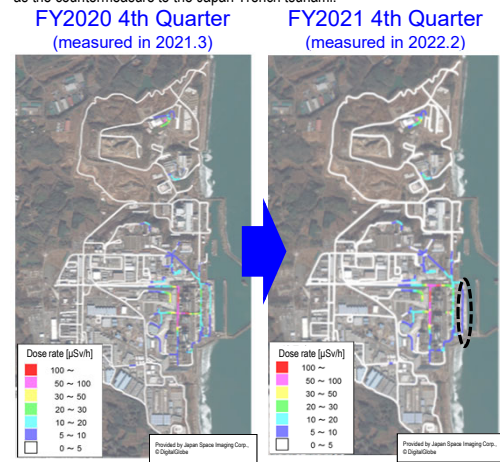
<Travel survey results of major roads within the site>
The dose rate has been declining every year. In particular, in the area on the east side of the Turbine Building shown a black dotted line, the dose rate declined by facing related to installation of the seawall as the countermeasure to the Japan Trench tsunami.
