Main decommissioning work and steps

Fuel removal from the spent fuel pool was completed in December 2014 at Unit 4 and on February 28, 2021 at Unit 3.
 Work continues sequentially toward the start of fuel removal from Units 1 and 2 and debris (Note 1) retrieval from Units 1-3.
 (Note 1) Fuel assemblies having melted through in the accident.

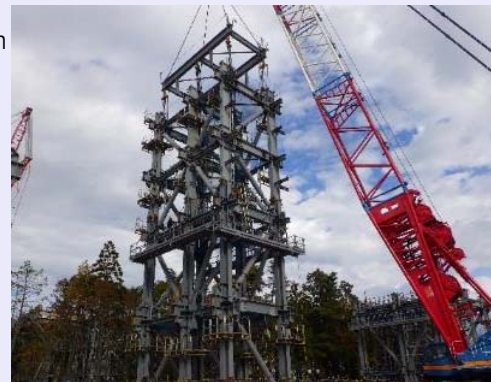
<Steel frame unit connection verification (November 5, 2022)>

Outside the building, the gantry is being installed and concrete placement of the 2nd (final) layer for the gantry foundation is underway from September 13. Outside the site, ground assembly of steel frames proceeds from August 31 and assembled steel frames will be carried in from mid-January for on-site assembly.

- Outside the building, construction of a gantry foundation has been underway since June 2022. After the construction is completed, steel structure erection will commence. Outside the site, before erecting the steel structure, ground assembly continues.

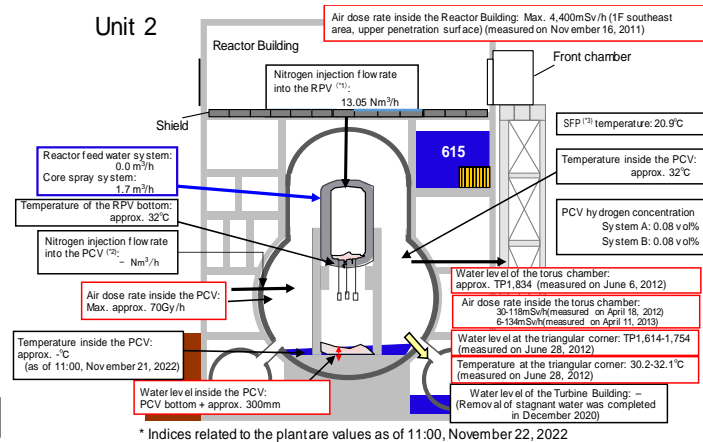
Through continuous reactor cooling by water injection, the temperatures of the Reactor Pressure Vessel (RPV) bottom and the Primary Containment Vessel (PCV) gas phase were maintained within the range of approx. 20 to 35°C for the past month, though it varied depending on the unit and location of the thermometer.

*1 The trend graphs show part of the temperature data measured at multiple points.
*2 A part of data could not be measured due to maintenance and inspection of the facility and other work.

(*1) RPV (Reactor Pressure Vessel)
(*2) PCV (Primary Containment Vessel)
(*3) SFP (Spent Fuel Pool)

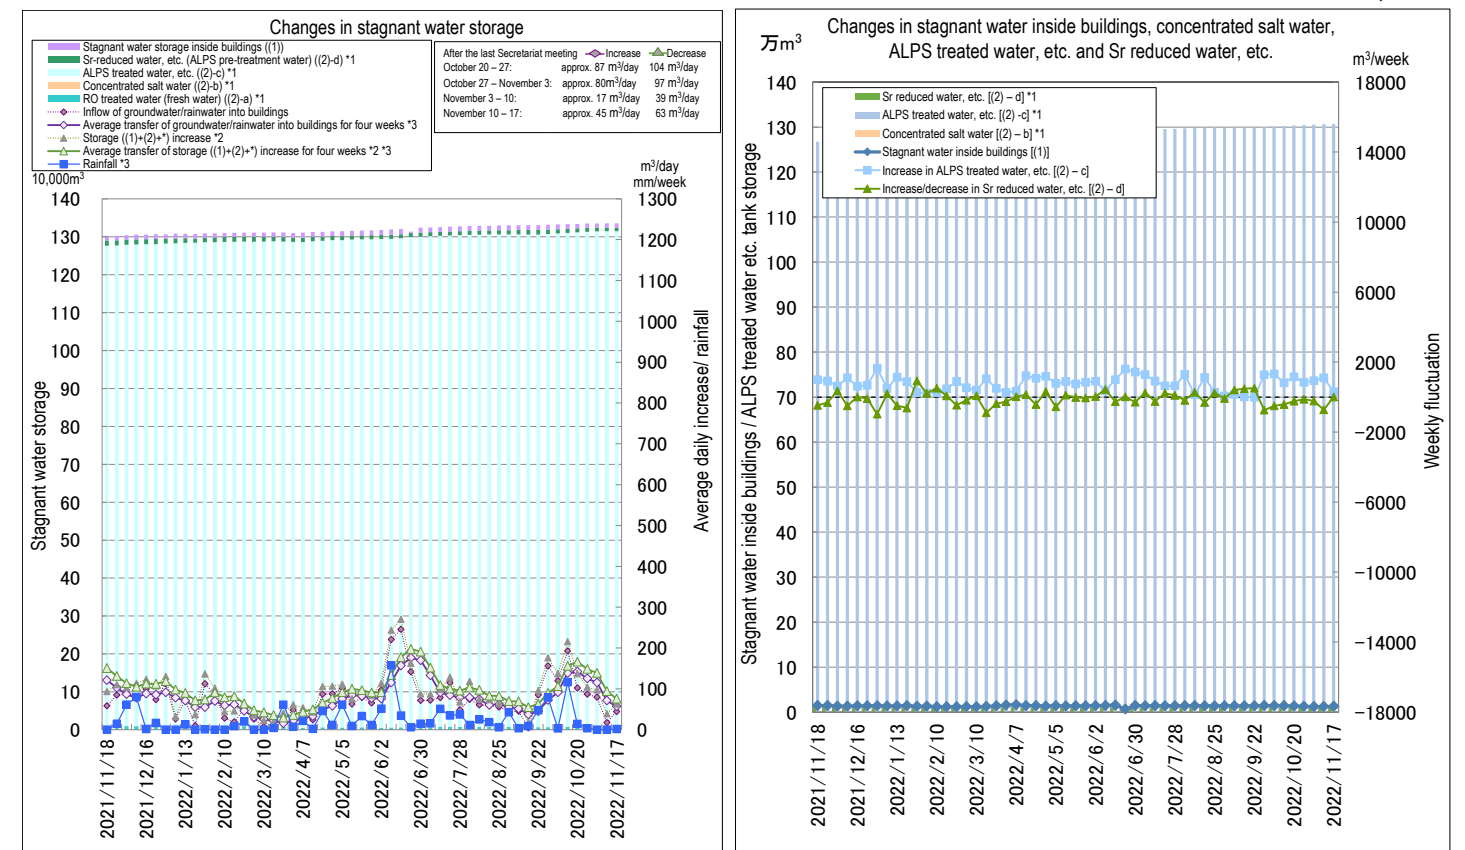
Figure 3: Status of stagnant water storage

- To reduce the risks of strontium-reduced water, treatment using existing, additional and high-performance multi-nuclide removal equipment is underway. Up until November 17, 2022, approx. 861,000 m³ had been treated.

(1) Stagnant water storage inside buildings (Units 1-4, Process Main Building, High Temperature Incinerator Building, Waste Liquid Supply Tank, SPT (B))
 (2) Units 1-4 tank storage ((2)-a RO treated water (fresh water)) + ((2)-b Concentrated salt water) + ((2)-c ALPS treated water, etc.) + ((2)-d Sr-reduced water, etc. (ALPS pre-treatment water))
 *: Water amount from tank bottom to water-level gauge 0% (DS)
 *1: Water amount for which the water-level gauge indicates 0% or more
 *2: Calculated in the method of contaminated water generated [(Inflow of groundwater/rainwater into buildings) + (other transfer) + (chemical injection into ALPS)]
 *3: Average transfer of storage increase and groundwater/rainwater into buildings for four weeks was added (November 24, 2022)

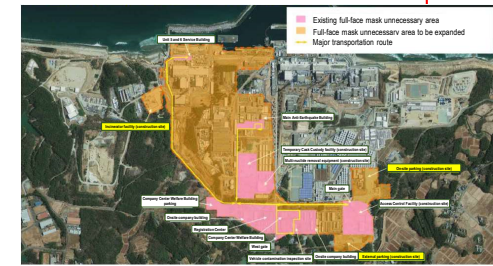
In May 2013, areas excluding those around Unit 1-4, tank areas and rubble storage areas were set to full-face mask unnecessary areas.

From May 2013, full-face mask unnecessary area was expanded sequentially.

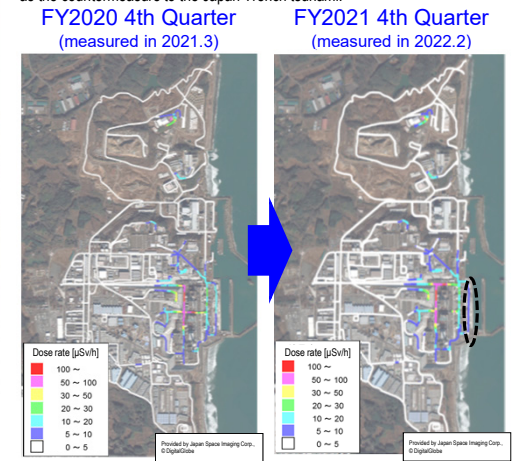
<Travel survey results of major roads within the site>
 The dose rate has been declining every year. In particular, in the area on the east side of the Turbine Building shown a black dotted line, the dose rate declined by facing related to installation of the seawall as the countermeasure to the Japan Trench tsunami.
