## Main decommissioning work and steps

## Progress status

## I. Confirmation of the reactor conditions

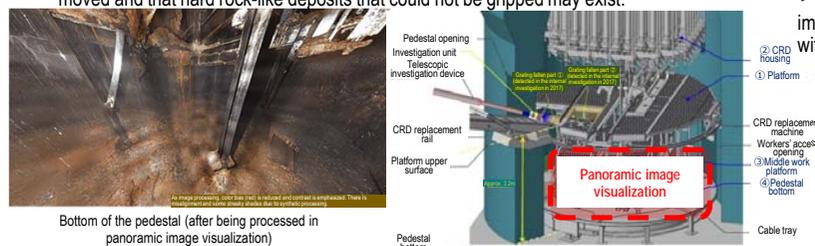
- In January 2017, a camera was inserted from the PCV penetration to inspect the conditions of the rail on which the robot traveled. The results of a series of investigations confirmed some gratings had fallen and deformed as well as a quantity of deposit inside the pedestal.

- In January 2018, the conditions below the platform inside the pedestal were investigated. Based on the analytical results of images obtained in the investigation, deposits, probably including fuel debris, were found at the bottom of the pedestal. Moreover, multiple parts exceeding the surrounding deposits were also detected. We presumed that there were multiple instances of fuel debris falling.

- In February 2019, an investigation touching the deposits at the bottom of the pedestal and on the platform was conducted and confirmed that the pebble-shaped deposits, etc. could be moved and that hard rock-like deposits that could not be gripped may exist.

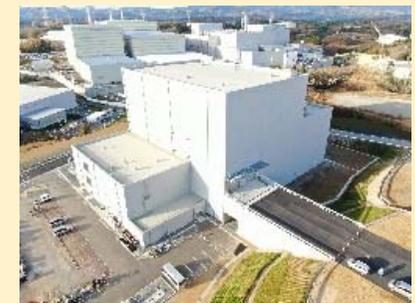
To incinerate trimmed trees and combustible rubble (woods, packing materials, paper and others), work to install the Additional Solid Waste Facility is underway.

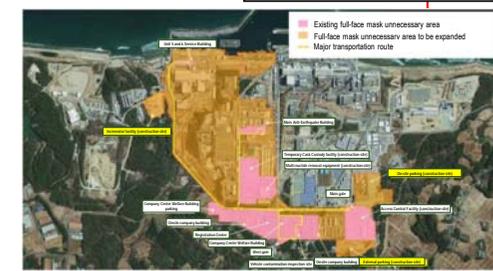
From May 2013, full-face mask unnecessary area was expanded sequentially.

In May 2013, areas excluding those around Unit 1-4, tank areas and rubble storage areas were set to full-face mask unnecessary areas.

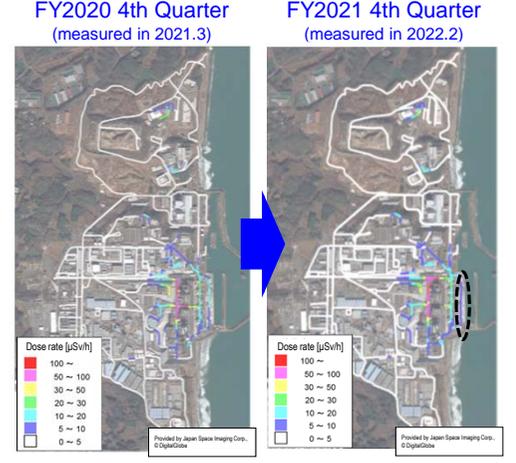
<Travel survey results of major roads within the site>  
The dose rate has been declining every year. In particular, in the area on the east side of the Turbine Building shown a black dotted line, the dose rate declined by facing related to installation of the seawall as the countermeasure to the Japan Trench tsunami.
